3.2.2 Definition of the main weak points of the investigated test sites

Deliverable Number 3.2.2

Project Acronym	PMO-GATE
Project ID Number	10046122
Project Title	Preventing, Managing and Overcoming natural-hazards risk to mitiGATE economic and social impact
Priority Axis	2: Safety and Resilience
Specific objective	2.2: Increase the safety of the Programme area from natural and man-made disaster
Work Package Number	3
Work Package Title	Assessment of single-Hazard exposure in coastal and urban areas
Activity Number	2
Activity Title	Assessment of meteo-tsunami exposure in coastal areas
Partner in Charge	UNIVERSITY OF SPLIT, FACULTY OF CIVIL ENGINEERING, ARCHITECTURE AND GEODESY
Partners involved	UNIVERSITY OF SPLIT, FACULTY OF CIVIL ENGINEERING, ARCHITECTURE AND GEODESY
Status	Final
Distribution	Public

1.2 Description of the test site – Kaštel Kambelovac

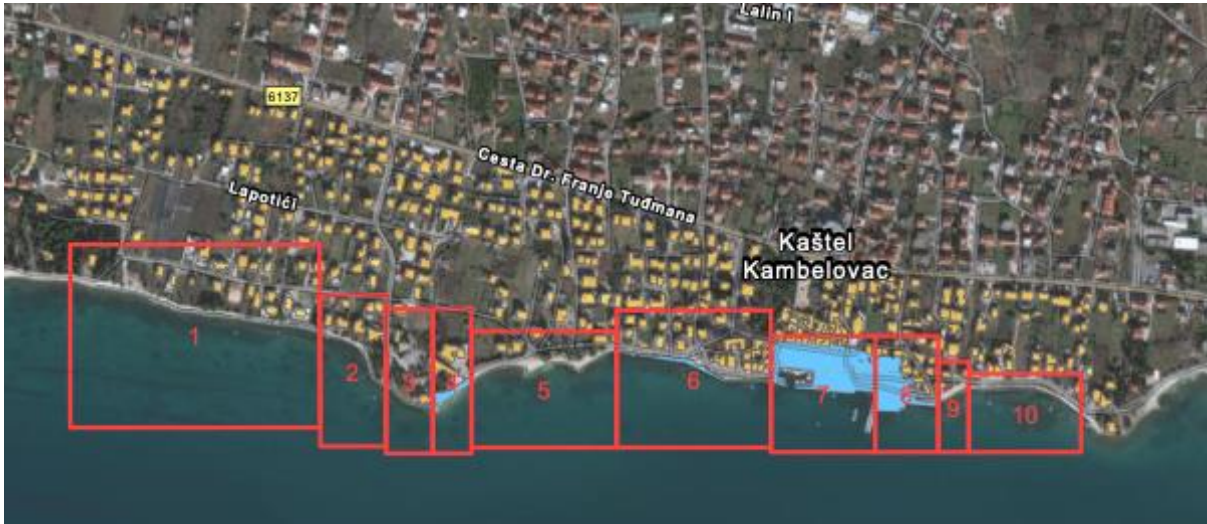
Figure 3. Flood extend in relation to exposed objects

Besides historical and public objects, the rest is mostly related to household and residential objects. Regarding these buildings, it is expected that objects near the coastal line and more sensitive to flooding. However, compared to protected households in the historical area, it is common to expect that recently built objects have higher adaptive capacity and the possibility to adjust to changing conditions. Regarding the identified endangered infrastructure, there is no record on significant infrastructure on the particular test site, only a local road placed along the coastal line of test site.
