# Determination of vulnerability indexes for buildings and infrastructures designed to protect the territory of Ferrara from flood - Part b -

Deliverable Number D.3.3.2.

<b>Project Acronym</b>	PMO-GATE
<b>Project ID Number</b>	10046122
<b>Project Title</b>	Preventing, Managing and Overcoming natural-hazards risk to mitiGATE economic and social impact
<b>Priority Axis</b>	2: Safety and Resilience
<b>Specific objective</b>	2.2: Increase the safety of the Programme area from natural and man-made disaster
<b>Work Package Number</b>	3
<b>Work Package Title</b>	Assessment of single-Hazard exposure in coastal and urban areas
<b>Activity Number</b>	3.3
<b>Activity Title</b>	Assessment of climate-unrelated hazards exposure in urban and coastal areas (seismic action)
<b>Partner in Charge</b>	UNIFE
<b>Partners involved</b>	UNIFE
<b>Status</b>	Final
<b>Distribution</b>	Public

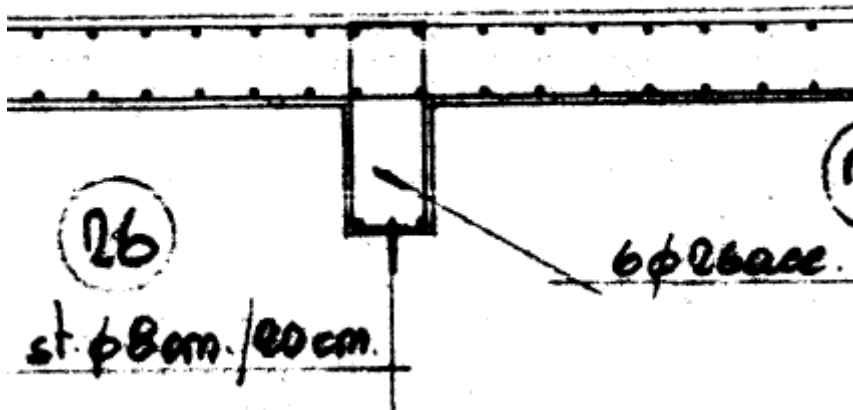
The bending moment capacity has been obtained by means of the VcaSlu software. The results obtained highlight a strong shear vulnerability on the short columns especially in the Y direction. The corresponding safety factor is 8% (section  $40 \times 100$ ).

Figure 11. Steel reinforcement in  $40 \times 100$  columns.

As expected, the most vulnerable elements are the short columns at the base, on which the highest values of shear and moment stresses are concentrated. In addition to the lack of slenderness, they have a variable section that gets thinner as it approaches the height of the seismic zero: the section is therefore weaker where there are the greatest shear and bending moment stresses.

With the assumptions adopted in this model, the safety level appears to be 8%. A first proposal, obviously not feasible, of intervention is to close the openings in the partitions at the base by casting new concrete elements collaborating with the existing columns. This would eliminate the weak sections, allowing the distribution of the total shear force on all the walls instead of only on the pillars.

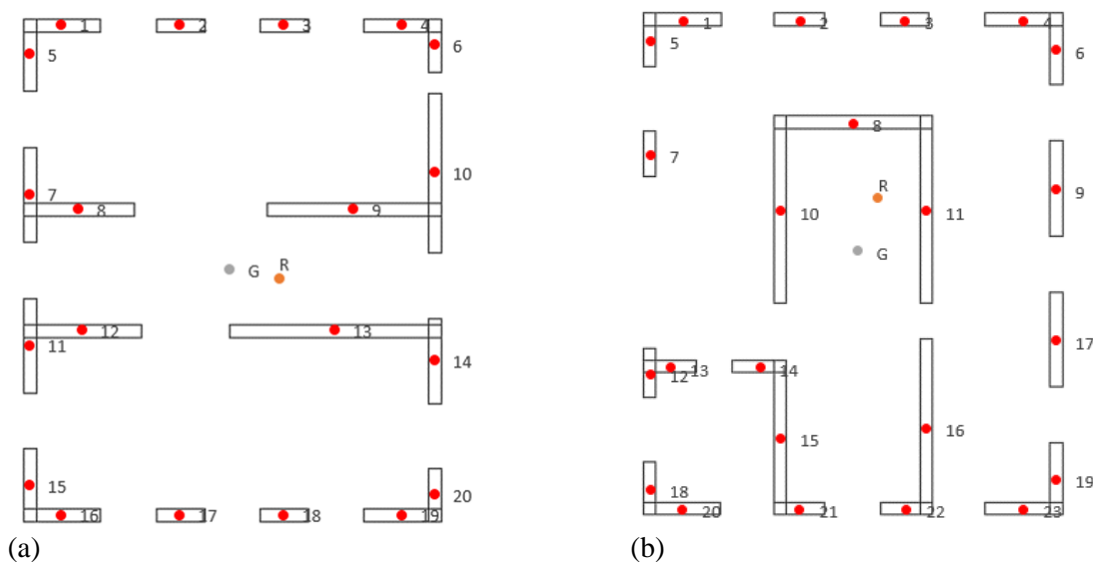
In the lateral bodies, some masonry walls are unverified to vertical loads. This can be attributed both to the high eccentricity of the loads and to the factorization used. The verification was limited to the walls of the ground floor as they are more loaded.

Figure 18. (a): left building, non verified walls: 1,2,3,4,16,17,18,19; (b): right building, non-verified walls: 6,7,9,12,15,17,19.

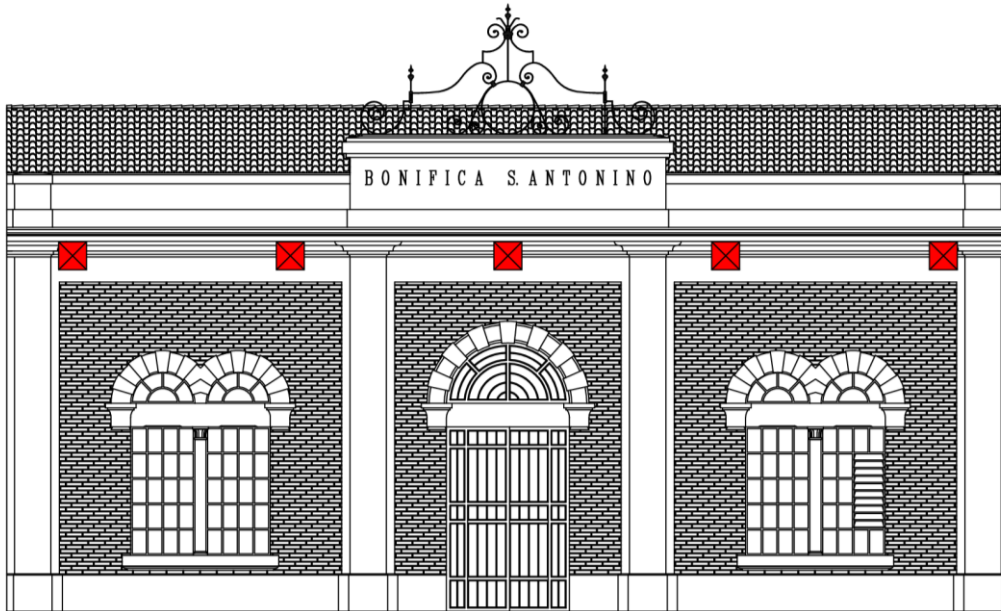
As can be seen from the calculations, the verifications against simple overturning of the entire façade are not satisfied. Therefore, to improve the existing safety level with regard to the seismic action, it is suggested to insert tie-rods at the level of the intrados of the beams carrying the attic floor.

*Figura 20. Disposizione dei tiranti sul prospetto Nord.*

In order to carry out the necessary verifications, S275 steel tie-rods with a diameter of mm 20 mm, on a 50x50 cm square plate have been adopted.

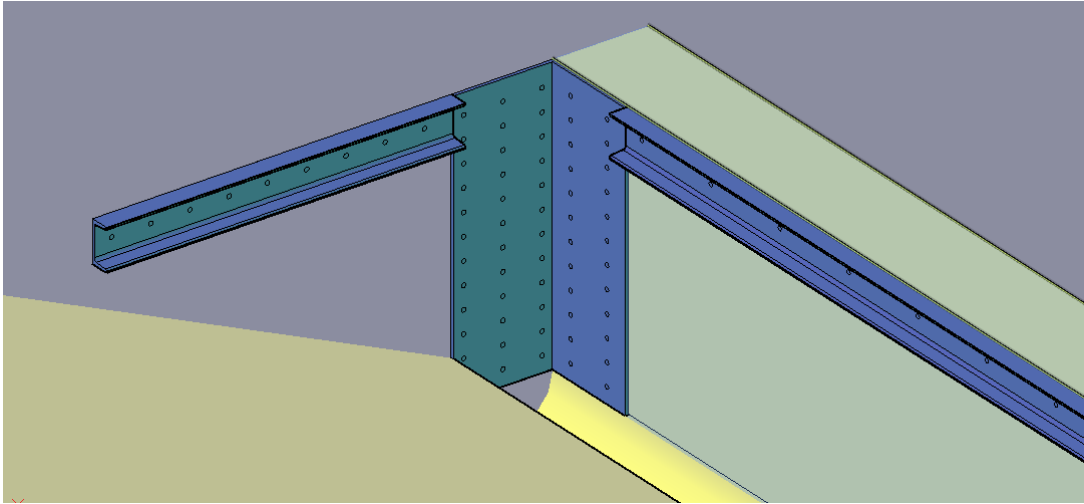
*Figure 21. 3D particular of the proposed overturning restraining system.*

In order to remedy the partial (top) overturning of the walls on the North and South side, it is possible to install an overturning restraining system anchored to the wall and to the side buildings that prevent the occurrence of this mechanism.

For this purpose, it is possible to prevent overturning by installing a UPN120 type metal profile at the upper edge of this wall using bolts fixed with chemical anchors. At the end of this profile it was decided to weld an L-shaped plate 30x30x82 cm with a thickness of 10 mm and to continue on the wall of the adjacent building by welding an additional UPN profile to the plate for another 125 cm. The use of this plate was necessary in order to be able to install an adequate number of bolts, since the weak point of the connections with the use of chemical anchors in the masonry is the low shear strength declared by the manufacturers of these anchors.

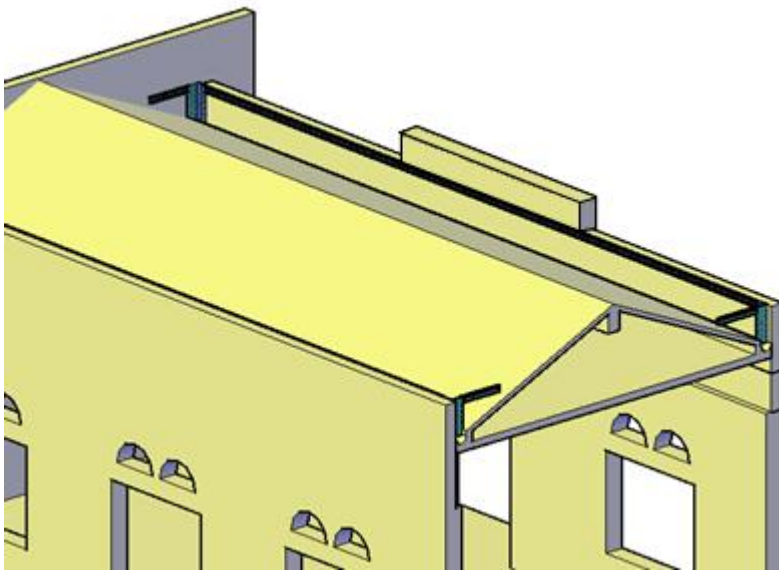
*Figure 22. 3D global scheme of the proposed overturning system.*

The proposed interventions are aimed at averting the most serious crises identified, that is to say the total and partial reversals of the walls of the central body. The application of tie rods can prevent the tilting mechanism, while the metal curb prevents the walls from falling down at high altitude. Once these mechanisms are prevented, the subsequent vulnerabilities are found on the global analyzes of the side buildings. The application of the proposed interventions would therefore bring the safety index of the structure to 40.4% (global response to the earthquake of the building on the right) and the time of intervention to 7 years.

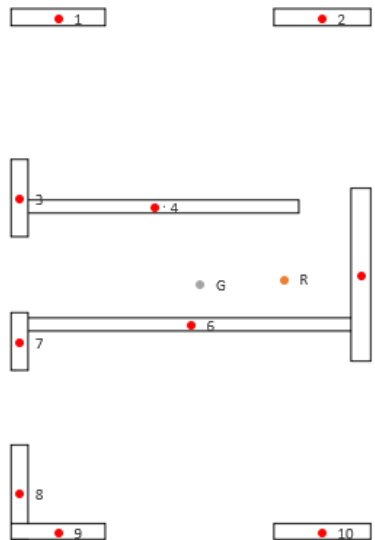
In the first hypothesis the verification is less severe, however there are still some unverified masonry walls.

Figure 27. Left building. Non-verified walls: 2,4,5,6,9,10.

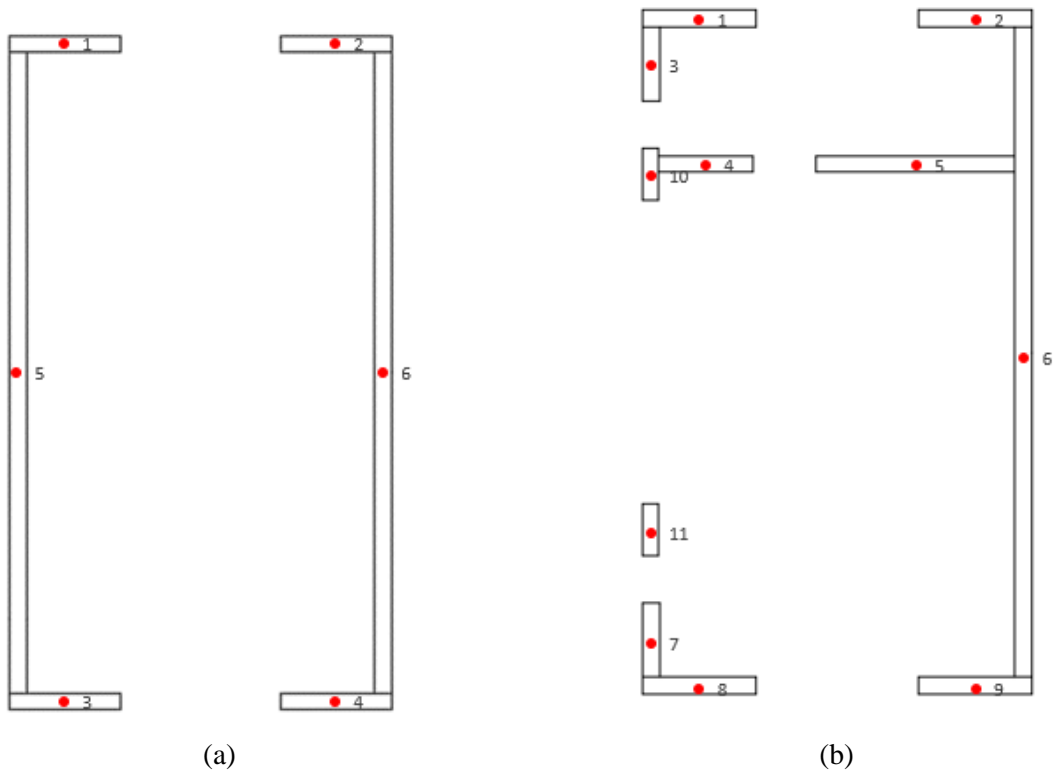
Figure 28. Right building. (a) Ground floor, non-verified walls:10,11; (b) first floor, non-verified walls:5,6.

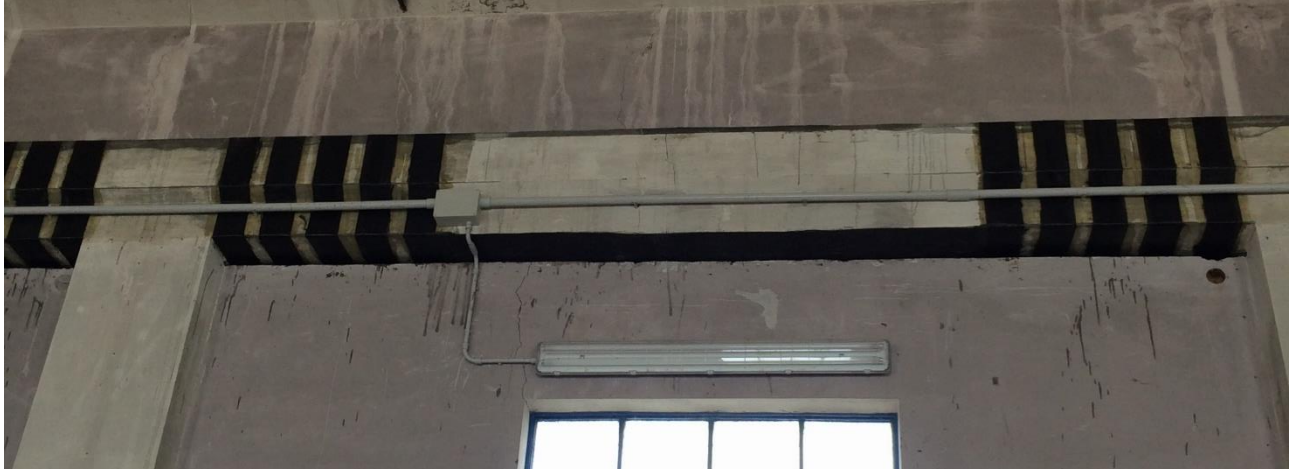
Finally, the presence of continuous vertical lesions from the base to the top of the main walls has led to the idea of a differential settlement at the level of the foundation. Given the presence of deep cracks at the extrados of the bridge crane support beams (atypical position with respect to the stresses normally induced by the loads to which it is subjected, see Figure 31), the effect that a differential settlement in the foundation was also investigated can have on the frame.

For what concerns the damage status of the bridge crane support beams (Figure 31), it was thought that it could be due to a constraining failure of one of the side portions of the system: this could have caused a redistribution of the stresses in the frame such as to stress traction the beams for use of the bridge crane.

The FEM analysis with overlapping of the yielding-vertical load effects has effectively shown, in the beams near the settlement, the presence of traction stresses concomitant with values of zero moment at the center line. The traction would therefore have caused the cracking of the concrete to the extrados of the beam (as the stresses were absorbed by the FRP reinforcement at the intrados). A resistance check on the section confirmed the hypotheses made.

*Figure 31. Damage state of the r.c. beams.*

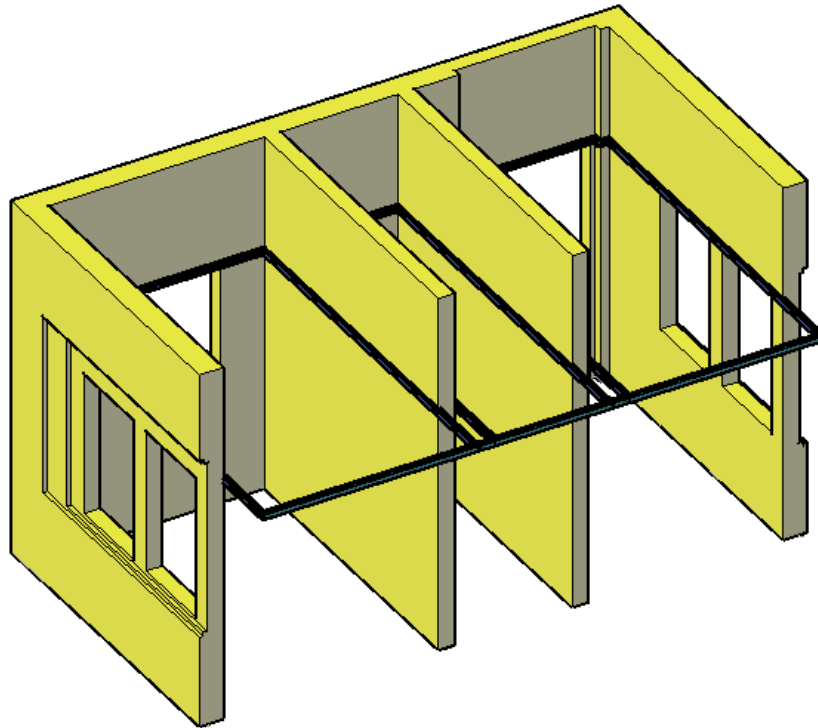
*Figure 32. Retrofit of the left building.*

In order to limit the excessive slenderness of the walls one can think of installing a metal curb at the height of the extrados of the openings, such that it prevents the masonry from going into crisis out of plane due to vertical loads. The metal curb can be made, as a first approximation, using a UPN120 type profile and anchored with masonry dowels in the order of 3-4 per meter. In Figure 32 we can see a cutaway of the left portion with the positioning of the metal curb. The installation of the metal curb allows a clear improvement in the outcome of the checks relating to the lower portion of the masonry, effectively eliminating the vulnerability to vertical loads.
