Project: “Monitoring Sea-water intrusion in coastal aquifers and Testing pilot projects for its mitigation” Interreg CBC Italy-Croatia 2014.-2020.

(D_3.1.4) Report on the initial hydrogeological and agricultural conditions of the Croatian site

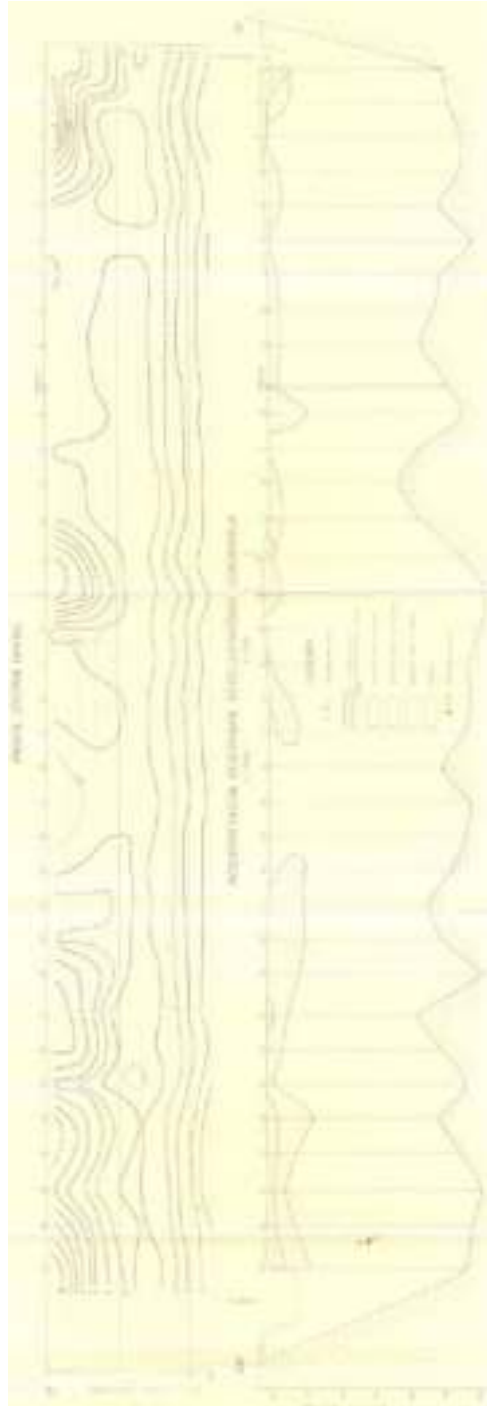
Figure 3.3 An example of the result of geoelectrical sounding

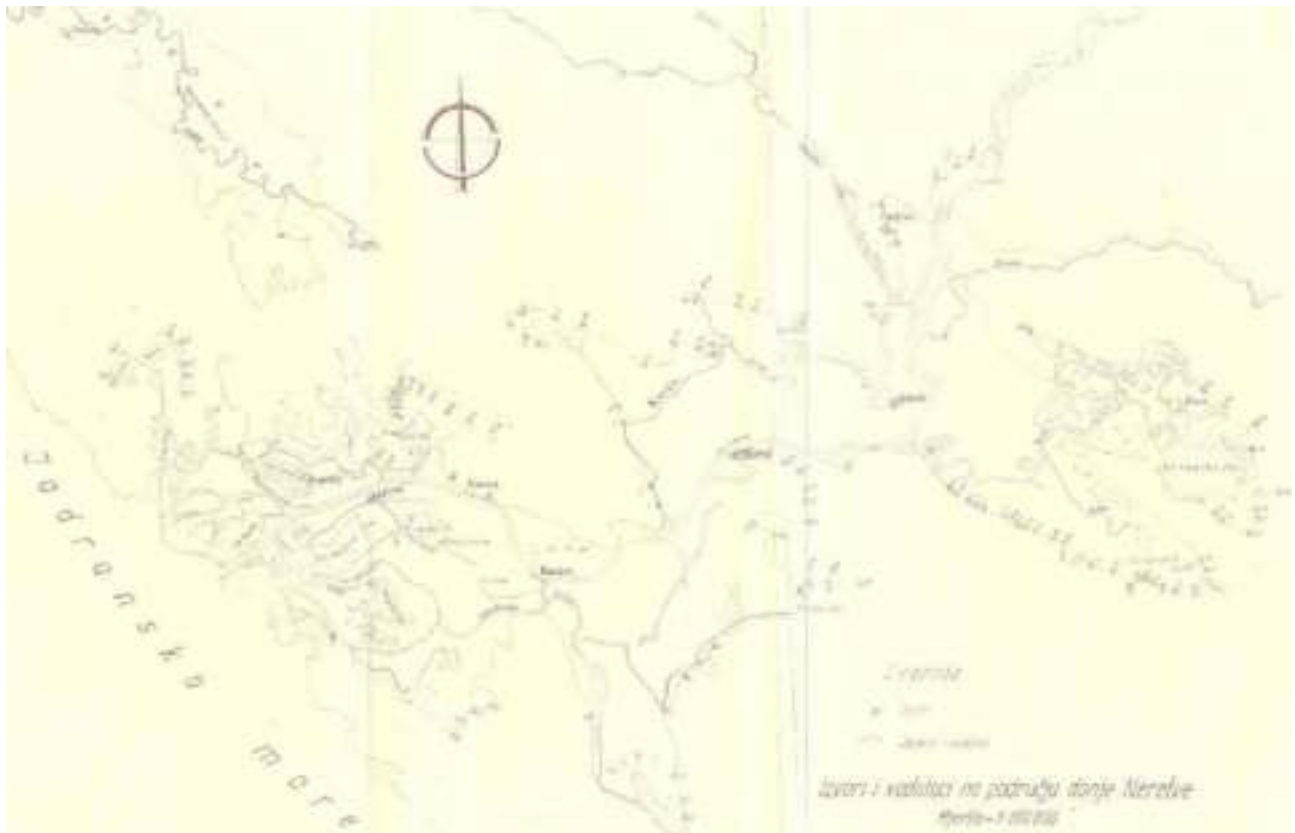
Figure 3.11 Springs and watercourses downstream of Neretva River

The whole area abounds in waters, whether the freshwater watercourses or springs and precipitation, and the main impact on it has seawater which during the high tides intrudes into the land and performs salinization of groundwater and terrain. Therefore, it is concluded that meliorations are necessary with a purpose of removing excess waters and soil desalinization to the depth required by agriculture.

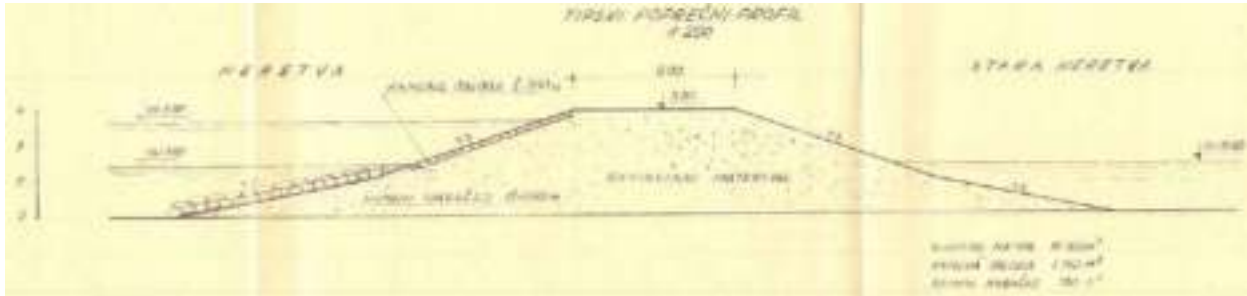
Figure 3.26 Cross section of an embankment dam at the beginning of the Stara Neretva River

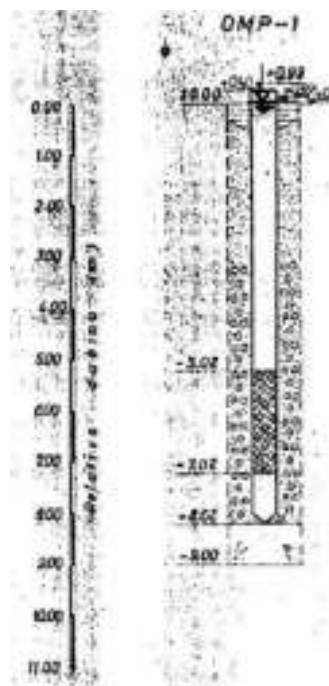
Figure 3.48 An example of technical profiles of the observation borehole

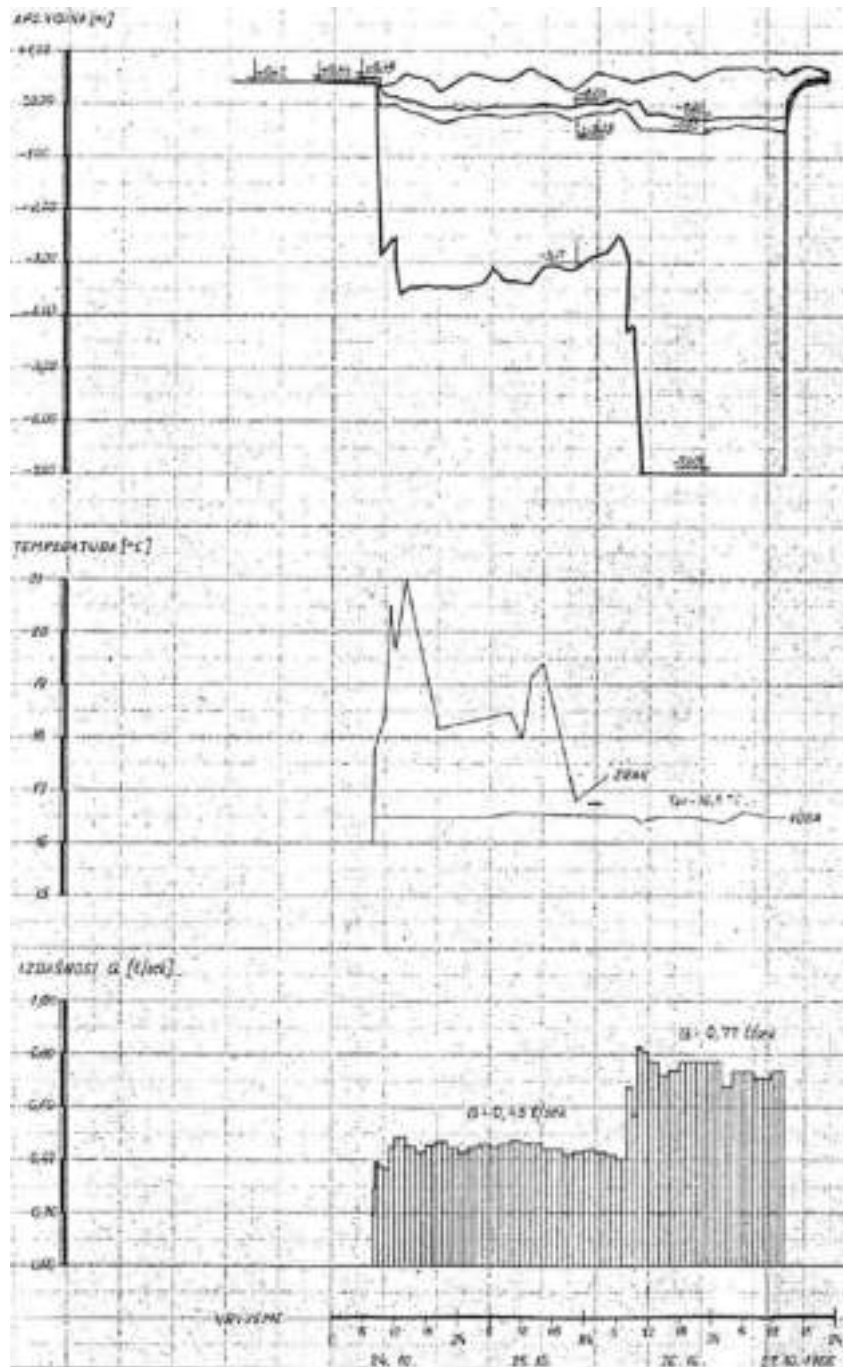
Figure 3.56 Diagram of well pumping

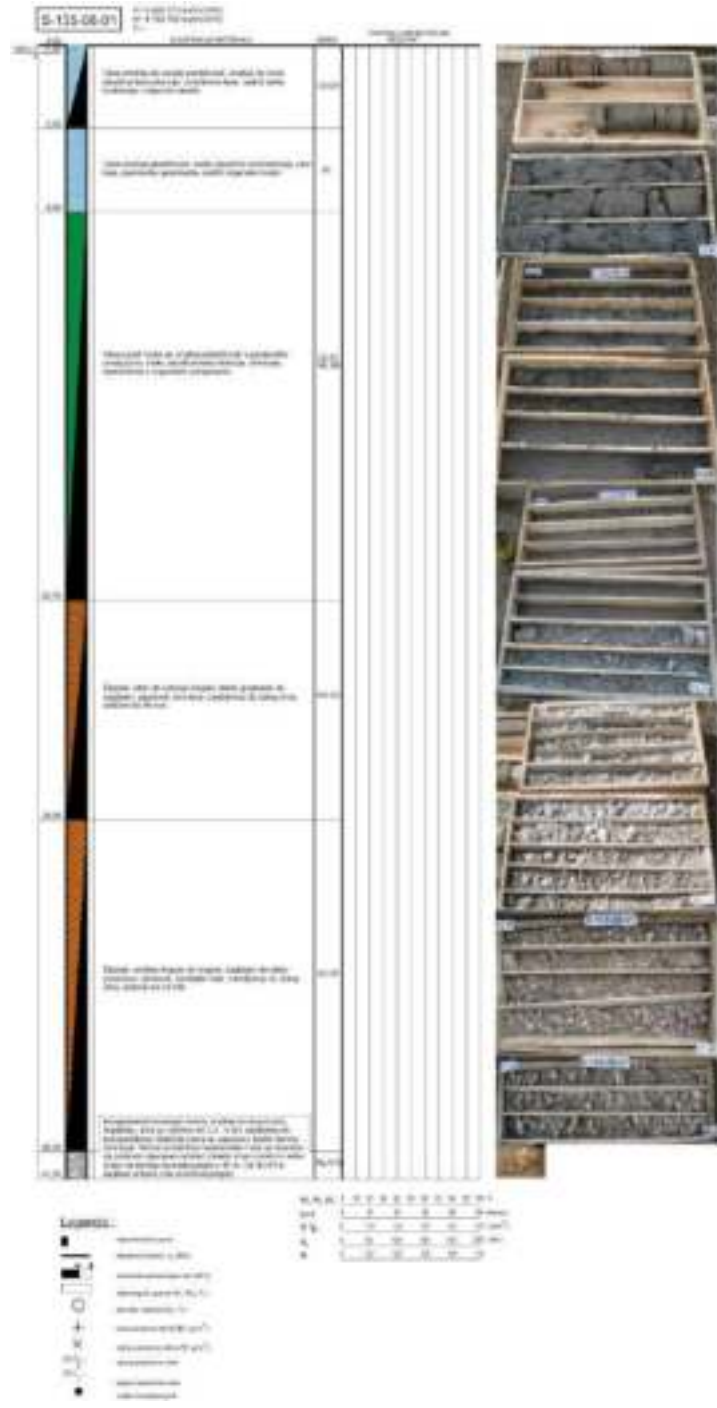
Groundwater level in open boreholes measured from the surface of the terrain is -0.2m at the first and +0.5 m at the second borehole, where artesian pressure exists and groundwater level was measured in a protective column that is elevated above the level of ground. Groundwater in the gravel layer is pressurized, so in case of foundation in these deposits, attention should be taken to buoyancy. According to data from one of the boreholes, hydrostatic pressure corresponds to the water column of $20,7\text{m} + 0,5\text{m} = 21,2\text{m}$.

Field conditions are represented by compressible surface deposits, large thickness of gravel that rises in the protective column due to buoyancy, the appearance of gravel (pebbles) up to 10cm in diameter and bedrock depth of more than 40 m.

Figure 3.72 An example of borehole profile

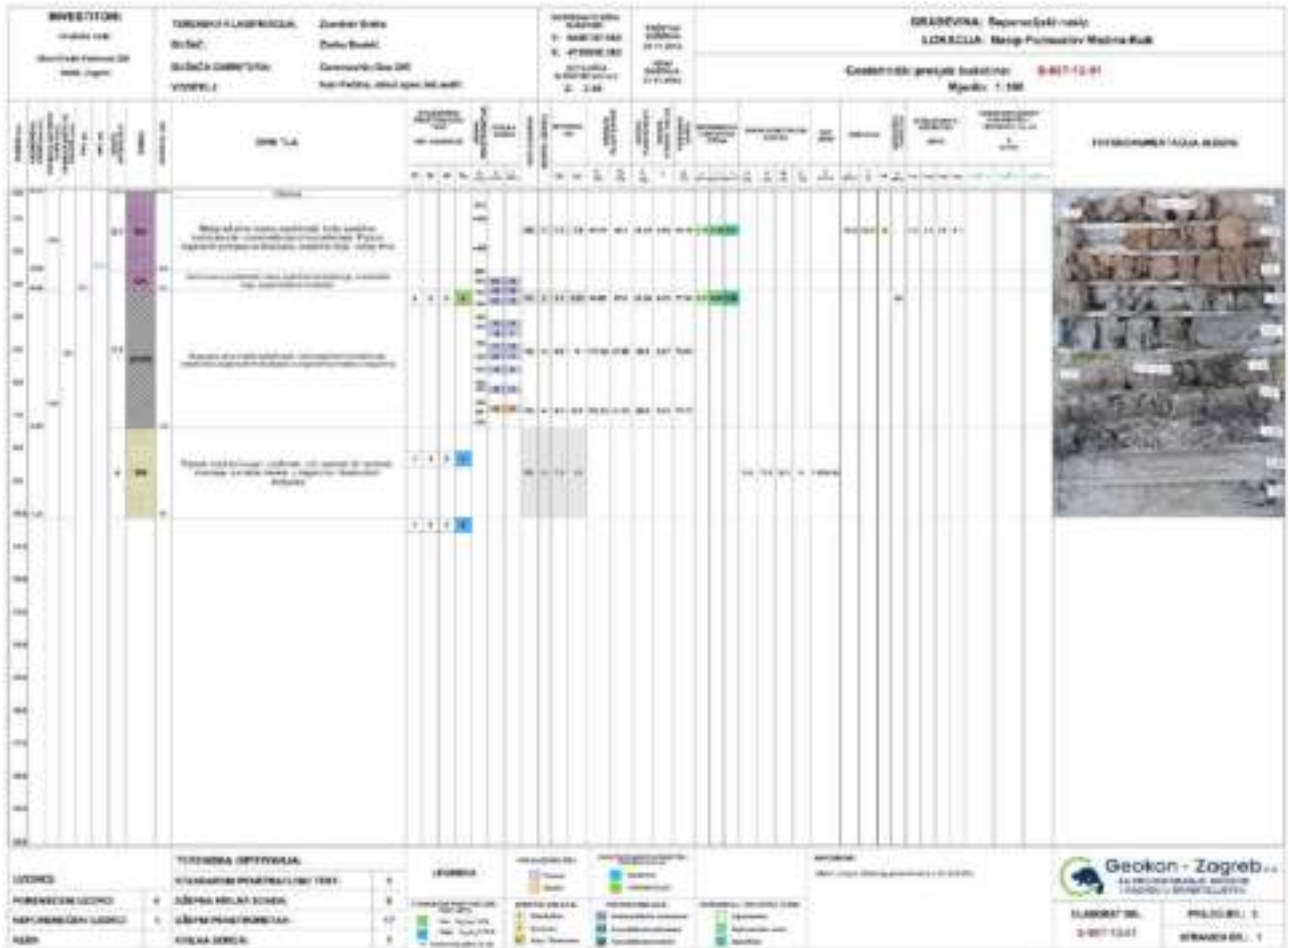
Figure 3.81 An example of borehole results

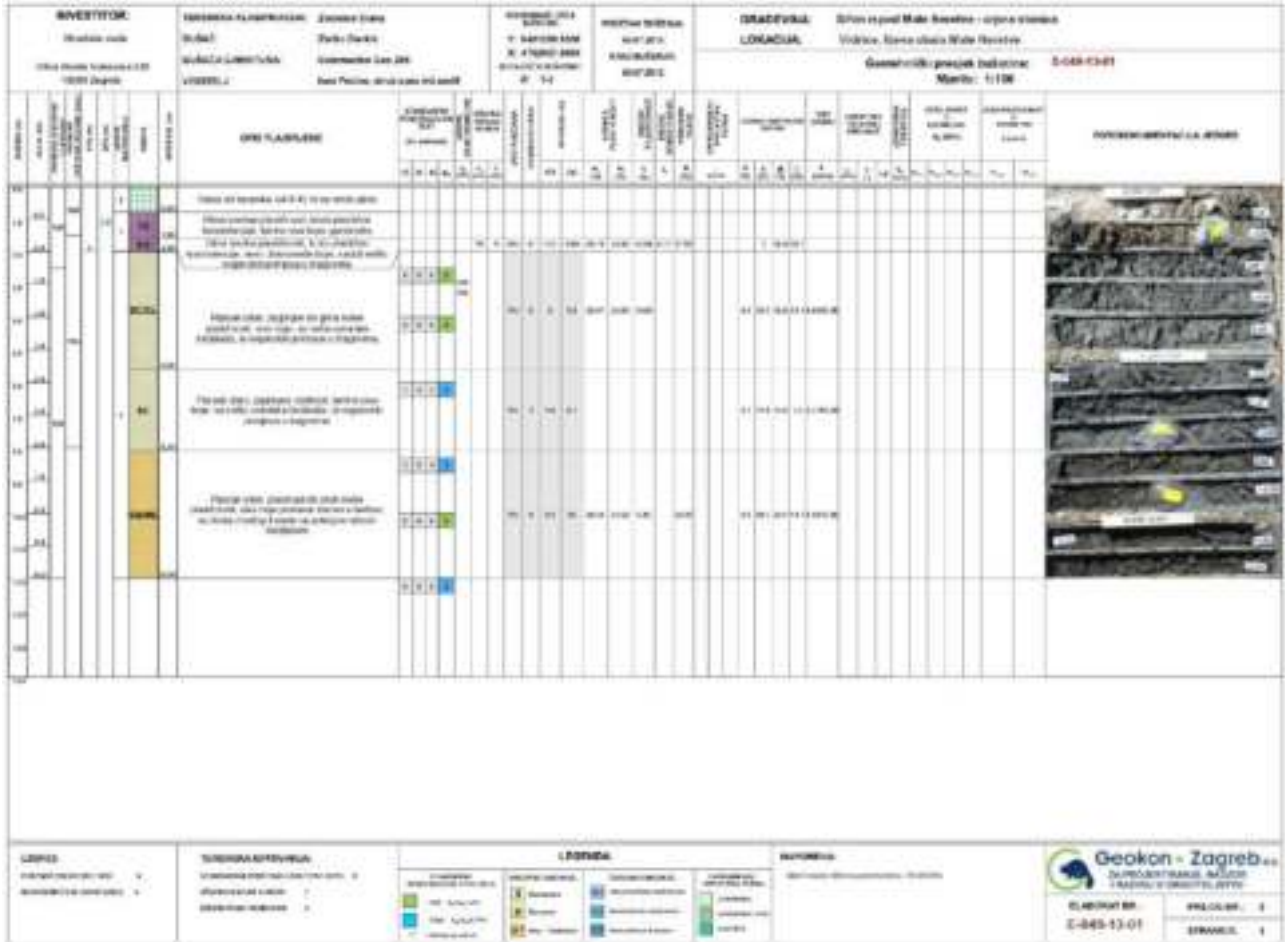
Figure 3.93 An example of borehole results

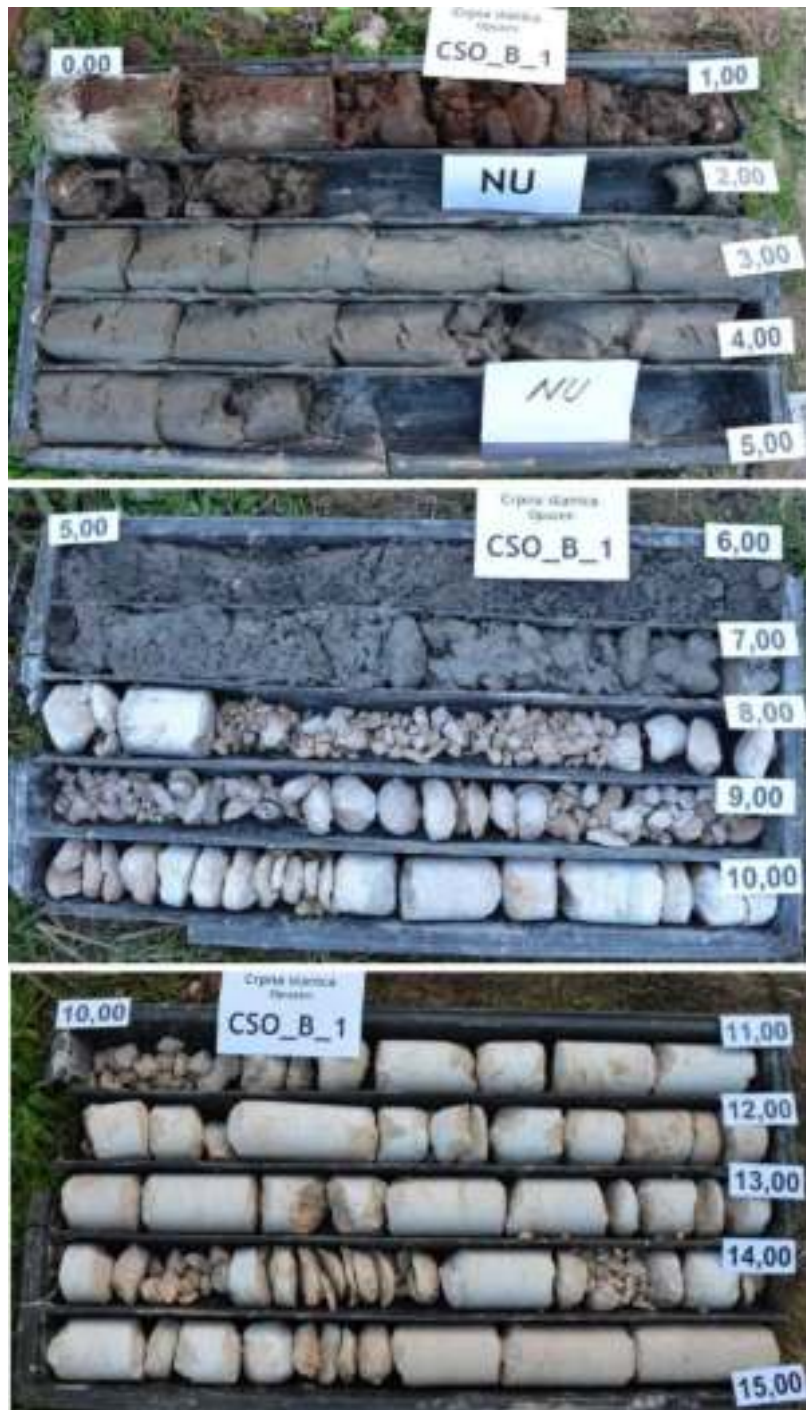
Figure 3.108 Investigation borehole core

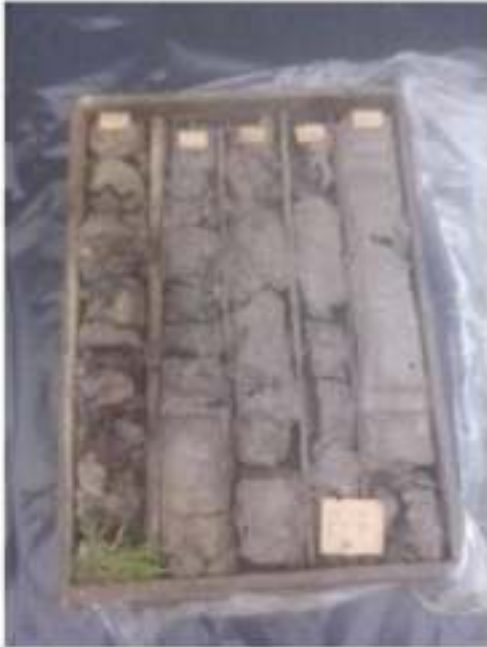
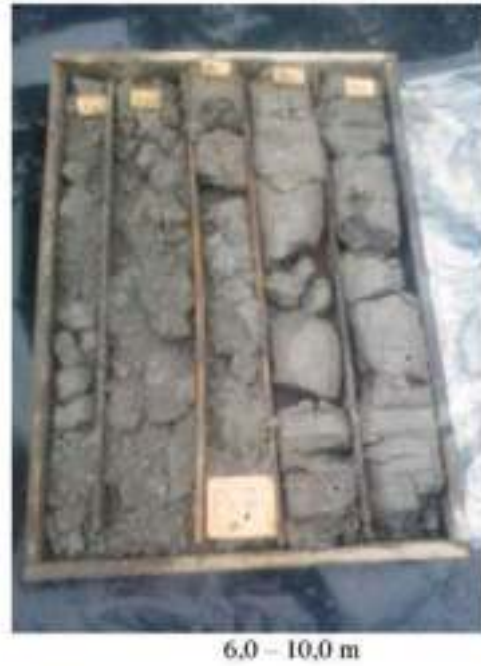
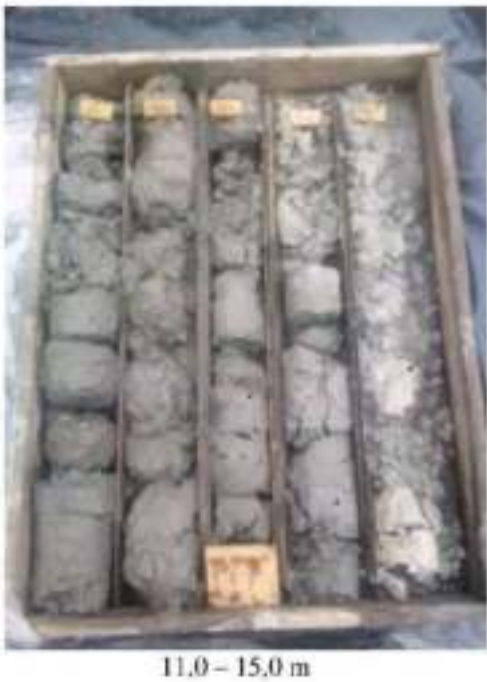
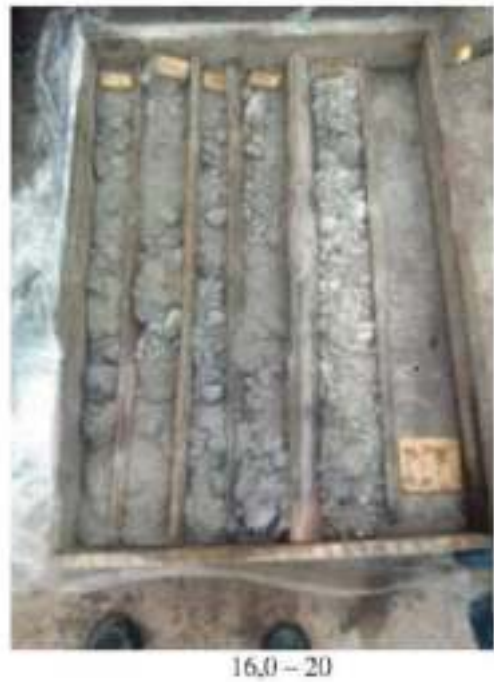
Figure 3.111 Investigation borehole core

(depths from 29.0 to 35.0 m) are made through the entire layer of silt clay and enter the lower layer that is formed of gravel with different sand content.

On the surface of the terrain, piezometers are properly protected by a concrete block. The pipe end (top of the pipe) is threaded to allow the plug (cover) to be fitted onto the piezometer. On the piezometer pipes the corresponding height is determined using a network of fixed elevation points of precise leveling in the area of the Lower Neretva. During the pumping tests, groundwater levels in piezometers were continuously measured. Immediately after the step-test and the constant-test, after the pump was switched off, the water level was measured. Logging measurements were taken on the wells P-5, P-6, and P-7 as well as DP.

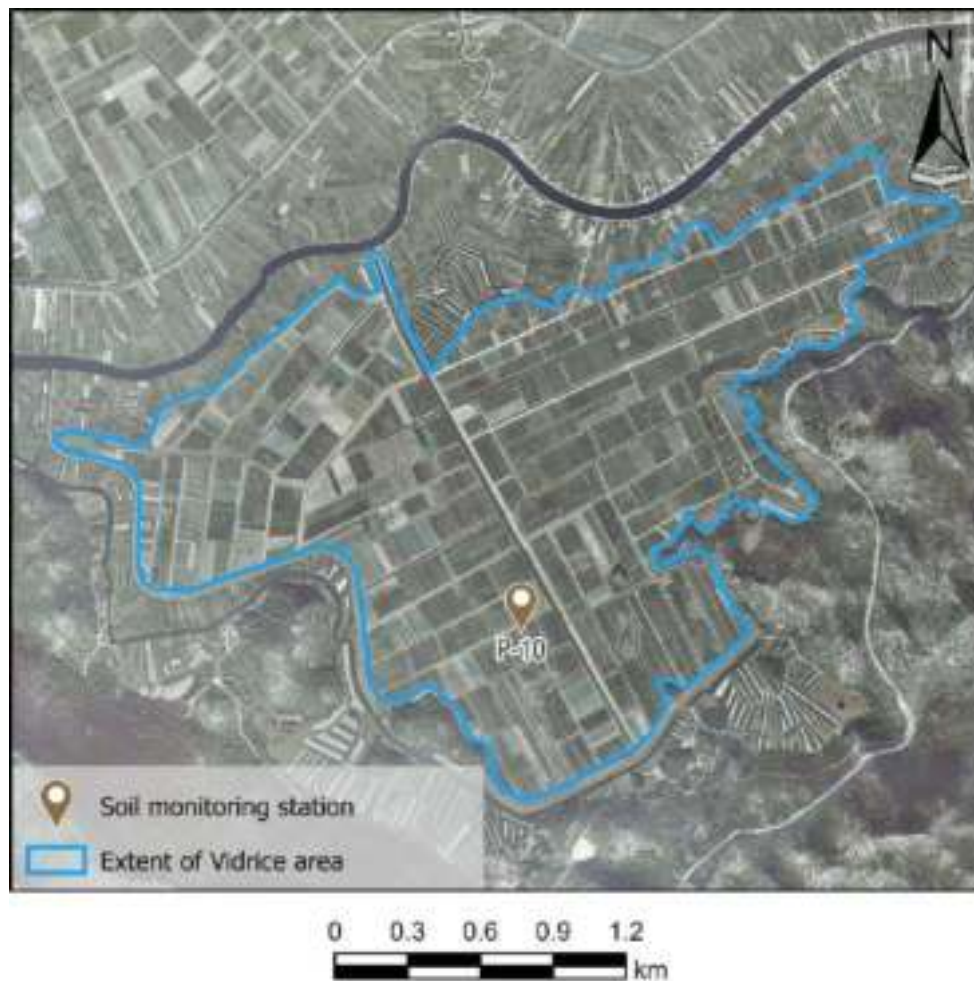
Figure 5.11 Extent of Vidrice area and location of soil quality monitoring station P-10

Soil amelioration works in Vidrice area (Figure 5.1 and Figure 5.11) started in 1970s and they were finished in 1980s. The works covered more than 400 hectares of agricultural fields. Vidrice is the southernmost region in the River Neretva Delta, and it is a pocket encompassed by Mala Neretva effluent from the North and limestone hills from remaining sides.

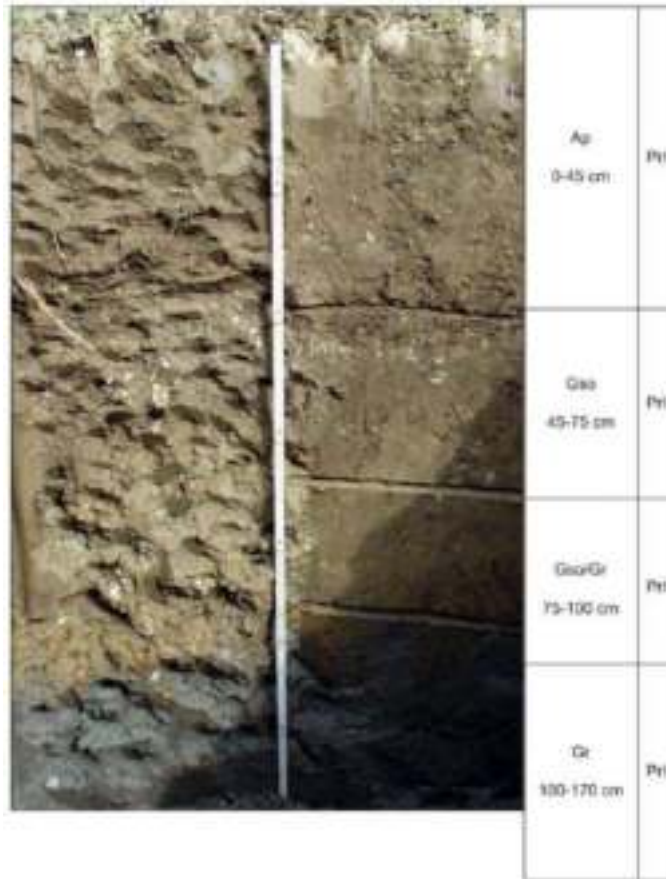
Figure 5.17 Pedological profile P-10 in Vidrice area (Figure 11)⁵

Soil quality monitoring station P-10 is established at land parcel that is being used for intensive production of mandarins with application of irrigation. Pedological profile is displayed in Figure 17 and it can be characterized as eugley, hipogley, mineral, non-carbonate, saline, anthropogenic, hydromeliorated by channels.

In the period 2014-2018, EC_e at station P-10 ranged from 0.97 to 5.0 dSm⁻¹ with average value of 3.3 dSm⁻¹ (Figure 5.19 and Table 5.2)⁵, thus 2.0 dSm⁻¹ can be taken as threshold for discrimination of saline and non-saline soils. Statistical parameters of soil quality parameters for station P-10 in period from 2014 to 2018 are listed in Table 5.2.

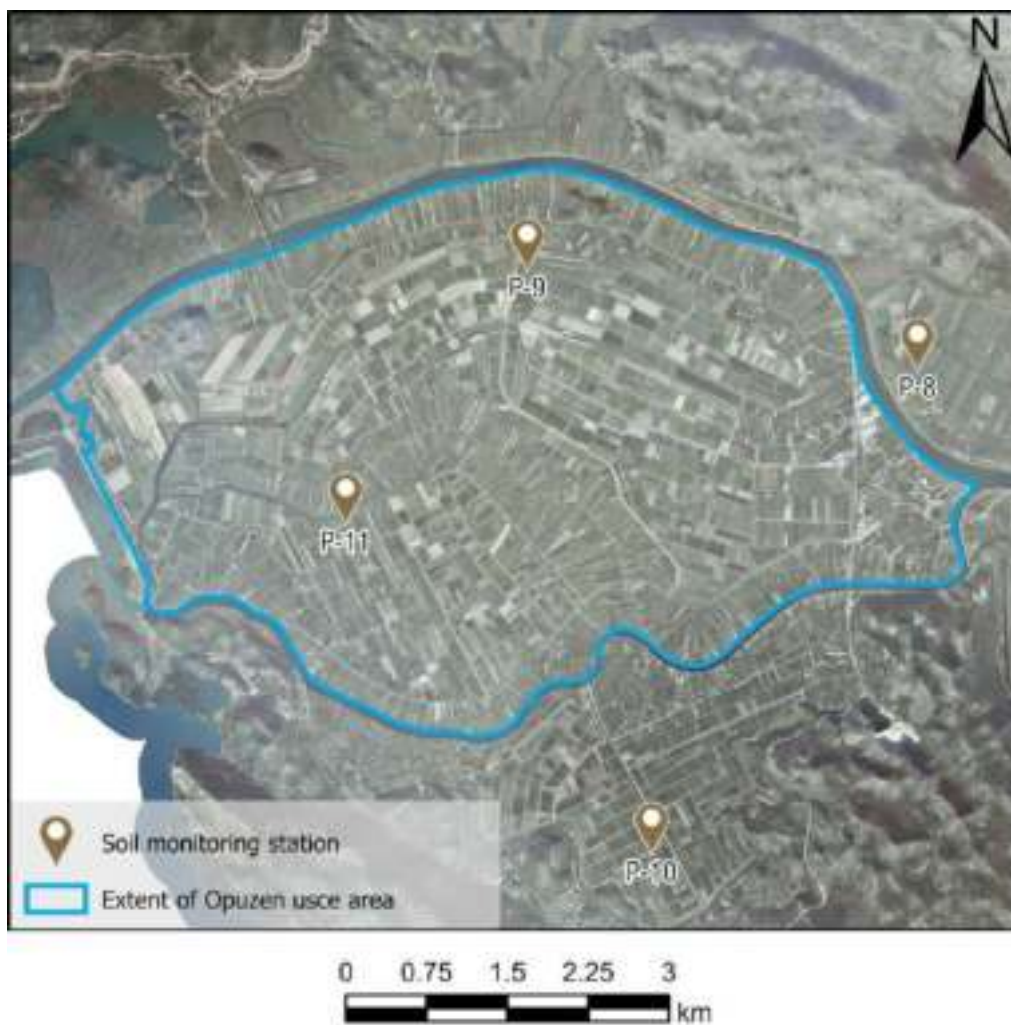
Figure 5.19 Extent of Opuzen ušće area and location of soil quality monitoring station P-9 and P-11.

Opuzen ušće (Figure 5.1 and Figure 5.19) is the single largest area in the River Neretva Delta, covering an overall area of almost 3000 hectares. It is encompassed by the river Neretva, the river effluent Mala Neretva, and the Adriatic Sea. Soil amelioration works in Opuzen ušće area started in 1960s.

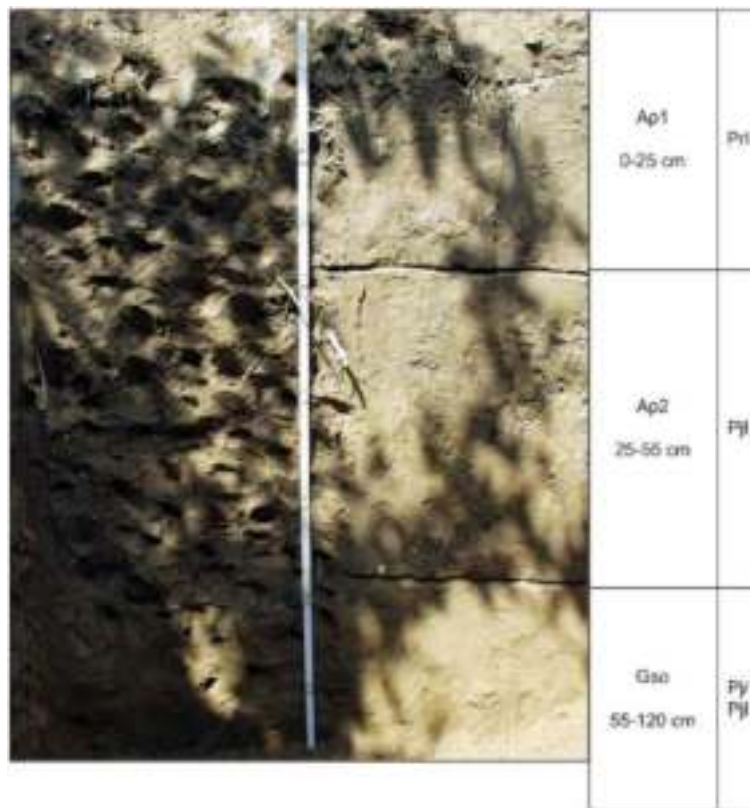
Figure 5.29 Pedological profile P-11 in Opuzen ušće area (Figure 19)⁵

Soil quality monitoring station P-11 is established at land parcel that is being used intensive production of mandarins. Pedological profile is displayed in Figure 5.29 and it can be characterized as fluvisol.

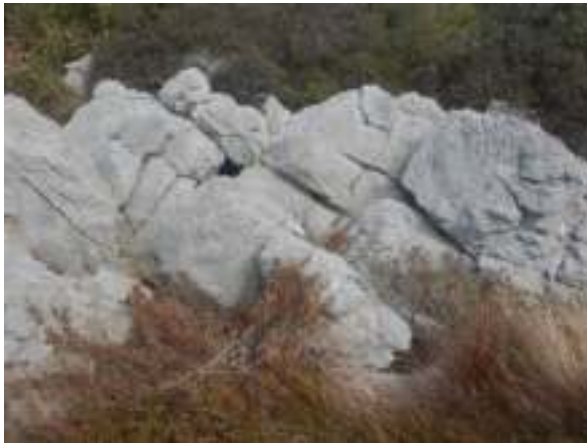
Figure 6.3 Layered limestones in the southern part of the Galičak hill

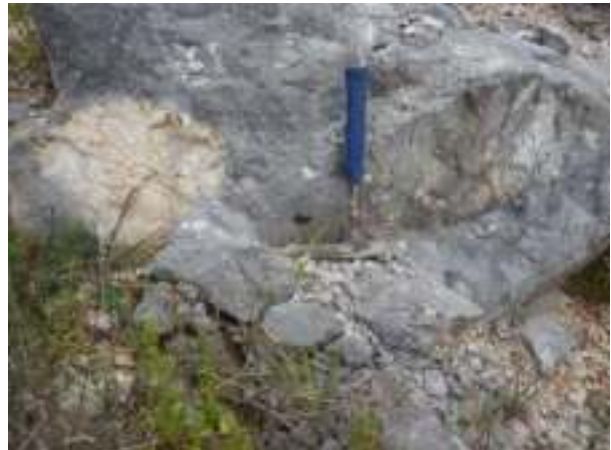
Figure 6.4 Fault scarp, NW-SE strike

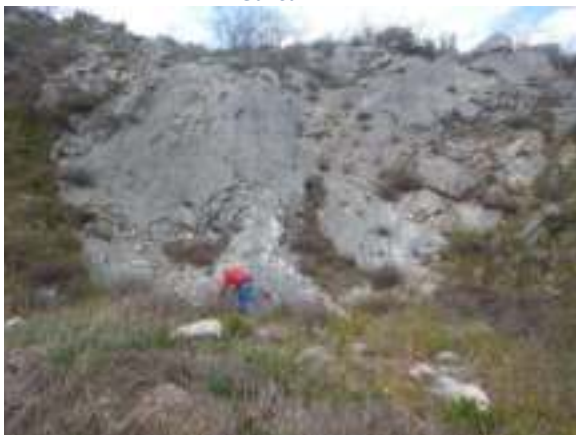
Figure 6.5 Fault plane, WNW- ESE strike

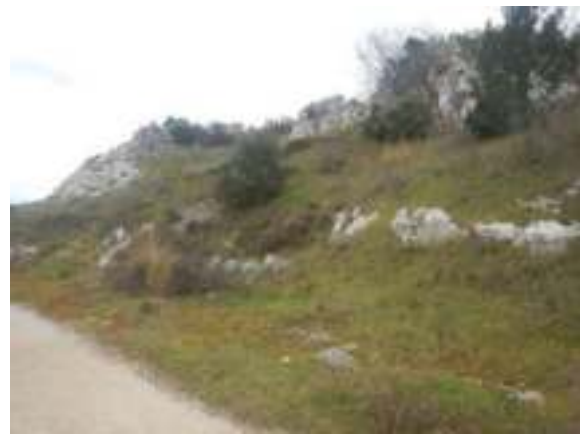
Figure 6.6 Fault zone of NW-SE in the north of the Galičak hill

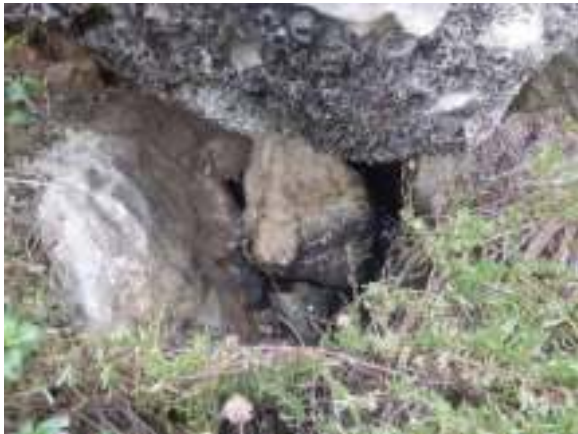
Figure 6.7 Spring on the east side of the Galičak hill

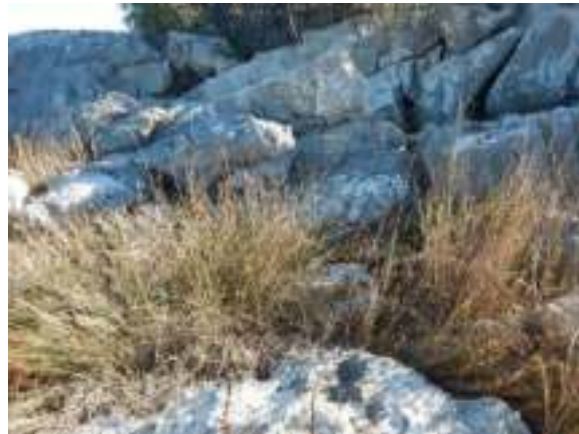
Figure 6.8 Layered limestone on the southeastern mound of Kučice

Within the valley, approximately 470 m east of the northern edge of the Diga profile, there are two smaller mounds measuring 40x60 m and 40x75 m called KUČICE. These are light cream limestones, structural type mudstone, and in some places there are fine-grained varieties. The deposits are intensively karstic and tectonic, and lapies and caverns are common as karst forms. Limestones are mostly massive or thickly stratified, dm dimension (5-9) or m (1-1,2). The layers lie to the southwest at an angle of 33-50° and to the northwest (10-20 °) (Figure 6.8). The joints

are subvertical, most often extending NW-SE, or steeply laid to the SW or NE. They are mostly open, with aperture 5-25 cm. The fossil community is represented by microfossils, predominantly algae, while macrofossils are less common, mostly mollusk shells.

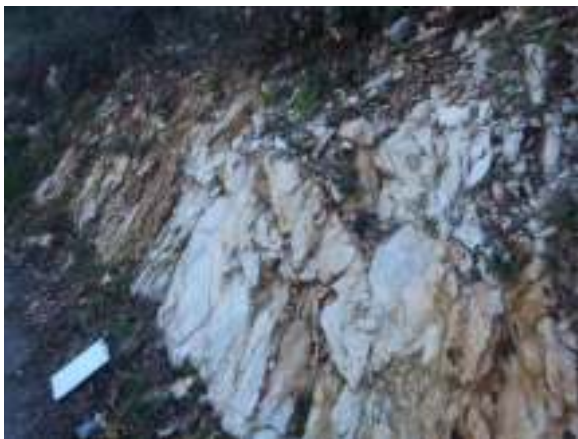
Field mapping established that the southern part of the Opuzen road profile is represented exclusively by limestone. Mudstones, crystalline and fine-grained limestones are represented. The colour of the limestone is light cream, cream to grey cream. The deposits are tectonised, fractured, karstified, with numerous joints, joint systems and caverns. Joints and smaller cavities are filled with red clay, and often are open. The veins are mostly filled with crystallized calcite, less often with clay. Limestones are mostly massive. Where stratification is observed, they are thickly layered, in dm dimension (4-10). Thinly layered, almost laminated, cm dimensions (1-10) limestones are rarely observed (Figure 7.9). The layers lie toward the north, northeast at an angle of 48-52°. Inside the thinly layered limestones come layers of grey to dark grey limestone. Among macrofossils, rudists are represented (Figure 7.10), and among microfossils foraminifera are rarely observed.

Figure 6.9 Thinly layered limestones, Rkalovac

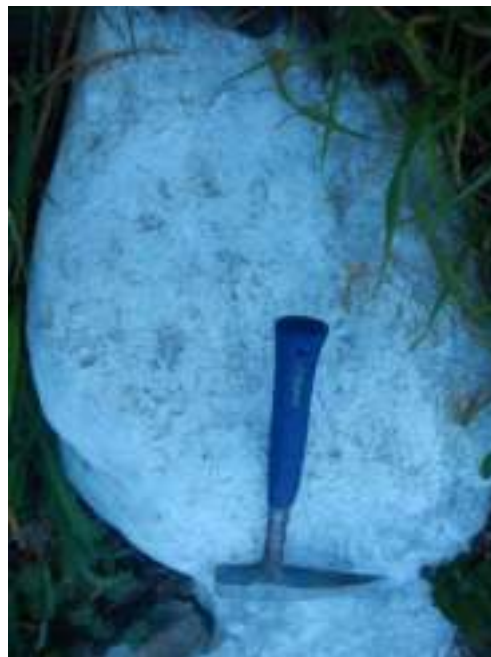
Figure 6.10 Rudist limestones

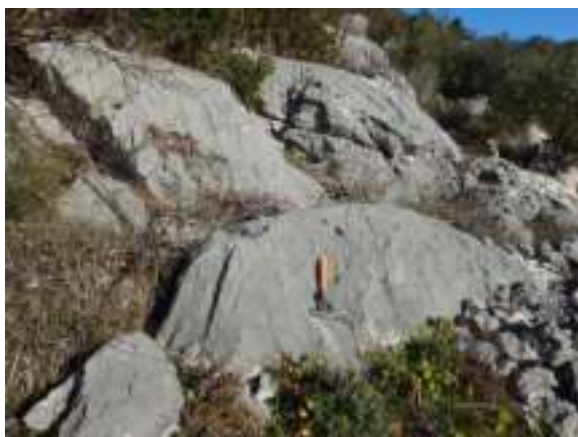
Figure 6.11 Massive limestones on the edge of the valley on SE

On the EDGE OF THE VALLEY, eastward of the Vidrice profile Late Cretaceous limestones are represented. The sediment is light cream in color, structural type mudstone. Limestones are massive, bulky, and in some places there are layers of dm dimensions (3-10) and over 1 m. The layers are laid in the direction of the WSW, but also the NNW. The deposits are highly tectonised, fractured and karstified (Figure 6.11), with numerous karst forms, lapies and caverns. Joints and joint systems are mostly open. Limestones are fossiliferous, microfossils are represented by algae and less often foraminifera, and macrofossils by rudists and other mollusk (Figure 6.12).

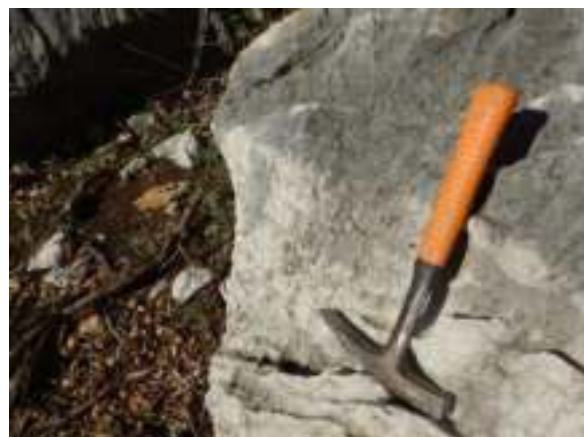
Figure 6.12 Cretaceous rudists limestones on the SE of the valley

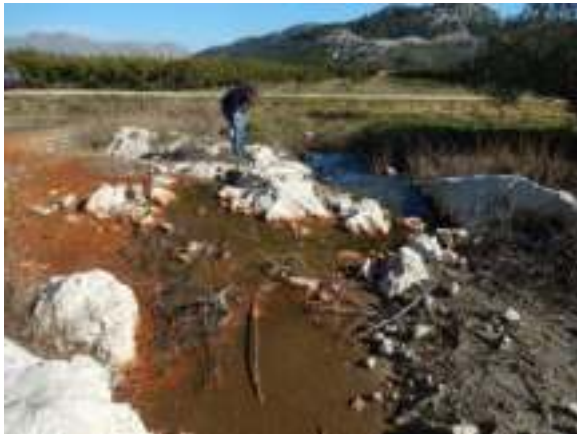
Figure 6.13 Limestone outcrops north of the Veliki školj

East of the Vidrice profile come five hills in a row. To the north, inside the olive groves, there are LIMESTONE OUTCROPS of relatively small extent. They cover an area of 70x10 m, almost at the level of the surrounding terrain, so they are not singled out on the basic map M 1:5000. The outcrops are located approximately 370 m east of the Vidrica profile. They extend in a north-south direction, along the water channel. Limestones are light cream in color, structural type mudstone. The sediments are karstified and fractured. These are probably Late Cretaceous limestones. Stratification is not observed. In the northern part of the described area, a spring approx. 0,1 l/s was registered (Figure 6.13). A limestone outcrop, measuring 3x5 m, is also located

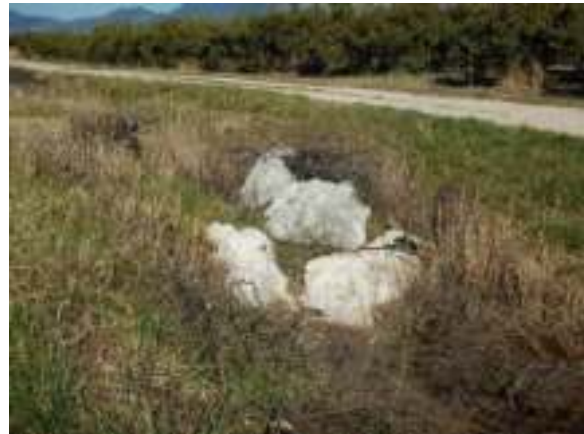
Figure 6.14 Limestone outcrops in the channel bed

in the channel bed (Figure 6.14). The fossils are represented by rudists, shells of snails and other mollusk.

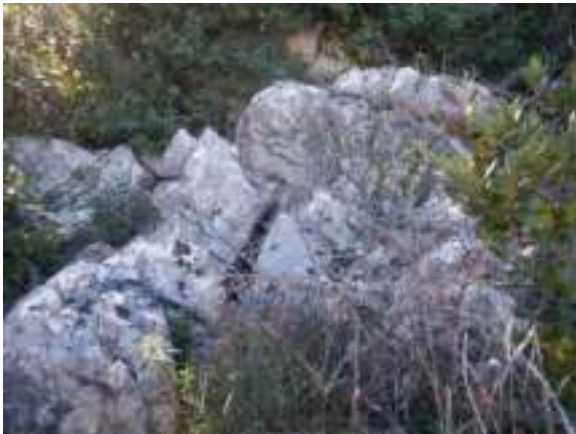
Figure 6.15 Cretaceous limestones, Veliki školj

VELIKI ŠKOLJ covers an area of 85x65 m, 250 m east of the Vidrice profile. Late Cretaceous limestones of light cream colour, structural type mudstone was mapped in the field. Limestones are massive, and in some places stratification of dm dimensions (3-10) is observed, but also over 1 m (Figure 6.15). The layers are oriented to the west at an angle of 25-38°. The deposits are fractured and karstified. The joints are open, with aperture 1-10 cm and 2-4 dm. The deposits are fossilized, the microfossils are algae and subordinate foraminifera, and the macrofossils shells of mollusk.

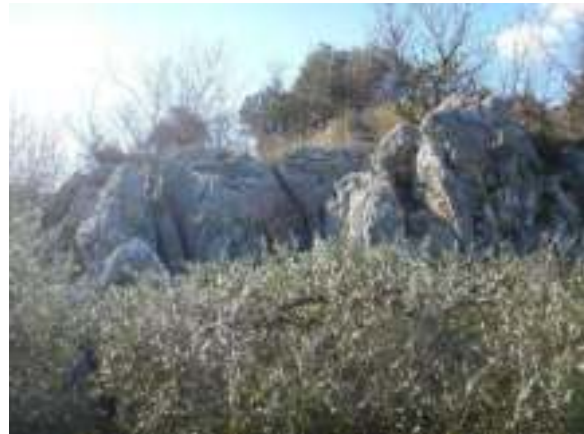
Figure 6.16 Fractured Cretaceous limestones, Srednji školj

SREDNJI ŠKOLJ covers an area of 50x40 m, followed by the MALI ŠKOLJ on an area of 110x50 m. They are 130 to 200 m east of the Vidrica profile. The terrain is built of limestones of Late Cretaceous period, light cream colour, structural type mudstone. Limestones are massive, no stratification is observed. The deposits are tectonised, fractured, karstified, cavernous. Joints and joint sets are mostly subvertical (Figure 6.16). Along the western edge of the Mali školj springs out a series of ascending springs, approximately 0,1-0,2 l/s each (Figures 6.17 and 6.18). On this point, toward to the Srednji školj the fault zone is assumed, stretching in direction NNE-SSW. The fault zone was also mapped in the central part of the Srednji školj, stretching in direction NW-SE. The deposits are fossiliferous, the most common microfossils are algae, and

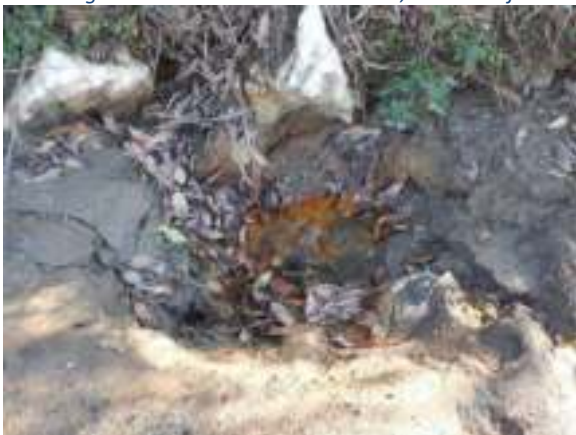
Figure 6.17 Spring on the west side of the Mali školj

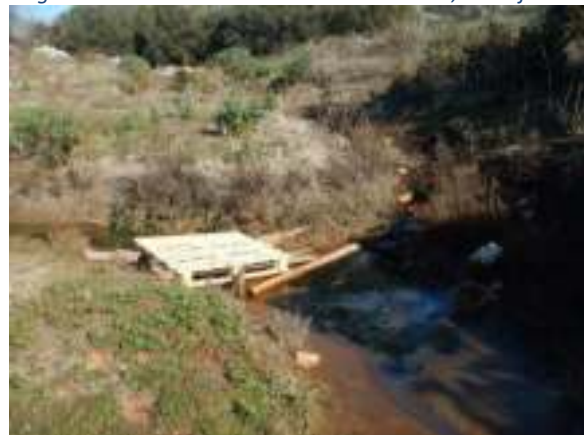
Figure 6.18 A series of springs along the fault zone between the Srednji and Mali školj

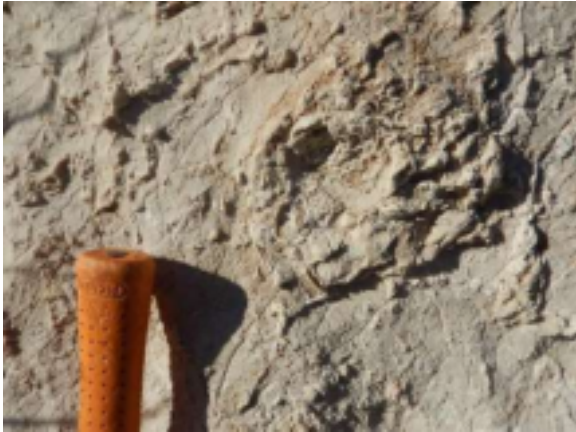
Figure 6.19 Fossil Cretaceous limestones, Mali školj

foraminifera are subordinate. Macrofossils are also observed, shells of mollusks, snails and rarely rudists (Figure 6.19).

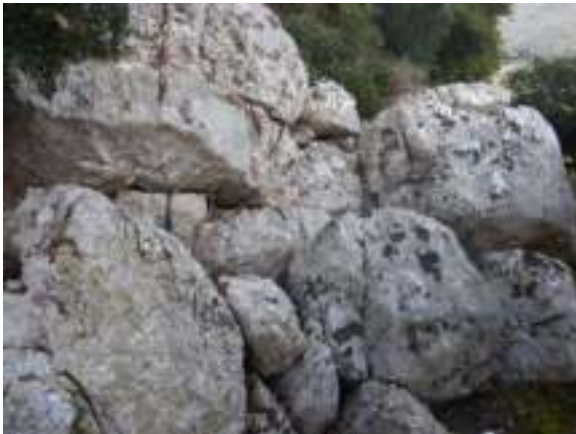
Figure 6.22 Fractured massive limestones, Veliki obalac

VELIKI OBALAC is located north of the Rečina canal, and covers an area of 440x150 m. Geological mapping has established only limestones at the location. Limestones are light cream in color, structural type mudstone. The deposits are tectonised, fractured, karstified, with numerous joints and joint systems of various orientations (Figure 6.22). Lapies appear as karst forms. Numerous veins are filled with crystallized calcite. Limestones are massive, no stratification is observed. The joints are mostly open, with aperture in cm dimension (10-15), dm (5-9) but also

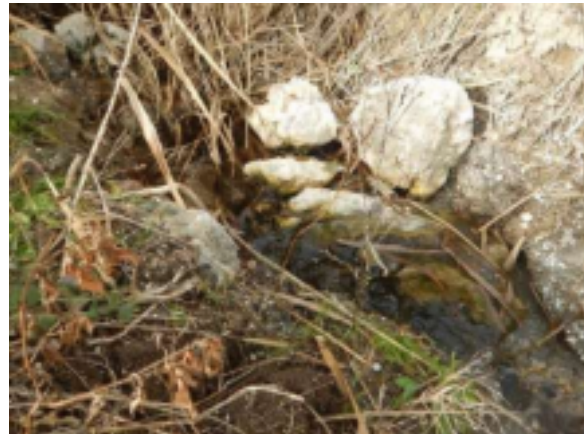
Figure 6.23 Spring on the east side of Veliki obalac

m (1-1,5). Microfossils are represented by algae, while macrofossils and rare, represented by shells of mollusk. On the eastern side of the hill, a series of springs were registered in a zone about 30 m wide, approximately 0,5 to 1 l/s each (Figure 6.23).

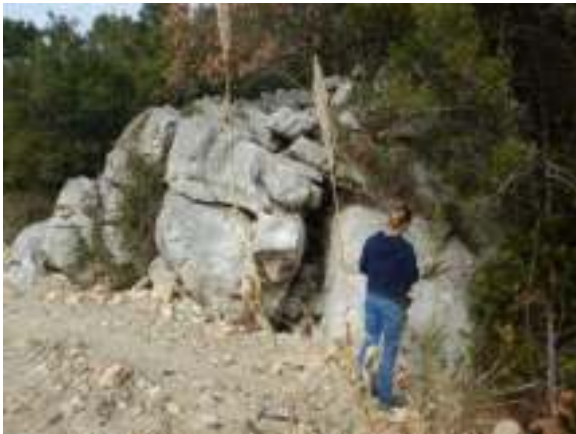
Figure 6.24 Fractured massive limestones, Mali obala

MALI OBALAC is located on the southern channel of Rečina, opposite Veliki obalac. It covers an area of 200x130 m. Light cream limestones are present in the area of Mali obalac. Apart from mudstone, there are also fine-grained varieties of a slightly darker color. The deposits are tectonised, fractured and karstified, cavernous, with numerous joints and joint systems of various orientations (Figure 6.24). Limestones are massive, no stratification is observed. The joints are mostly open, with aperture in various dimension, cm (10-20), dm (5), but also there are joints without aperture. Limestones are slightly fossiliferous, algae and shells of mollusk are very rare (Figure 6.25).

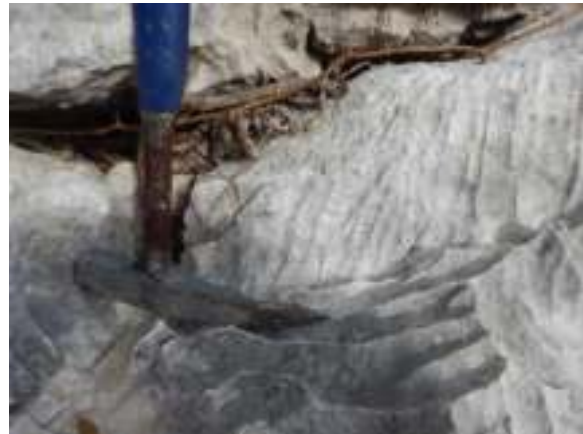
Figure 6.25 Karstified limestones with rare shells, Mali obalac

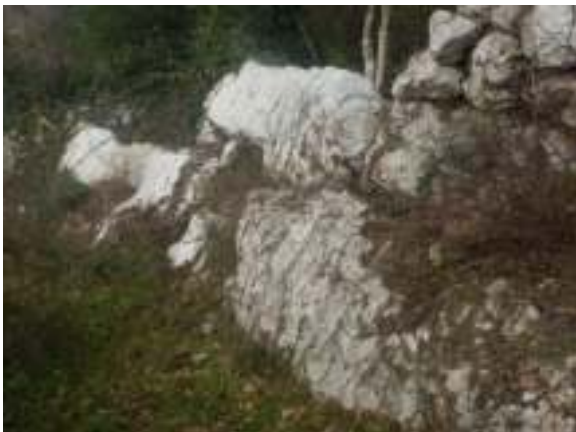
Figure 6.26 Layered limestones in the northwestern part of Tuštovske glavice

TUŠTOVSKA GLAVICA is located further west to Veliki and Mali obalac, next to Tuštevaca. It covers an area of 550x430 m. Limestone it is a light cream, structural type mudstone, but there are also fine-grained and medium-grained varieties. The deposits are tectonised, fractured and karstified, with developed karst forms, lapies and caverns. Numerous joints and joint sets and systems have a various orientation. The joints are opened, with aperture in cm dimensions (3-9), or dm dimension (1-3), and in some places filled with clay and soil. On the eastern side of the hill, the NE-SW fault is assumed. Stratification is very rarely observed in the northwestern part of the hill, where layers are 7-10 dm thick. The layers are laid in a northeast direction, in a very small

angle (Figure 6.26). Microfossils are represented by algae and macrofossils by shells of mollusk, very rarely snails. In the northwestern part of the hill limestone with rudists are common, which indicates the stratigraphic affiliation of the deposits to the Cretaceous period (Figure 7.27).

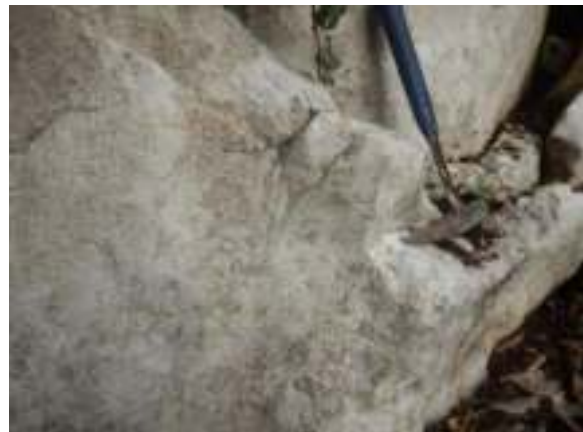
Figure 6.27 Rudist limestones in the northwestern part of Tuštovske glavice

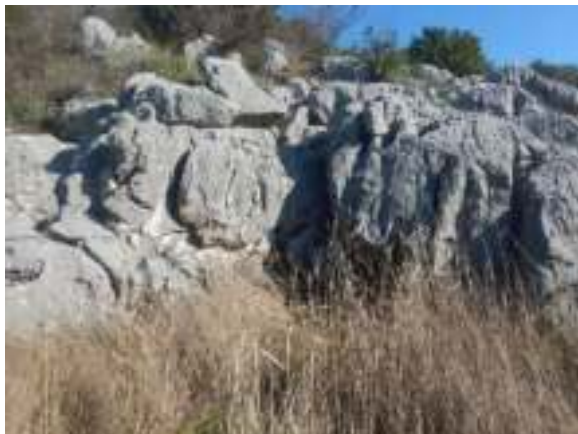
Figure 6.28 Massive Cretaceous limestones, Kozjak

The KOZJAK hill stretches along the Neretva River in the northwestern part of the research area. It covers an area of 770x520 m. Based on geological mapping limestones were determinate, structural type mudstone, light cream to whitish cream color. The deposits are tectonised, fractured, karstificated, cavernous, with numerous lapies (Figure 6.28). Limestones are usually massive, stratification is very rarely observed, with a layer thickness of dm dimension (3-10). The layers are laid in a southwest direction, by angle of 34-52° (Figure 6.29). The rock mass is intersected by joints and joint sets, which are either subvertical or relatively steeply laid, over 50°. The joints are stretching in the Dinaric direction, NW-SE, but also NE-SW. The joint aperture varies, from cm to m dimensions. The fossil community is represented by microfossils, algae and less common foraminifera, and macrofossils, shells of mollusk.
