Project: “Monitoring Sea-water intrusion in coastal aquifers and Testing pilot projects for its mitigation” Interreg CBC Italy-Croatia 2014.-2020.

(D_3.1.4) Report on the initial hydrogeological and agricultural conditions of the Croatian site

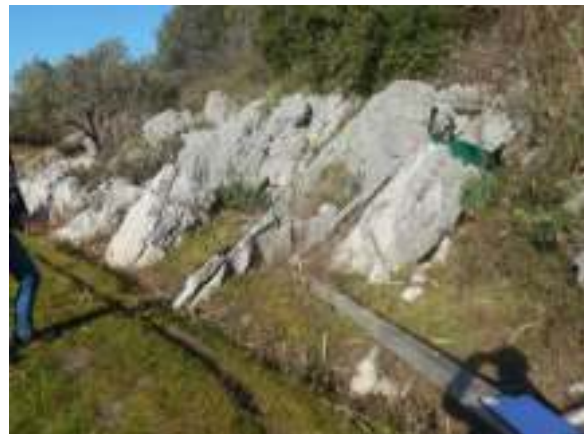
Figure 6.29 Layered Cretaceous limestones, Kozjak

The KOZJAK hill stretches along the Neretva River in the northwestern part of the research area. It covers an area of 770x520 m. Based on geological mapping limestones were determinate, structural type mudstone, light cream to whitish cream color. The deposits are tectonised, fractured, karstificated, cavernous, with numerous lapies (Figure 6.28). Limestones are usually massive, stratification is very rarely observed, with a layer thickness of dm dimension (3-10). The layers are laid in a southwest direction, by angle of 34-52° (Figure 6.29). The rock mass is intersected by joints and joint sets, which are either subvertical or relatively steeply laid, over 50°. The joints are stretching in the Dinaric direction, NW-SE, but also NE-SW. The joint aperture varies, from cm to m dimensions. The fossil community is represented by microfossils, algae and less common foraminifera, and macrofossils, shells of mollusk.

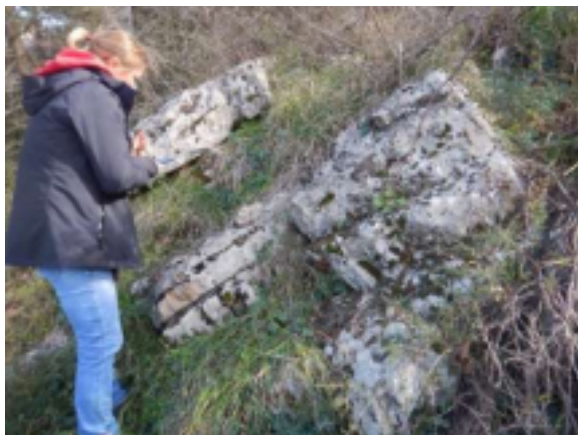
Figure 6.30 Layered Cretaceous limestones, Dobruške glavice

The DOBRUŠKE GLAVICE elevation is located near the D8 state road, in the northern part of the research area. These are three connected hills that cover an area of 420x250 m. The terrain around the hill is mostly inaccessible, especially on the south side, overgrown with dense vegetation, and along the very edge of the mound is a canal. Late Cretaceous limestones were determined by field mapping. Structural type is mudstone, and in some places fine-grained varieties appear. Their color is light cream, whitish cream to gray cream. They are mostly massive, rarely thicker layered, dm dimension (2-9), but also m dimension (1-1,2). Where stratification is observed, the layers are laid in a northeast direction at an angle of 15-25° (Figure 6.30). The deposits are tectonised, fractured and karstificated. Joints and joint systems have a various orientation. The joints are vertical or relatively steep (Figure 6.31). A fault between the eastern and western hill is assumed, stretching in direction NNW-SSE. The deposits are weakly fossiliferous, foraminifera are rarely observed, same as shells of mollusk and rudists.

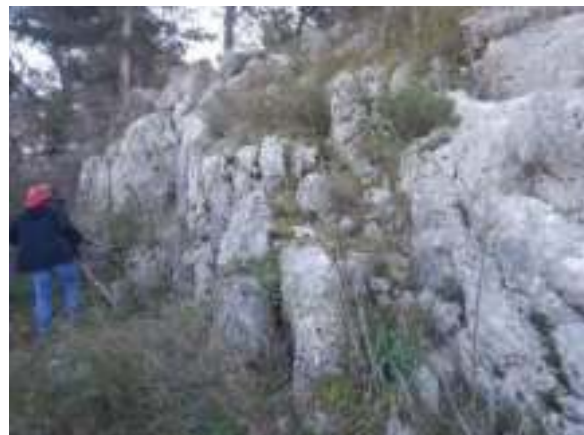
Figure 6.31 A set of joint parallel to the assumed fault, Dobruške glavice

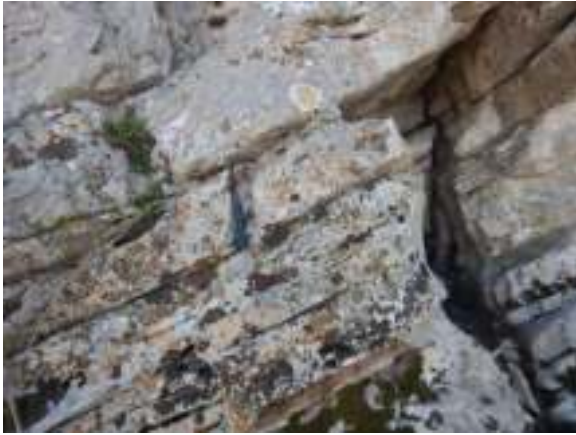
Figure 6.32 Layered limestones, Gubava glavica

GUBAVA GLAVICA extends east of Dobruške glavice, on an area of 100x50 m. Late Cretaceous limestones, structural type mudstone, light cream colored has been determined by field mapping. On the northern side, medium-grained brownish-gray limestones have been identified. The deposits are fractured and karstificated. Limestones are stratified in dm dimension (2-8), laid

in the direction ESE (Figure 6.32). Set of vertical joints are stretching in direction NNW-SSE. The fossil community has not been spotted.

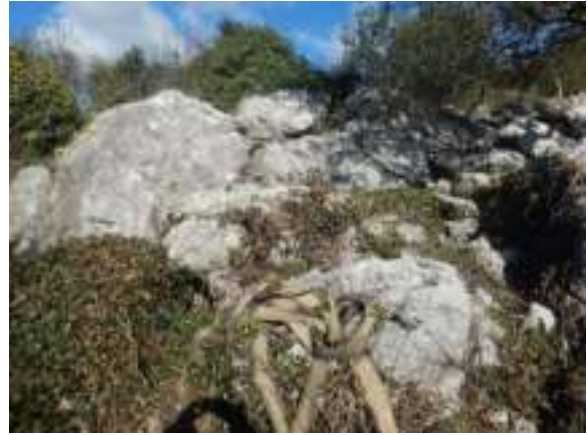
Figure 6.33 Massive limestones, western head without toponymic mark

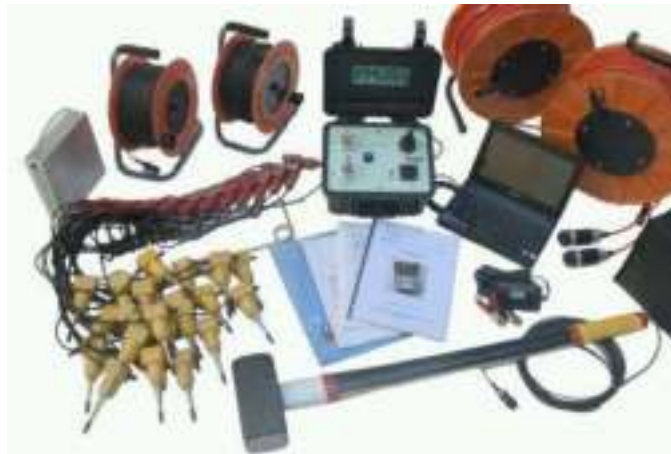
- Seismograph: PASI GEA-24, s.b. 16077, 24 channels,
- 40 Hz geophones (reflection),
- Seismic cables with 12 takeouts,
- Seismic source: 12 kg hammer and steel plate, seismic gun

Figure 7.10 Equipment for seismic surveys.

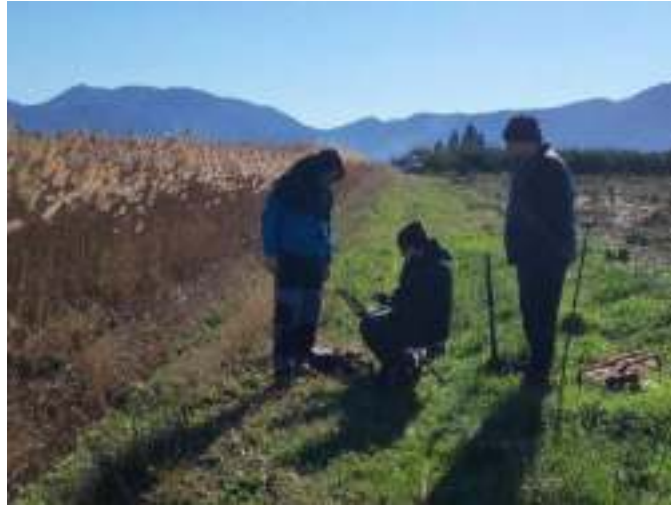
Figure 7.11 Seismic reflection measurement on RFL-1 profile position.

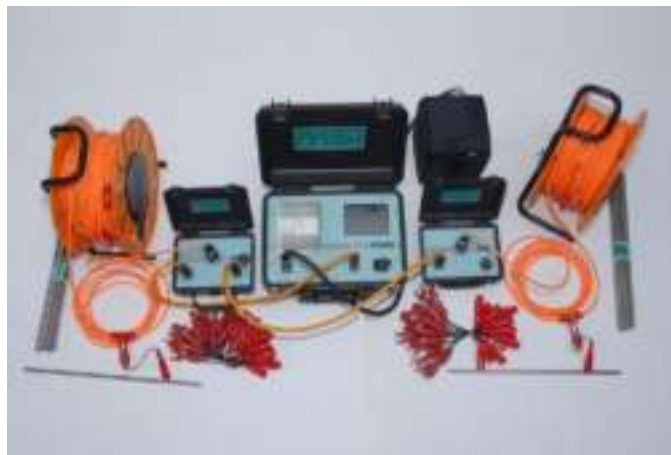
- Instrument: PASI Polares, s.n. 13008,
- Cables with 16 takouts,
- Steel stakes (electrodes).

Figure 7.12 Equipment for geoelectrical surveys.

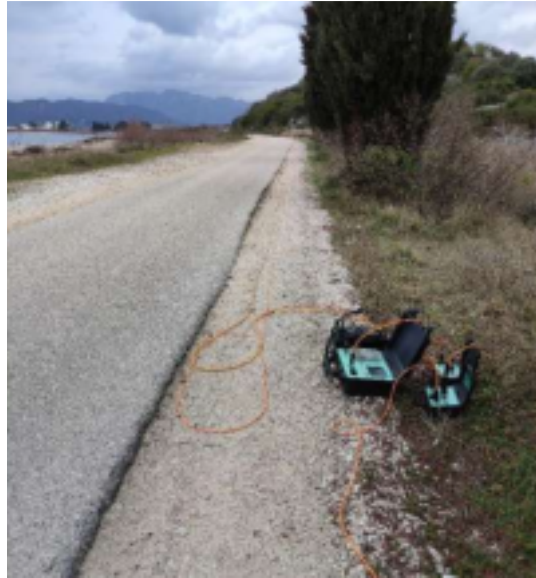
Figure 7.13 Geoelectrical tomography on GE-5 profile position.

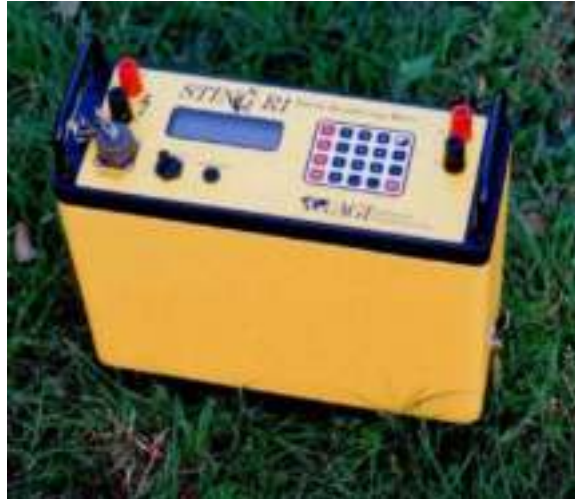
- Instrument: AGI Sting R-1
- Geoelectrical cables
- Current and potential electrodes

Figure 7.14 Equipment for geoelectrical sounding AGI Sting R-1

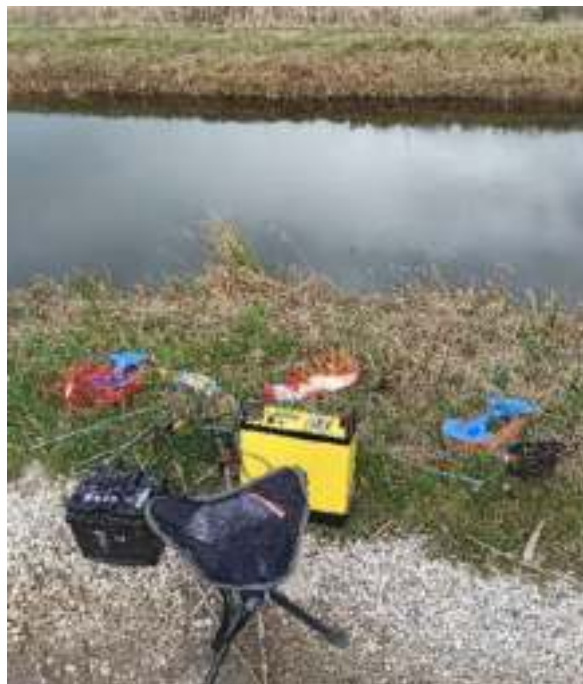
Figure 7.15 Electrical sounding on GS-100-24 position.

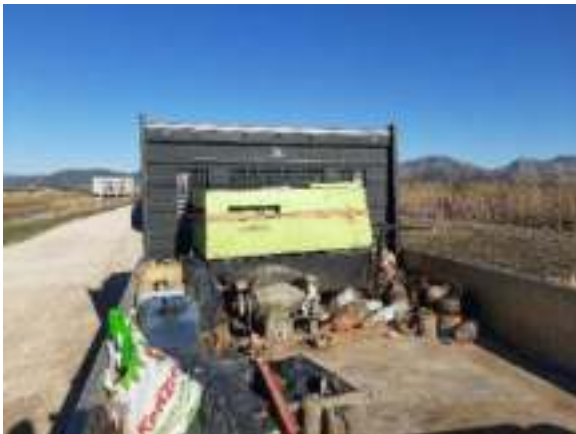
- Electric generator 15 kwh,
- Turbo mixer type Crealius for preparation of bentonite suspension, production of injection mixture and injection up to a pressure of 15 bar,
- Injection flow and pressure meters and
- Pressure hoses.

Figure 8.1 Electric generator 15 kwh

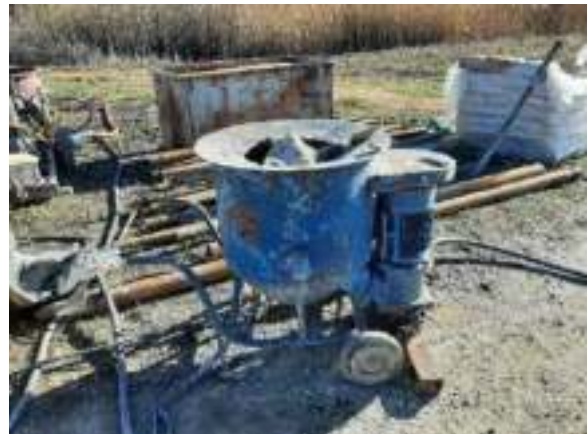
Figure 8.2 Turbo mixer type Crealius

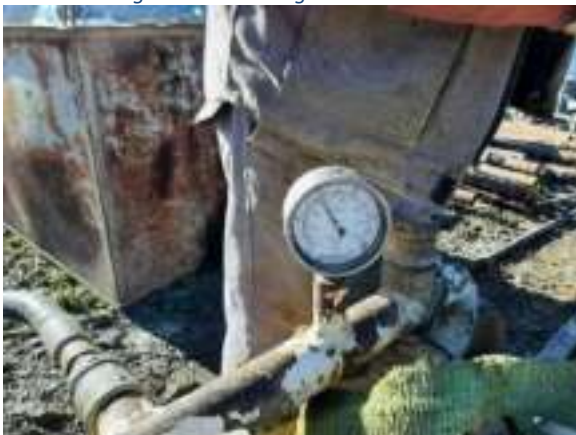
Figure 8.3 Injection flow and pressure meter

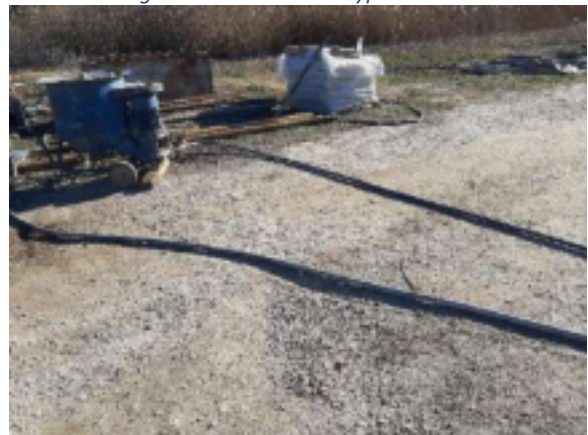
Figure 8.4 Pressure hoses

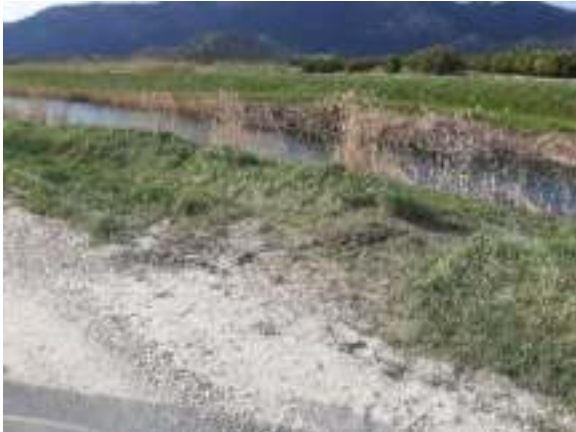
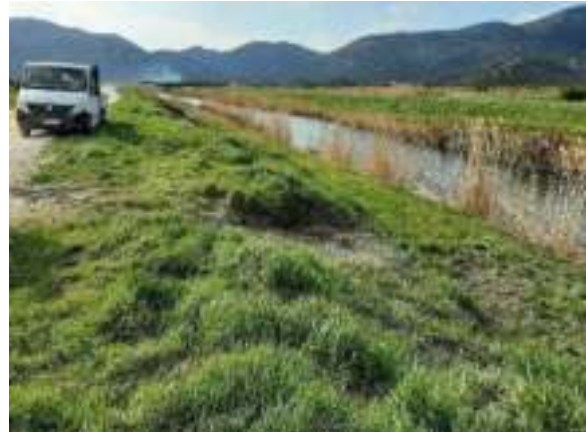
Remediation of the surrounding terrain at the position of the borehole B-1 (S-104-21-01)

7. After the level of the mixture at the borehole mouth stabilizes and the mixture begins to set, the remediation of the borehole is completed.

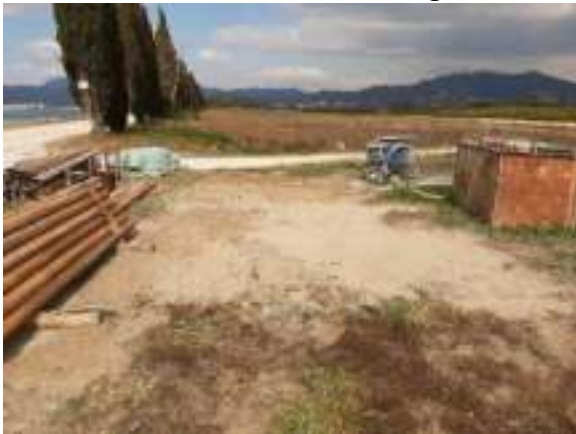
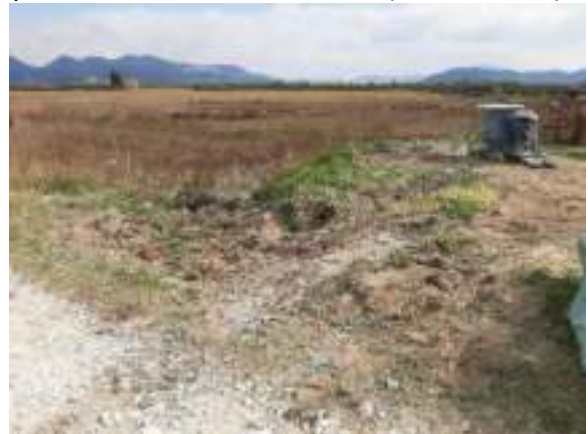
Remediation of the surrounding terrain at the position of the borehole B-2 (S-104-21-02)

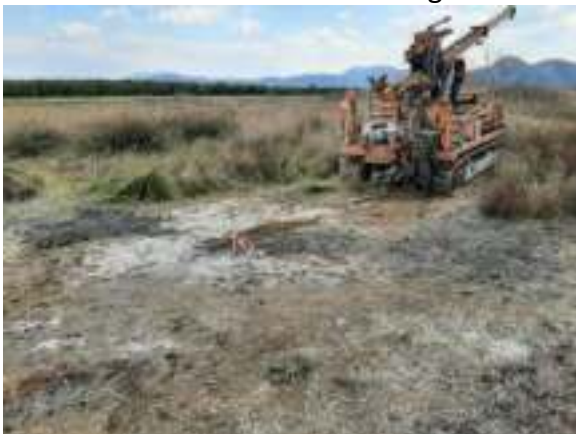
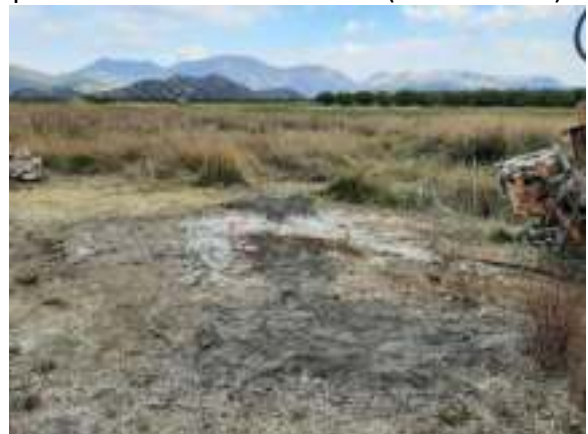
Remediation of the surrounding terrain at the position of the borehole B-3 (S-104-21-03)
