Report on the final hydrogeological and agricultural conditions of the Italian site (after the realization of the mitigation interventions)

Deliverable D_3.1.5

MoST WP3.1 Action (Venice coastal plain) aims at characterizing the Italian site in terms of hydrogeological conditions after the realization of the mitigation strategies. Specifically, a sub-irrigation system through drainage pipes was established along a sandy high-permeable paleo-channel crossing the farmland.

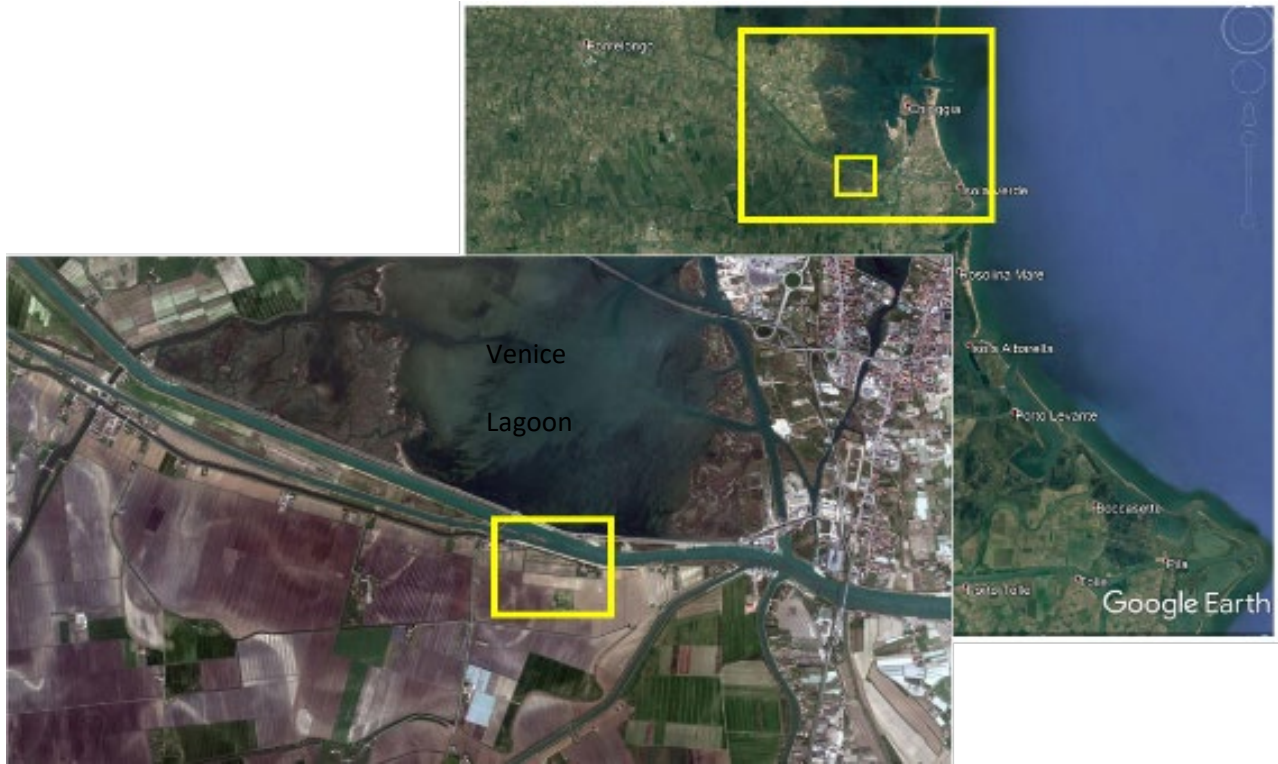
Fig. 1 - Location of the study area and the pilot test site.

The study area is located in a low-lying farmland just south of the Brenta and Bacchiglione rivers at the southern Venice lagoon margin (Fig. 1).

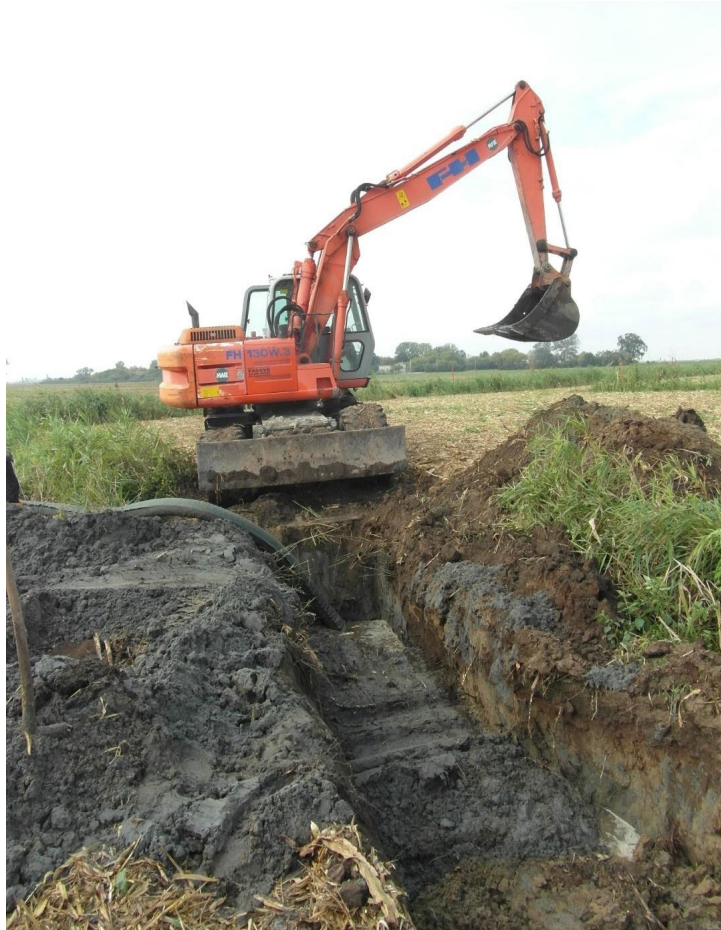
Fig. 3 – Excavation of the trench and positioning of the pipe.

The works for the installation of the drainage pipe started in October 2020 and finished at the beginning of November 2020 (Fig. 3).

A trench around 2 m deep has been excavated along the selected path, around 220 m long. The pipe has been located at a depth of 1,7 m from the ground level. The functioning and the mitigation effectiveness of the mitigation infrastructure has been preliminary tested in November 2020, March 2021 and Summer 2021. For further information see DOC n. MoST-CNR 4.2-008.

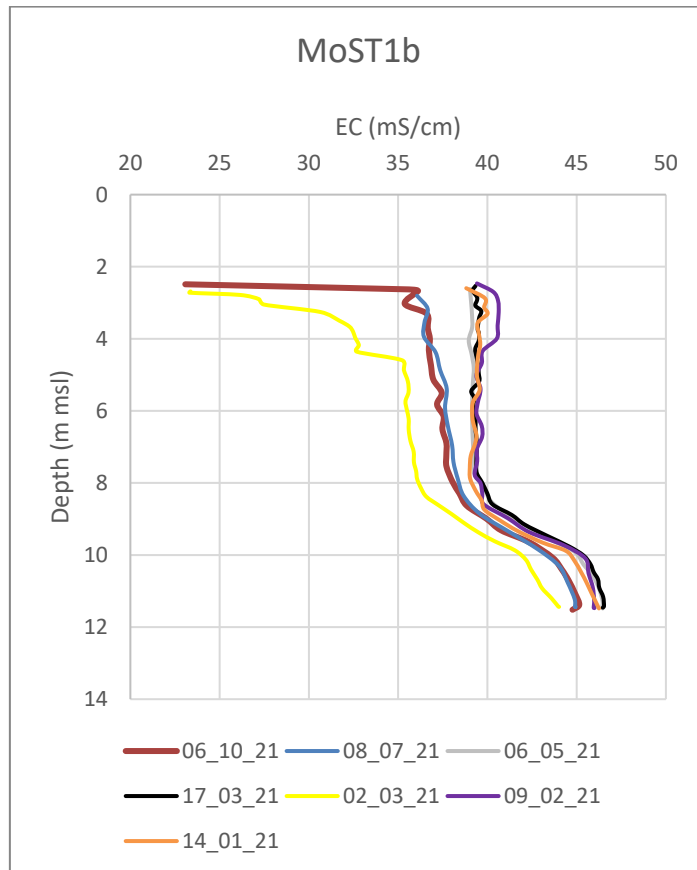
Fig. 4 – MoST1b EC vertical profiles recorded between January and October 2021.

MoST1b is the northernmost well potentially influenced by the installation of the pipe. It is located at the northern end of the pipe, next to the water catchment on the Canal Morto. The EC recorded in this well roughly varies between 22 and 47 mS/cm, showing lower values at the top and higher values at the bottom of the aquifer.

The collected EC data testifies a salt-water contamination condition of the phreatic aquifer comparable with the conditions existing before the installation of the pipe (see Doc MoST-CNR 3.1-009). The variability recorded in some piezometers (i.e. MoST1b and MoST2) is considered to be related to seasonal variability in freshwater input (i.e. leakages from the Canal Morto, precipitation events).

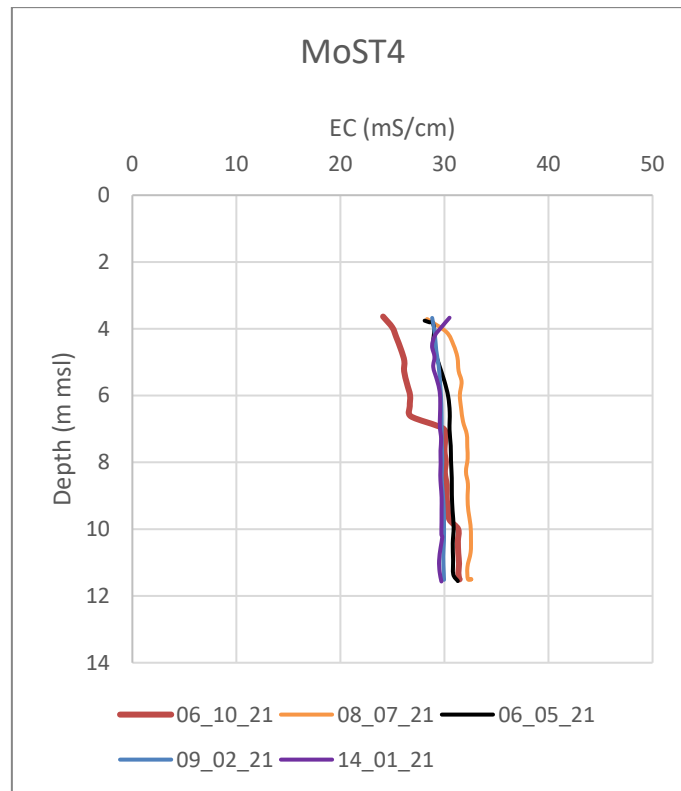
Fig. 7 – MoST4 EC vertical profiles recorded between January and October 2021.

MoST4 is the farthest well from the pipe, considered to analyze the hydrogeological conditions of the site. It shows EC values roughly between 25 and 33 mS/cm, without showing a vertical stratification.

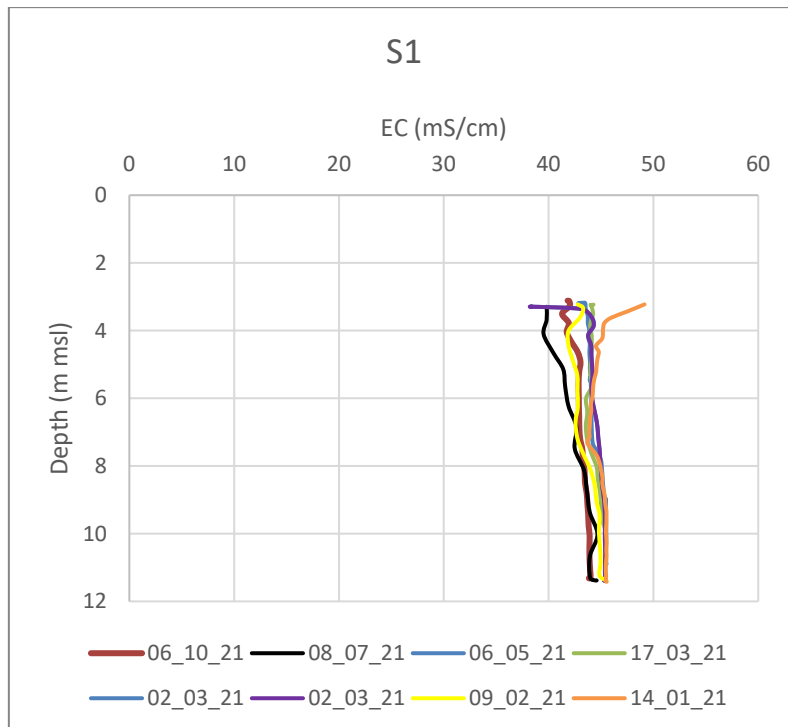
Fig. 8 – S1 EC vertical profiles recorded between January and October 2021.

S1 well is located around 50 m to the east of the sub-irrigation pipe. The EC recorded show values between 40 and 50 mS/cm without showing a clear vertical stratification.

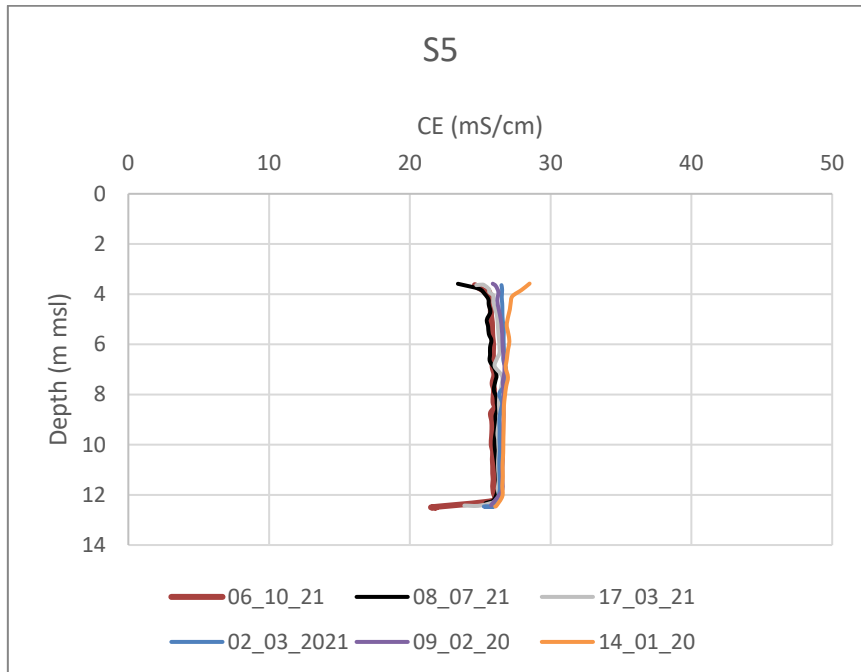
Fig. 9 – S5 EC vertical profiles recorded between January and October 2021.

S5 is the southernmost well considered to characterize the hydrogeological conditions of the Italian site after the installation of the pipe. It is located beyond the cut-off wall at the southernmost end of the sub-irrigation system. The EC shows values around 25-27 mS/cm without a vertical stratification.

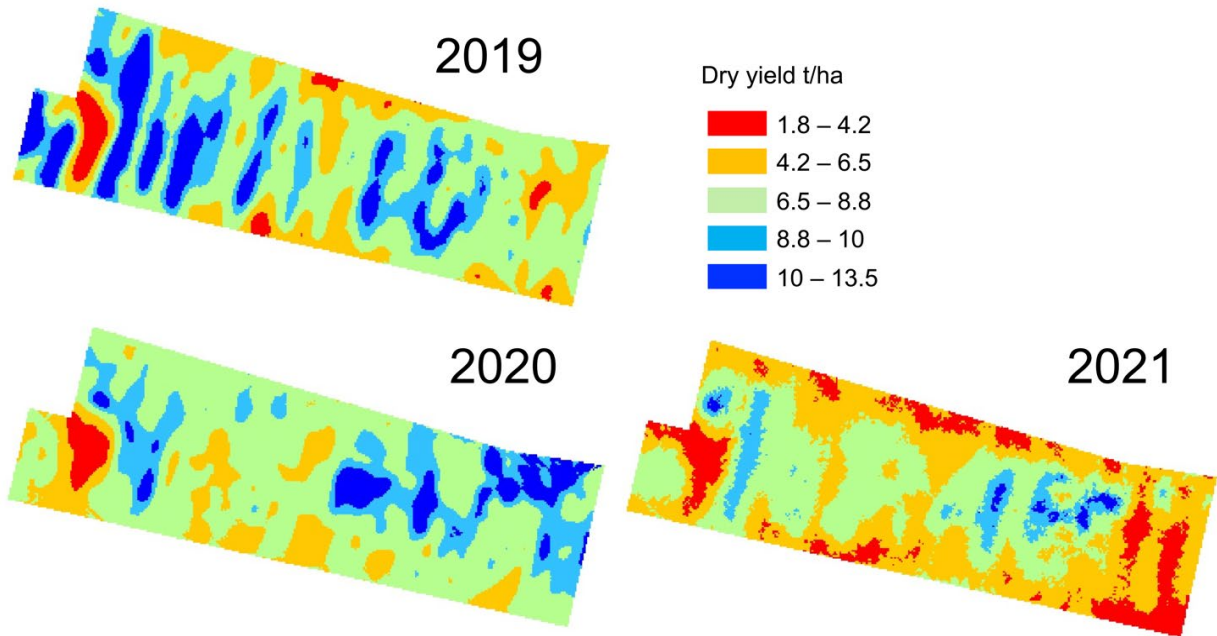
Fig. 11 – Yield maps of 2019, 2020 (before the drain pipe installation), and 2021 (after the drain pipe installation).

Yield data were recorded using the Claas yield monitoring system mounted on a Lexion 750 TT combine harvester. Yield sensors measured yield and grain moisture while geographic coordinates were recorded using GPS satellite data. The yield points were automatically uploaded into a cloud platform (Telematics) and a point layer was obtained by using a geo-graphical information system (GIS). Geostatistical tools (kriging) were then used to obtain a continuous map. Yield maps (Fig. 11) show some similarities: for example, low production was gained in the red area located in the southwest part of the experimental site because of the high sand content and deep groundwater. On the contrary, the highest productions were always gained in the blue central-east part of the site. The average dry yield was quite similar in 2019 and 2020 with 8.1 t/ha and 8.4 t/ha, respectively, while it decreased in 2021 with an average of 6.3 t/ha.
