# 3.3.3 Determination of seismic vulnerability indexes for masonry historical buildings located in the HR test site

Deliverable Number 3.3.3

<b>Project Acronym</b>	PMO-GATE
<b>Project ID Number</b>	10046122
<b>Project Title</b>	Preventing, Managing and Overcoming natural-hazards risk to mitiGATE economic and social impact
<b>Priority Axis</b>	2: Safety and Resilience
<b>Specific objective</b>	2.2: Increase the safety of the Programme area from natural and man-made disaster
<b>Work Package Number</b>	3
<b>Work Package Title</b>	Assessment of single-Hazard exposure in coastal and urban areas
<b>Activity Number</b>	3
<b>Activity Title</b>	Assessment of climate-unrelated hazards exposure in urban and coastal areas (seismic action)
<b>Partner in Charge</b>	UNIVERSITY OF SPLIT, FACULTY OF CIVIL ENGINEERING, ARCHITECTURE AND GEODESY
<b>Partners involved</b>	UNIVERSITY OF SPLIT, FACULTY OF CIVIL ENGINEERING, ARCHITECTURE AND GEODESY PUBLIC INSTITUTION RERA SD FOR COORDINATION AND DEVELOPMENT OF SPLIT DALMATIA COUNTY NATIONAL INSTITUTE OF OCEANOGRAPHY AND EXPERIMENTAL GEOPHYSICS TRIESTE CITY OF KAŠTELA

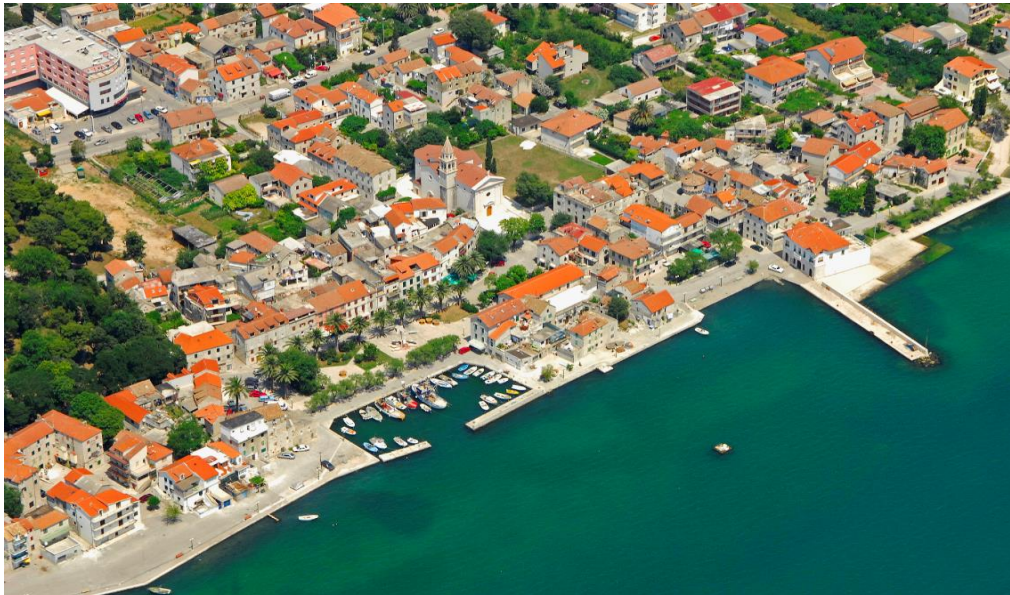
Fig. 4. The view on a historical centre, Kaštel Kambelovac

According to [5] the line of the existing coast was changing throughout the history. Original coastline (Fig. 3 - red line) was formed of reefs that served as foundations for the historical fortresses. Through the time, the inhabitants of Kaštel Kambelovac were gradually expanding the coast which resulted in the present state where the former fortresses are integrated within the urban tissue (Figs. 4 and 5).

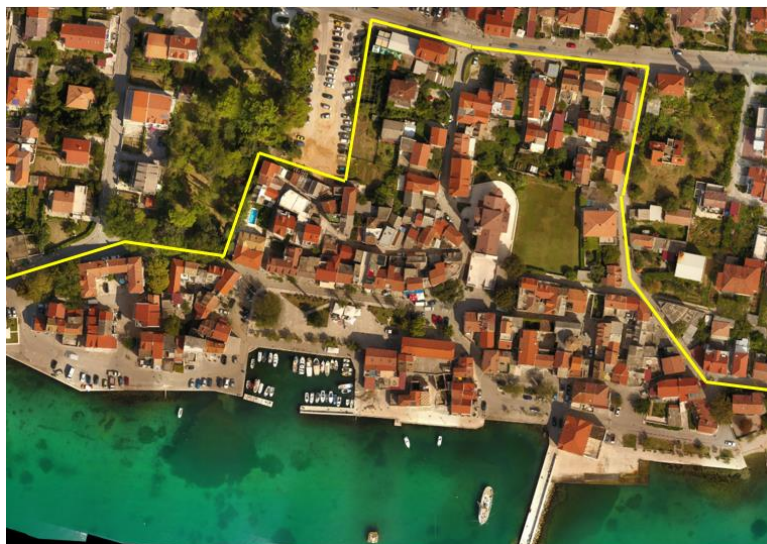
Fig. 5. Plan of a historical centre of Kaštel Kambelovac

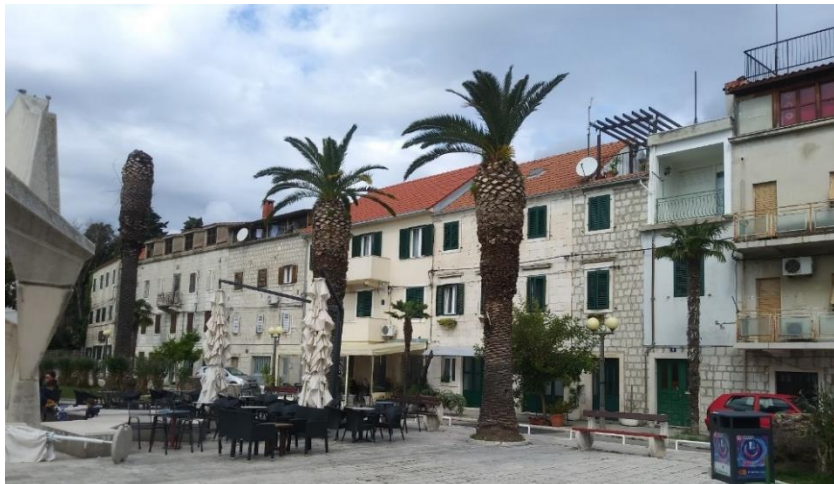
Fig. 6. Historical urban area of Kaštel Kambelovac, view on Drago Britvić Street

The buildings in the historical centre (Fig. 6 and 7), built between the 15th and 19th centuries, are mostly made of stone blocks with mortar joints. The walls have a thickness between 45 and 75 cm. Namely, thickness of the load-bearing walls is specified, so that the thickness of the last-floor-walls should be minimally 45 cm. Lower floors have an increase of thickness in amount of 15 cm per floor, starting from the last floor towards the ground floor. According the rule 3-storey building would have walls with thickness of 75cm, 60cm and 45cm counting from the first floor (ground floor) to the third floor. Original floors were made of wood. Recently, some of those buildings were reconstructed and wooden floors were often replaced with monolith reinforced concrete plates. Some original stone buildings facade covered with plaster (Fig. 6).

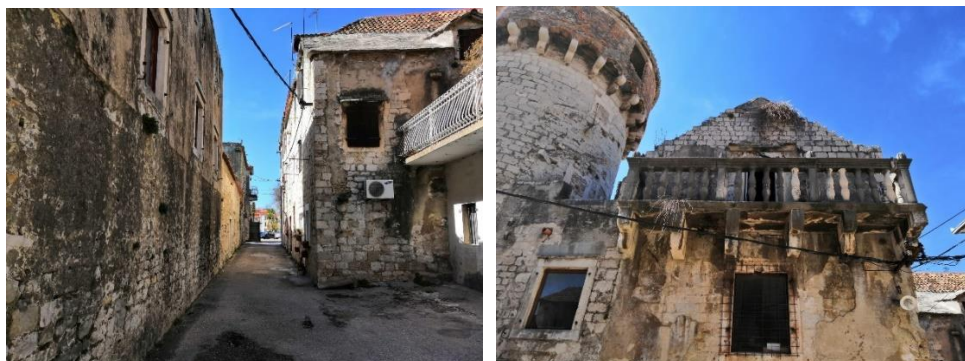
Fig. 10. Damaged buildings in the historical centre

Some buildings are in very poor condition, quite damaged, with joints between the stone blocks from which the mortar fell (Fig. 10), damaged walls, deformed, and in some cases destroyed roofs (Fig. 11).

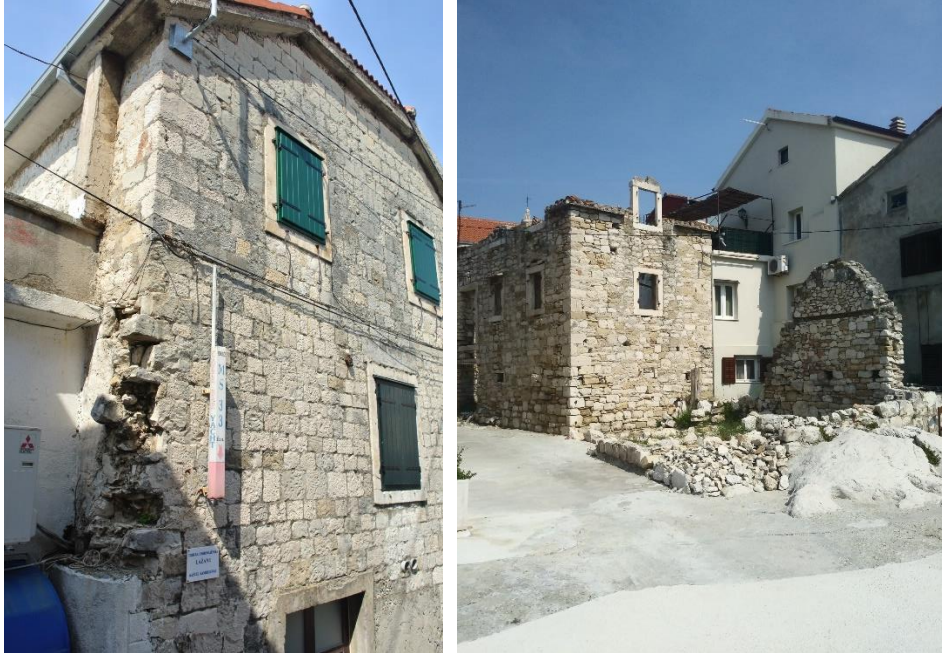
Fig. 11. Damaged walls and destroyed roofs of the buildings

In addition, there are several completely demolished buildings (Fig. 11). Also, some residential buildings have significant cracks in the load-bearing walls so their safety is low (Fig. 12 and 13).

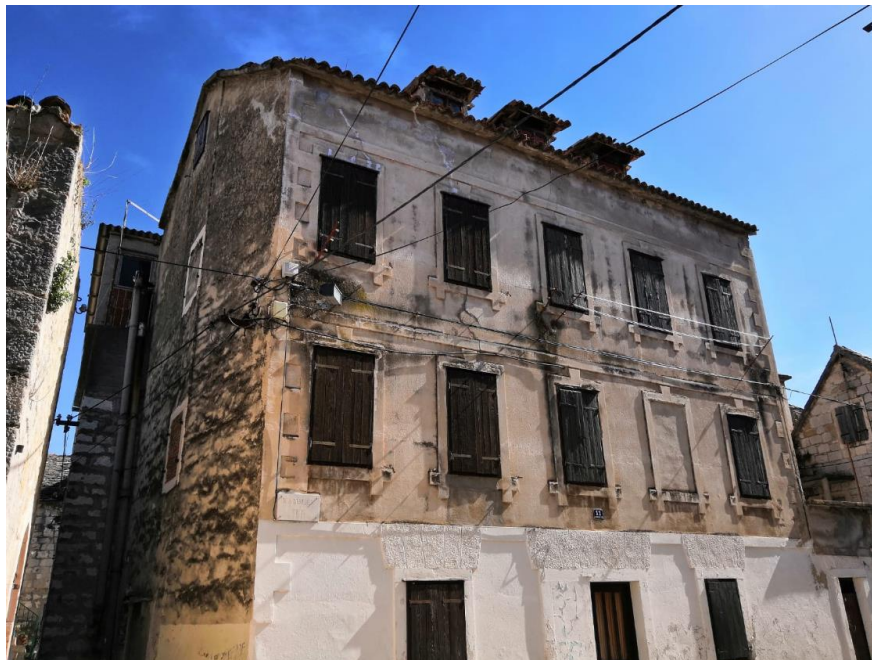
Fig. 12. Uninhabited building in the centre with significant cracks

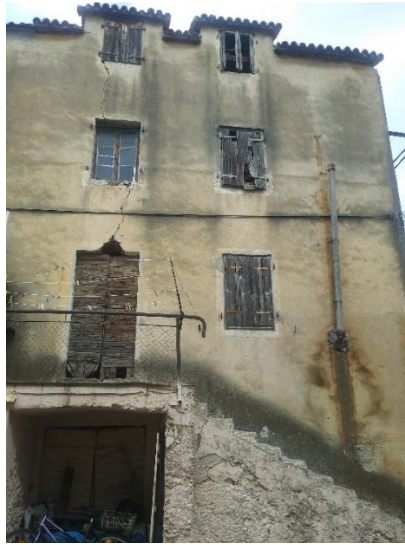
Fig. 13. Building with significant cracks

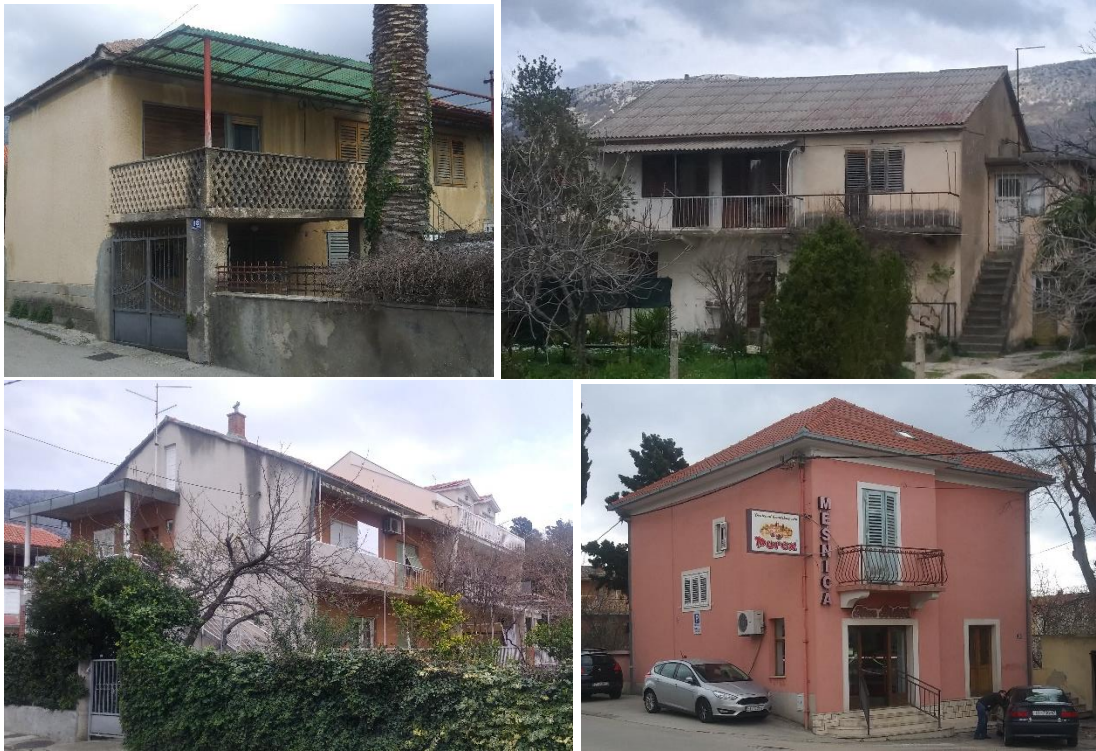
Fig. 14. Typical residential buildings outside the historical centre built in period 1960-1980.

The general problem with assessing earthquake vulnerability of the buildings, regardless of the construction period, is that many private residential buildings were built illegally, so it is not possible to determine whether their construction has been complied with applicable regulations.

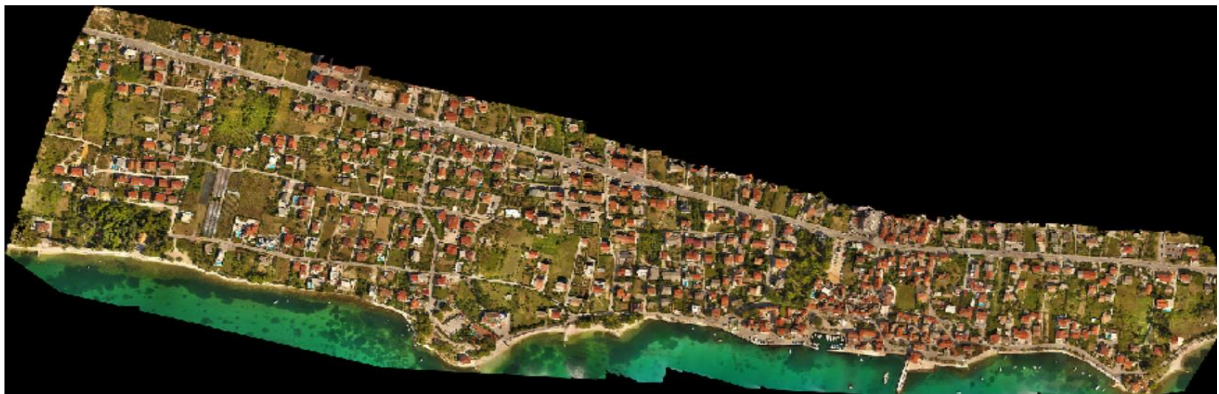
Fig. 15. Geodetic basis of the HR test site

The detailed geodetic survey of terrain was performed using geodetic drone recording, and then high-resolution geodetic basis of the HR test site was created in order to define cadastral and building parcels and topographic characteristics of the area. This basis is high quality foundation used to show spatial distribution of the vulnerability of the buildings and to develop seismic vulnerability map. In addition, it will be used to present other risks that will be analysed in the project (sea flood and extreme sea waves), as well as single-hazard and multi-hazard exposure of the area. The geodetic basis of the HR test site and the cadastral and building parcels are shown in Figs. 15 and 16.

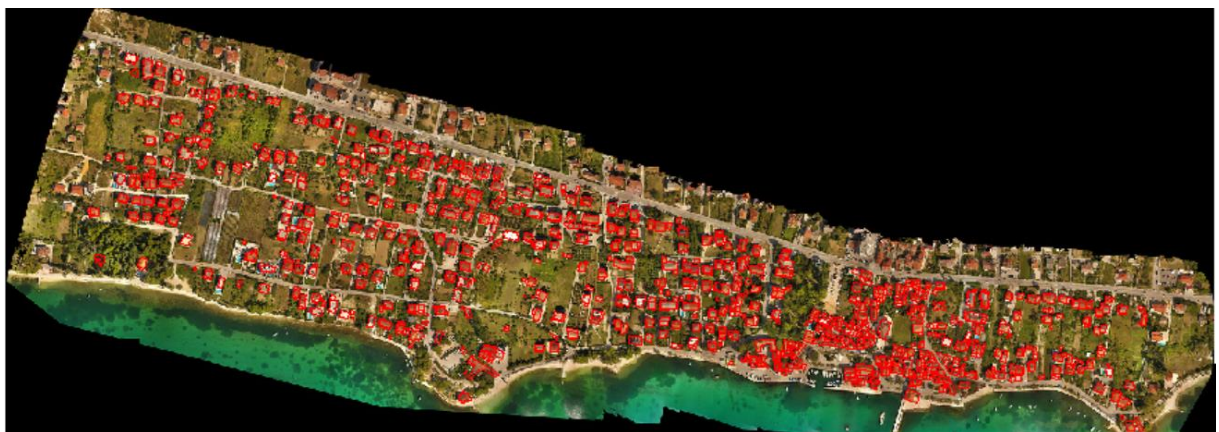
Fig. 16. HR test site with marked cadastral and building parcels

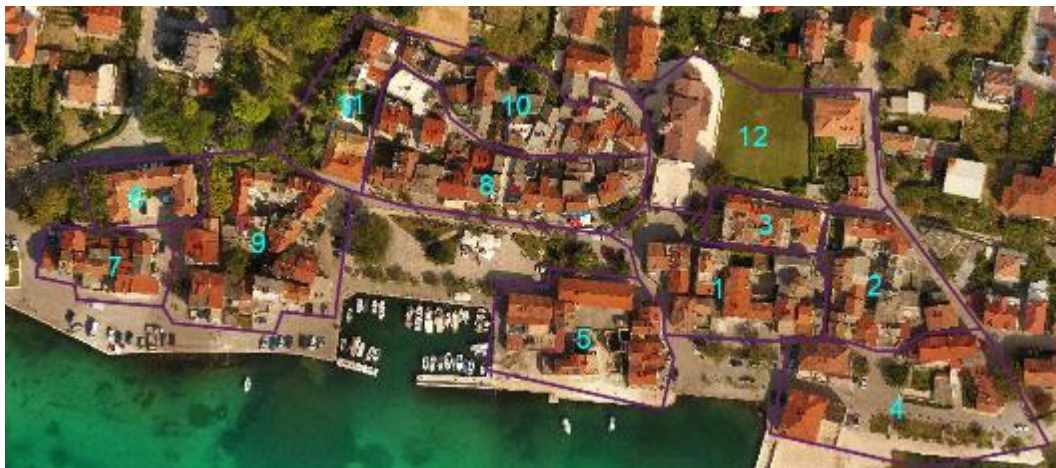
Fig. 18. Old city centre divided into blocks

In the historical centre no technical documentation was found for most of the buildings, an architectural survey, collection of photo documentation and visual inspection of material and construction characteristics were performed by field data collection. Several buildings in the historic core where material and structural features are not evident from visual inspection were examined by thermographic imaging. The results of the field investigation of the building characteristics are presented by drawn floor plans and cross sections of the buildings, photo documentation and description of the structural and material characteristics. These data are used in defining individual building vulnerabilities. As the special emphasis in the project is on researching the seismic vulnerability of old stone buildings, all the buildings in the historic centre were analysed (Fig. 18). Processing on a large sample enables later definition of characteristic typologies with conclusions about their vulnerability indexes and application to other old town cores in the Dalmatian coast.

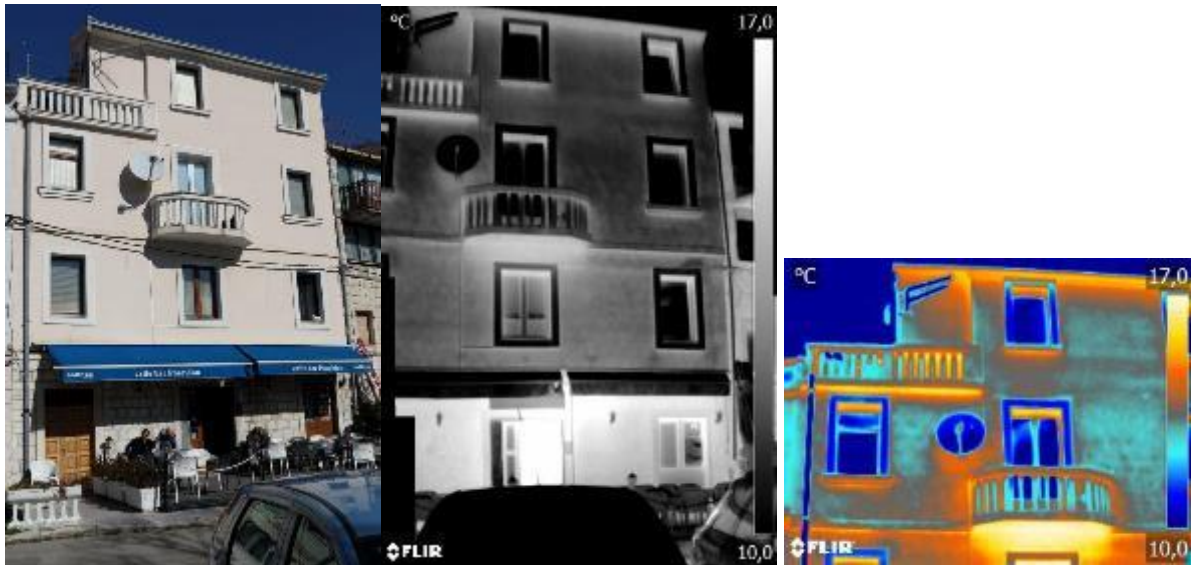
Fig. 22. Residential building Drage Britvića 13: Stone masonry walls with RC floors, balcony and roof slabs is characteristics of reconstructed old stone masonry building.

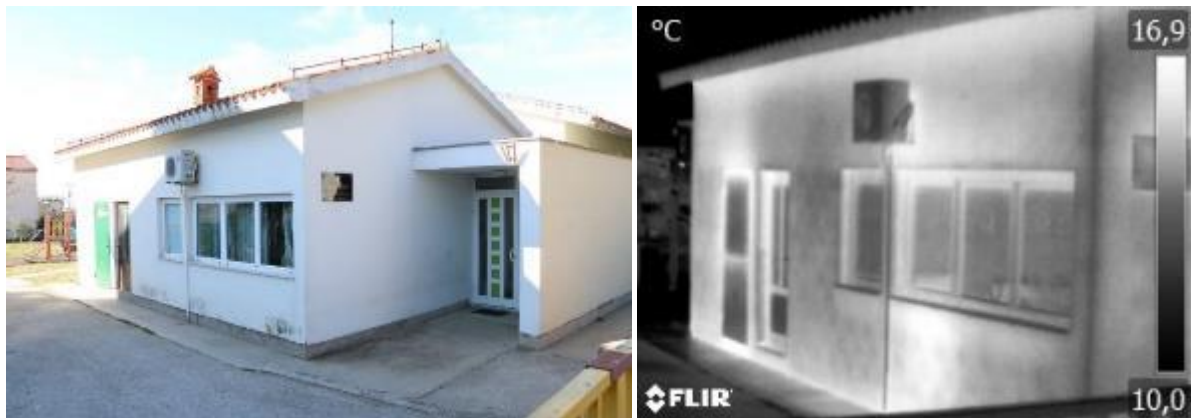
Fig. 23. Kindergarten Franje Tuđmana bb: Structure is brick masonry wall with vertical corner RC confinements, horizontal confinement and RC roof slab covered by roof tiles.

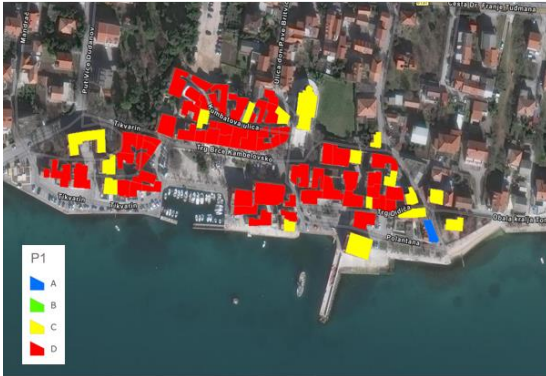
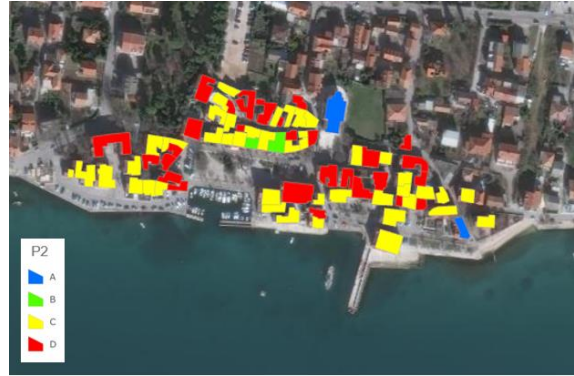
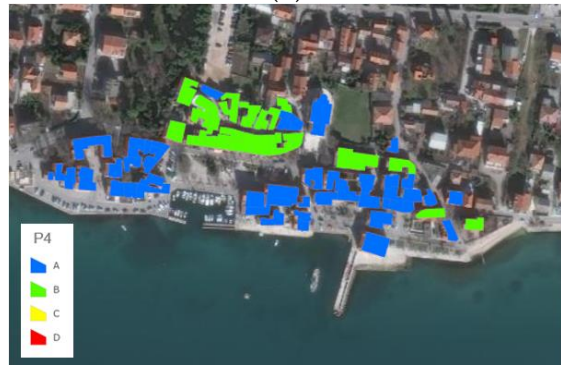
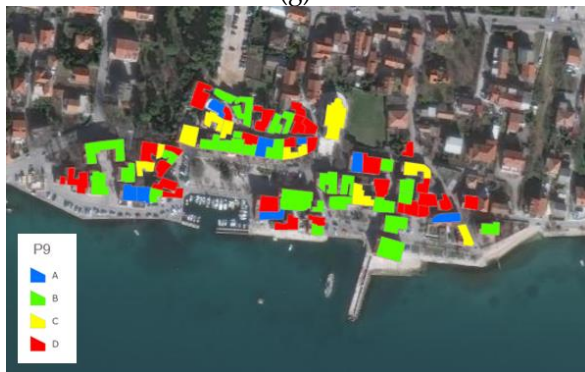
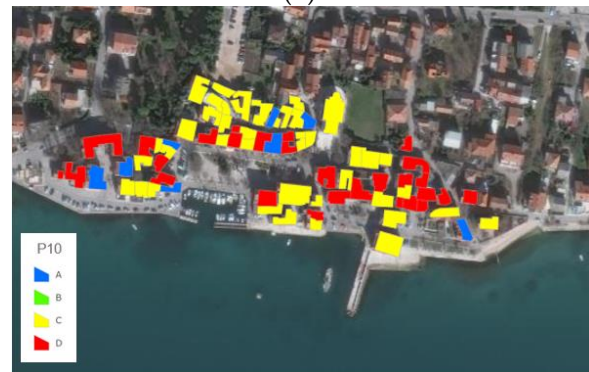
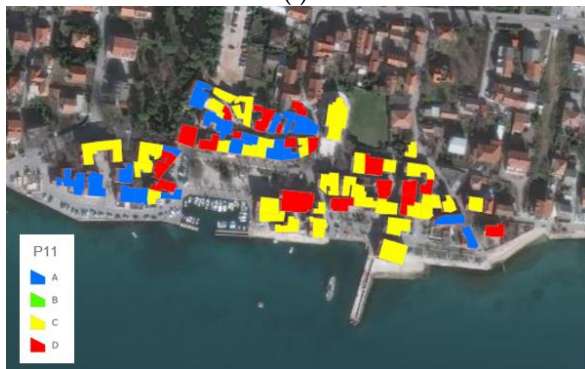
Fig. 27. Spatial distribution of the 11 parameters that comprise the seismic vulnerability index: (a) type and organization of the resistant system; (b) quality of the resistant system; (c) conventional resistance; (d) position of the building and foundation; (e) typology of floors; (f) planimetric configuration; (g) elevation configuration; (h) maximum distance among walls; (i) roof; (j) non-structural elements; (k) state of conservation.

The “position of the building and foundation” parameter considers the influence of the local morphology of the site and the natural slope of the ground. Its distribution in Fig. 27d showed a low level of vulnerability. Specifically, 57% of buildings were in class A and 43% were in class B. The reason for such a distribution is the presence of solid soil of type A and the relatively small slope of the terrain.

The presence of “non-structural elements”, which can cause damages due to falling, highlighted an area of high vulnerability because most buildings had weakly connected non-structural elements and belonged to classes C and D. The distribution shown in Fig. 27j was 12%, 0%, 53%, and 35% for classes A to D, respectively.

The “state of conservation” parameter analyses the condition of the building and the presence of cracks in structural walls. The relevant distribution, shown in Fig. 27k, was as follows: 27% were in class A, 0% in B, 45% in C, and 28% were in class D. Most old stone masonry buildings, which have not yet been reconstructed, are in a bad condition and belong to classes C and D, whereas reconstructed buildings are in class A.

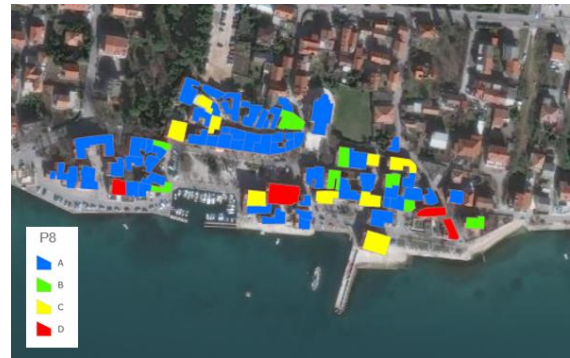
(h)

The “maximum distance among the walls” parameter validates the presence of structural walls orthogonally connected to transversal ones. The buildings in the historical core had a favourable distribution, as most of them belonged to classes A and B, with 69% in class A, 12% in class B, 13% in class C, and 5% in class D, as shown in Fig. 9h.

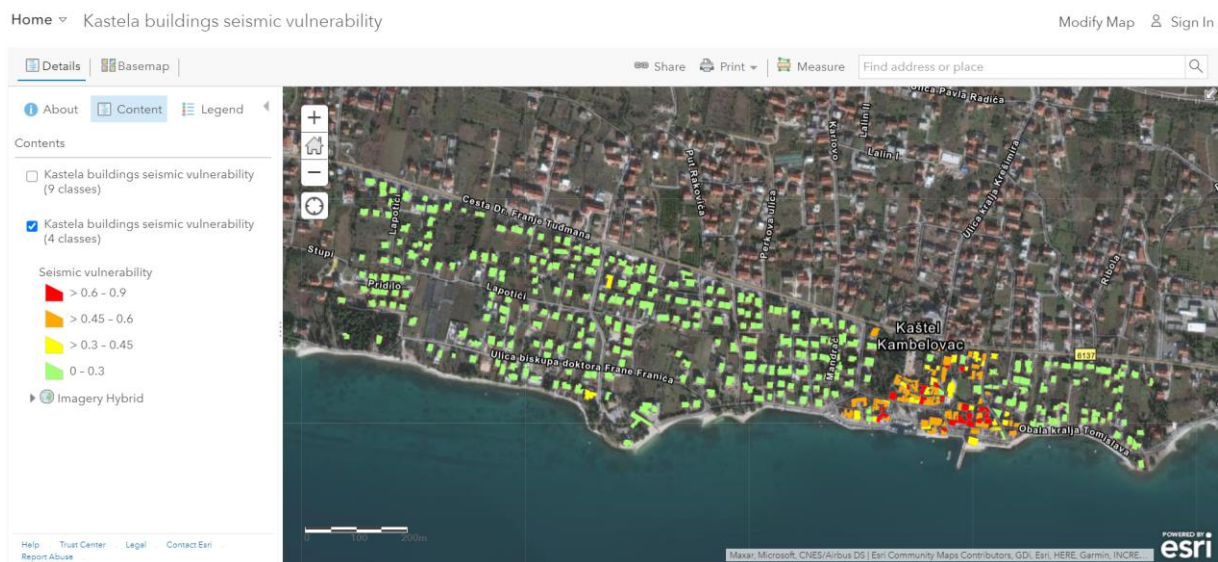
Fig. 29. Vulnerability of the buildings in the whole test site divided into 4 classes

In the eastern and western parts of the test site, the buildings are built with concrete or clay blocks, without confinement, only with confinement horizontal tie beams or with horizontal and vertical confinement. They mostly belong to the low vulnerability class ( $I_v < 30\%$ ).

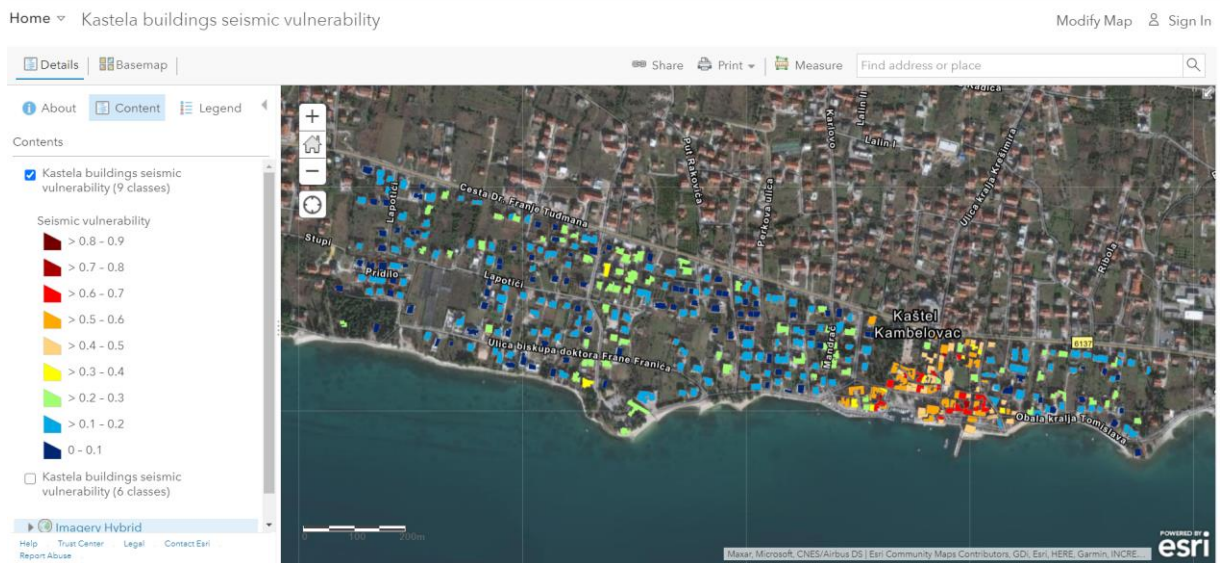
Fig. 30. Vulnerability of the buildings - 10% division intervals

Fig. 30 shows detail classification of the buildings according their vulnerability indexes with division into classes of 10%.

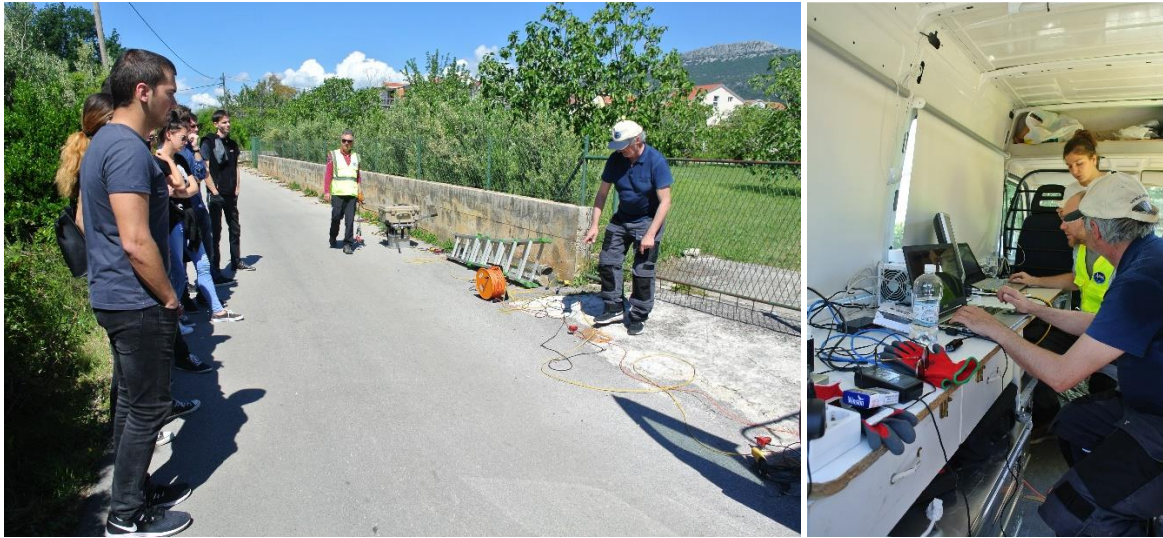
Fig. 35. Geophysical survey operated by OGS in Kaštel Kambelovac, May 14-24th, 2019.

The test site was investigated to classify soils according to [7] and define local ground conditions and its influence to the local seismic hazard in the HR test site (Fig. 35). Three seismic lines were acquired in May 2019 in the test site [7] (Fig. 36). A velocity analysis based on travel time tomography of P, SV, and SH arrivals, acquired on three seismic lines on the shore of the Kaštela Bay, was performed. The  $V_{s,30}$  map along each line was also computed by averaging the vertical  $V_{sH}$  tomographic values from the surface to a depth of 30 m. Relatively high obtained values, between 1.2 and 1.7 km/s, indicate the presence of shallow hard rock [13, 14], which can be classified as soil type A according EN 1998-1:2011 [11].

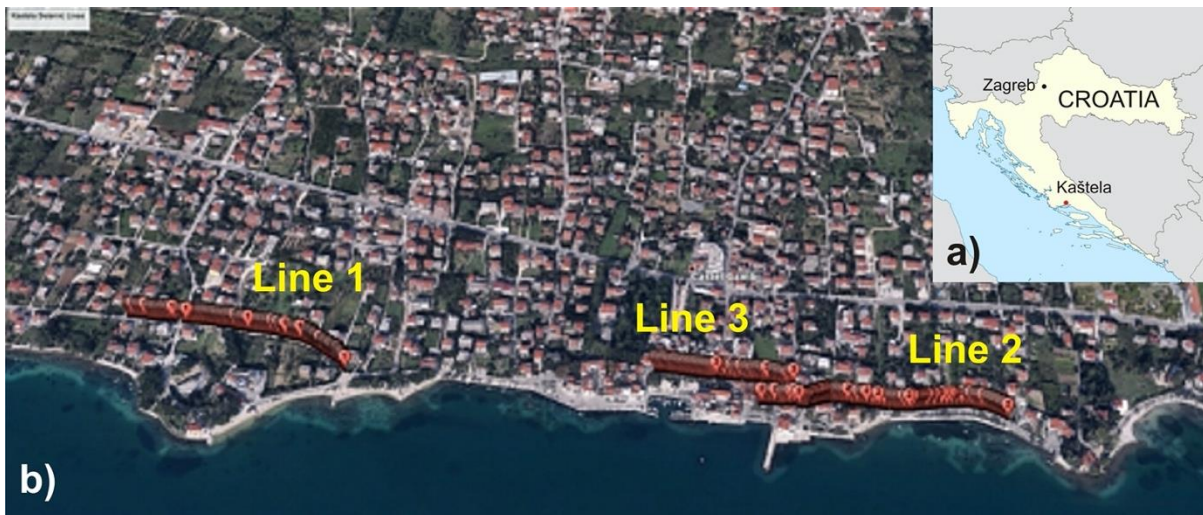
Fig. 36. a) Location of the town of Kaštela on the Dalmatian coast. b) Position of the seismic lines in the historical centre of Kaštela. Image taken from Google Earth on April 3<sup>rd</sup> 2020 [14]

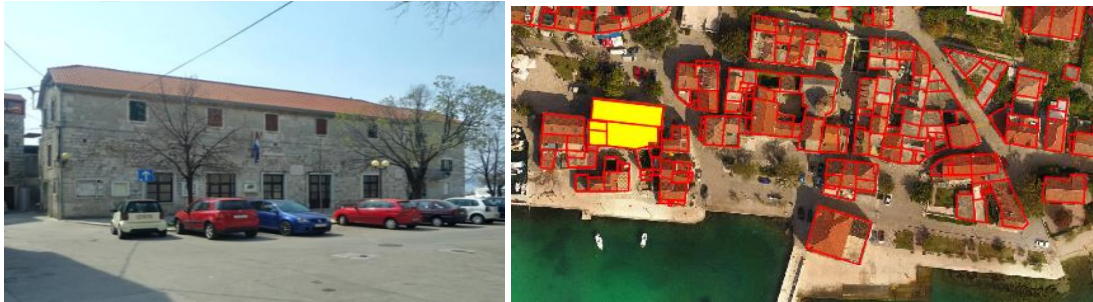
Public Library is a stone masonry structure built in the 19th century (Fig. 38). It has three floors (ground floor, first floor, and attic) and is intended for public usage. It consists of a library and a hall for events on the ground floor and offices on the first floor. The structure is made of stone walls and wooden floors. The walls were built of natural carved stone, 50-cm thick, with medium-quality mortar. The roof

Fig. 38. Public Library: photo and position of the building.

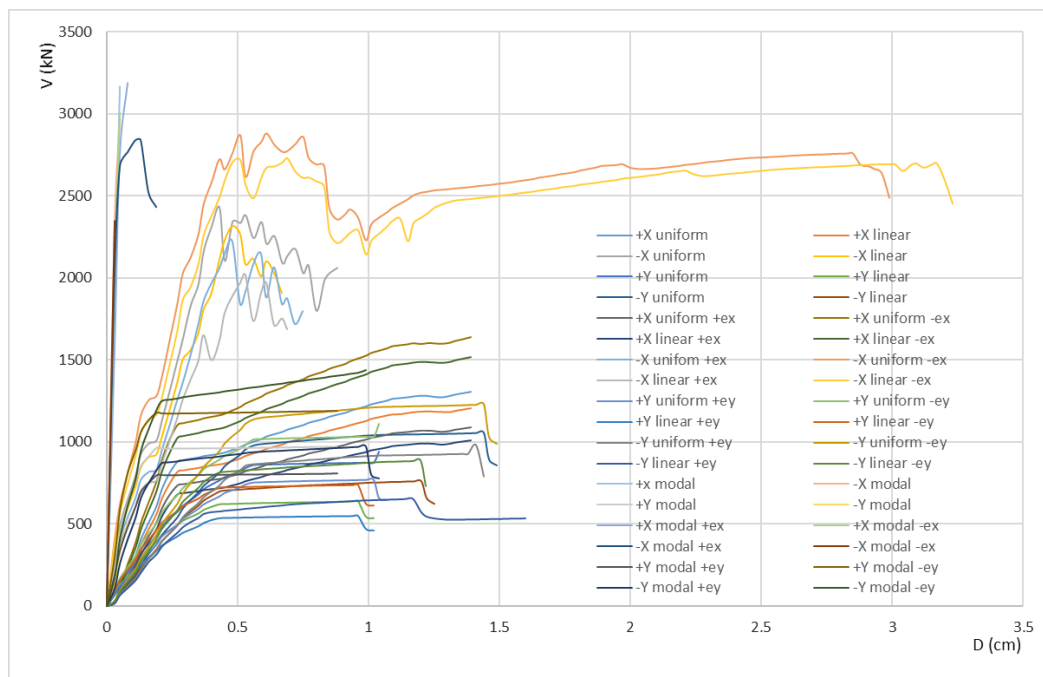
Fig. 40. Pushover curves for the Public Library building

The seismic demand was defined by the elastic acceleration response spectrum. A type 1 response spectrum [7] and soil class A [7] were used for the test site. The input parameters taken in the seismic analysis were the importance factor  $\gamma_1 = 1.2$ , the design ground acceleration  $a_g = 0.22$  g, and the soil factor  $S = 1.0$ . Fig. 40 shows the results of a total of 36 pushover analyses for uniform, linear and modal distributions of lateral forces obtained by TREMURI software. The behavior of the building was different along the two main directions and depended on the direction of the lateral loads.

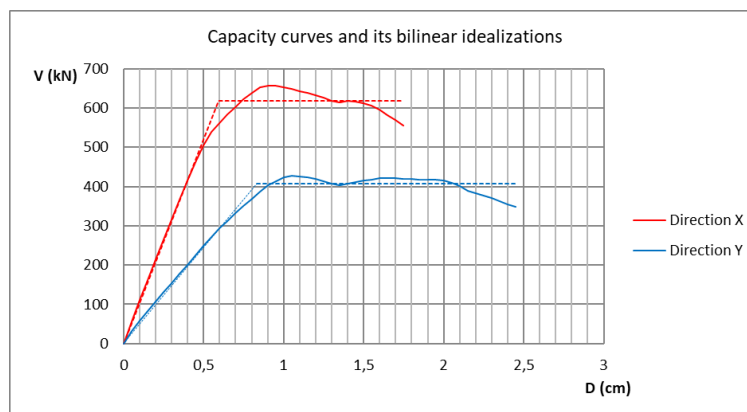
Fig. 47. The worst cases of pushover curves

The pushover curves which give the lowest capacity accelerations  $PGA_C$  in the x and y directions are shown in Fig. 47, together with their bilinear idealizations, which are essential for capacity identification. The lowest capacity in both directions was obtained for the linear distribution.

The capacity acceleration in terms of the collapse for the case study is equal to 0,147 g (0,668  $a_g$ ) in the x direction and 0,078 g (0,355  $a_g$ ) in the y direction, where  $a_g$  represents the design ground acceleration, defined by the seismic hazard map for the return period of 475 years, and it is equal to  $a_g = 0,22$  g. Finally, seismic capacity of the Cambi Tower, shown in terms of collapse acceleration of the building, is equal to 35,5% of demand acceleration  $PGA_D$ .

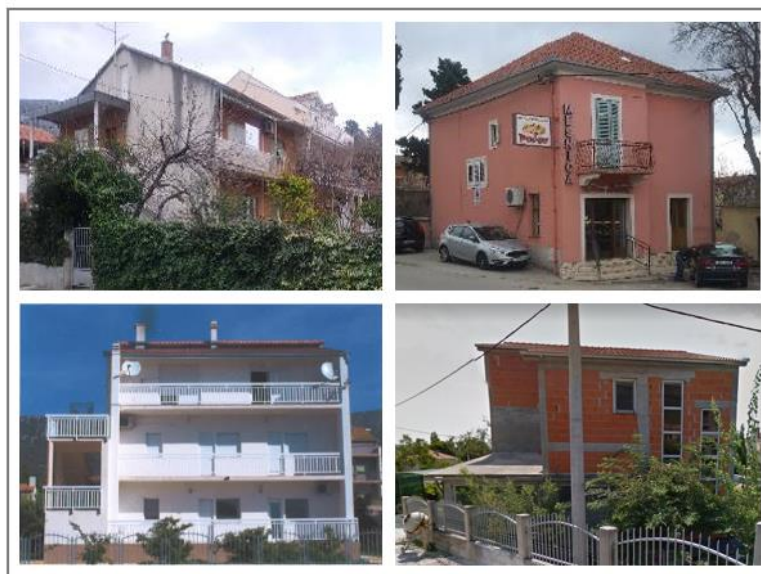
Fig. 51. Typical buildings outside of historical centre.

Eight masonry buildings typical for the constructions outside of historical center have been analysed by static non-linear analysis. The sample includes the buildings built of concrete or brick hollow blocks after the 1948 and can be classified according to the construction period. Between them there are following categories of the buildings: (1) unbounded concrete masonry built before the first seismic regulation in 1964; (2) concrete masonry with horizontal RC beams typical for the period between 1964 and 1980; (3) concrete masonry with horizontal RC beams and RC columns built between 1980 and 2005 and (4) clay masonry with horizontal RC beams and RC columns which are seismically resistant structures due to the applications of modern design standards based on Eurocode 8. The buildings have rigid RC slabs while the roof is mainly wooden with roof tiles. Two different elevation configuration have been analysed: (a) P+1 which consists of ground, one floor and roof; and (b) P+2 which consists of ground, two floors and roof. Typical buildings outside of historical centre are shown in Fig. 51. Plan and section view of the buildings are shown in Fig. 52.

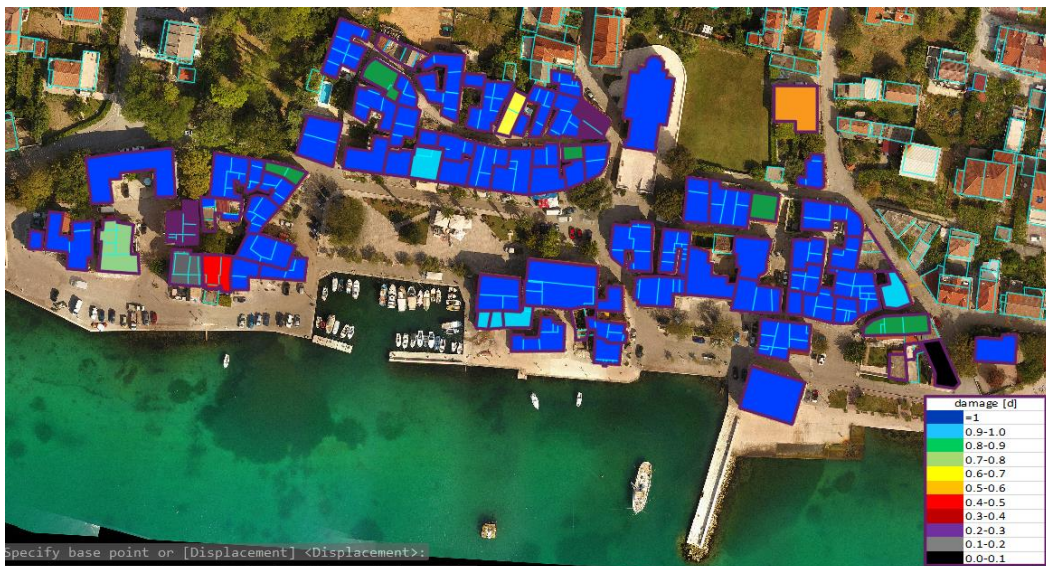
Fig. 49. Map of the damage index for  $PGA = 0.11$  g and a return period  $T = 95$  years

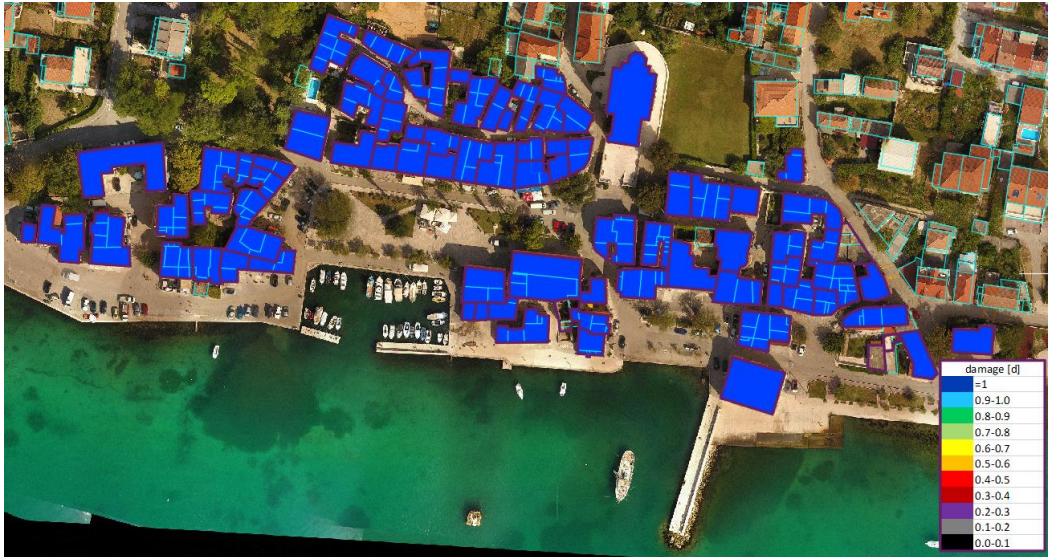
Fig. 50. Map of the damage index for PGA = 0.22 g and a return period T = 475 years

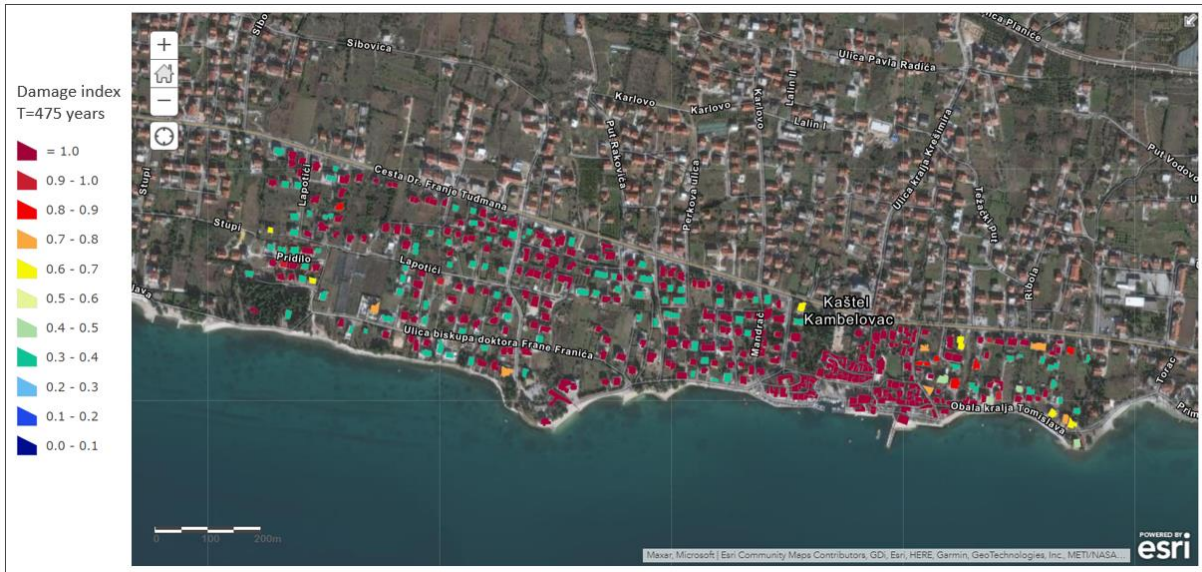
(c)

Fig. 53. Damage index distribution at the test site: (a) T=95 years; (b) T=225 years; (a) T=475 years.

Spatial distribution of the damage is represented by the damage index maps of the investigated area for given intensity of the earthquake. Three seismic scenarios corresponding to return periods 95, 225 and 475 years and demand peak ground accelerations of 0.11g, 0.17g and 0.22g, respectively, have been chosen. The damage of the buildings for different scenarios are shown in Fig. 53.

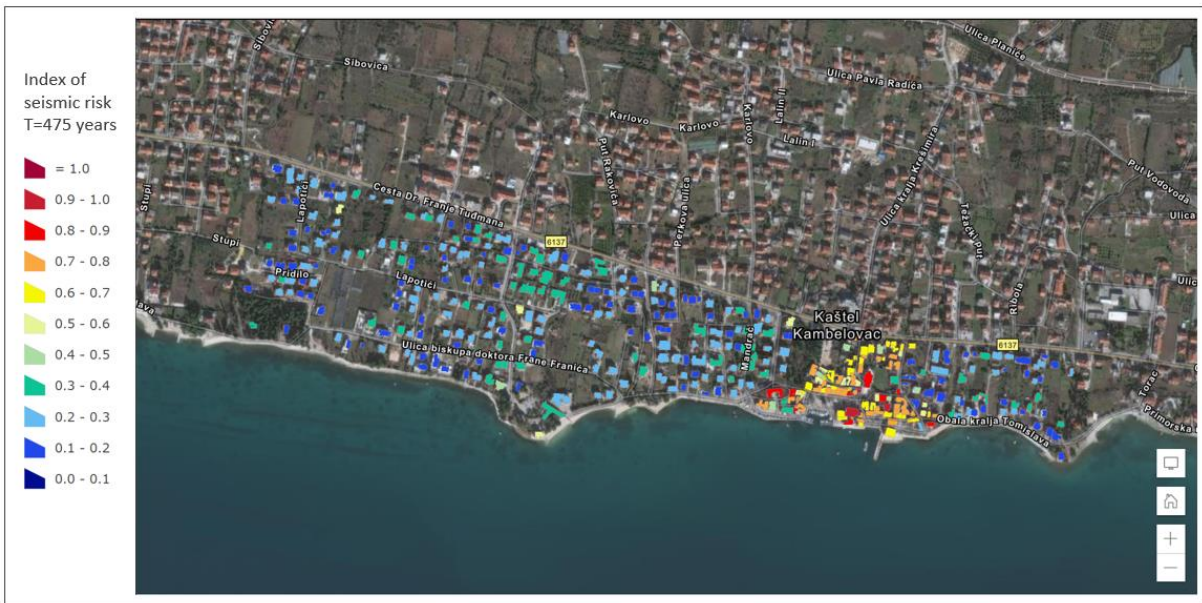
(c)

Fig. 54. Risk maps in terms of index of seismic risk: (a) T=95 years; (b) T=225 years; (a) T=475 years.

In this project the index of seismic risk for the collapse of the structure which corresponds to NC limit state is estimated for three return periods. The results are presented in Fig. 54.
