A sub-soil fresh-water distribution system using pipes located along the main sandy pale-channel

Deliverable D_4.2.3

Graphical tables describing the draining pipe and the control valve system

Sub-soil fresh-water distribution system planning and testing

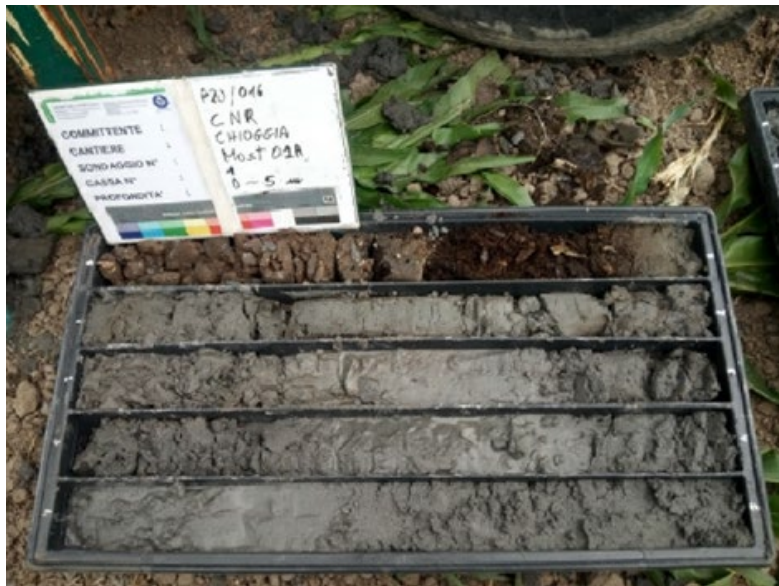
Fig. 2 - MoST1a sediment line cores 0-5m.

pipe installation. The photos of the sediment line cores 0-5m are shown in *Fig. 2, Fig. 3, Fig. 4, Fig. 5.*

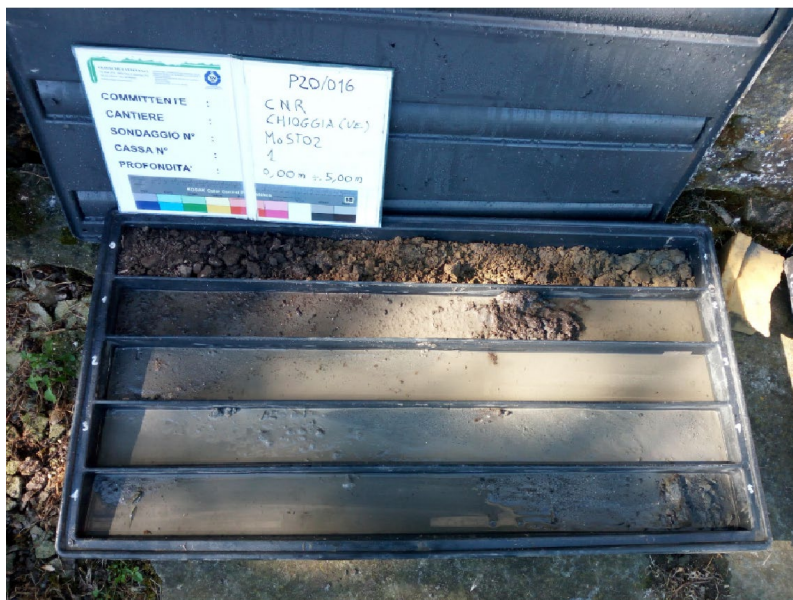
Fig. 3 - MoST2 sediment line cores 0-5m.

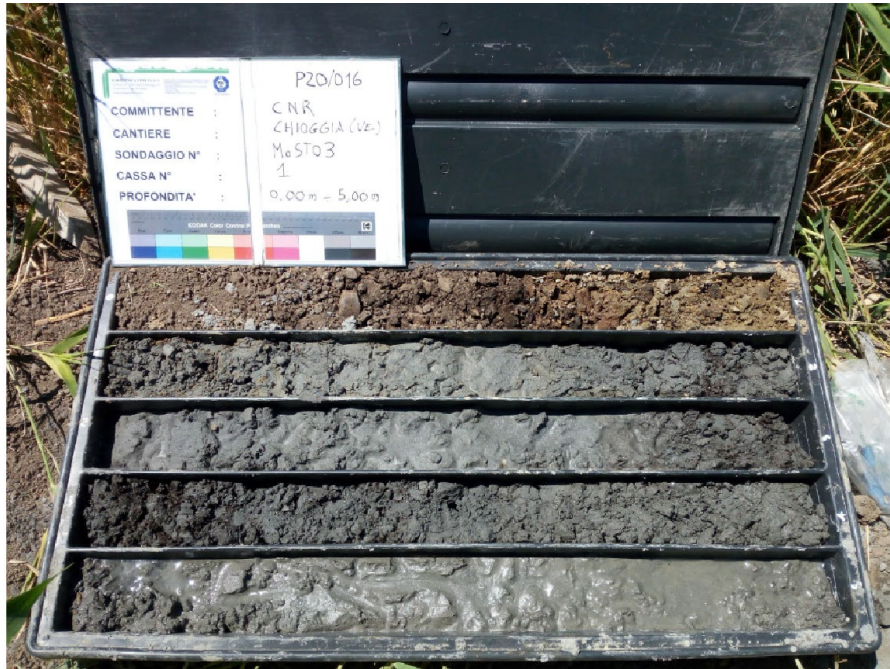
Fig. 4 - MoST3 sediment line cores 0-5m.

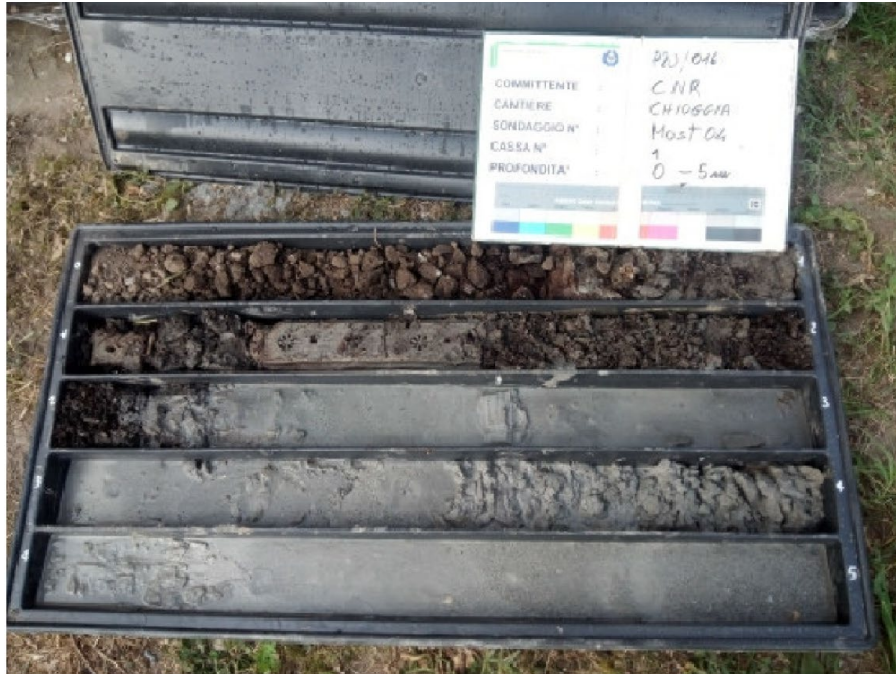
Fig. 5 - MoST4 sediment line cores 0-5m.

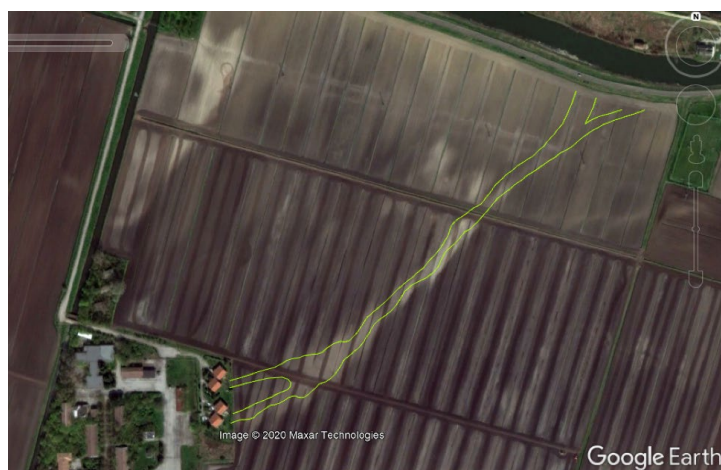
Fig. 7 - Geomorphological structure selected for a detailed investigation.

Once selected the study area, the first step was the choice of the sandy buried body along which will be established the sub-irrigation system. The study area (*Fig. 6*) is characterized by the presence of several buried sand bodies, mapped by remote sensing together with in-situ surveys and sampling. A further analysis of each single structure led to the selection of a specific paleo-channel system for more detailed investigation. The selected buried paleo-channel system is shown in *Fig. 7*.

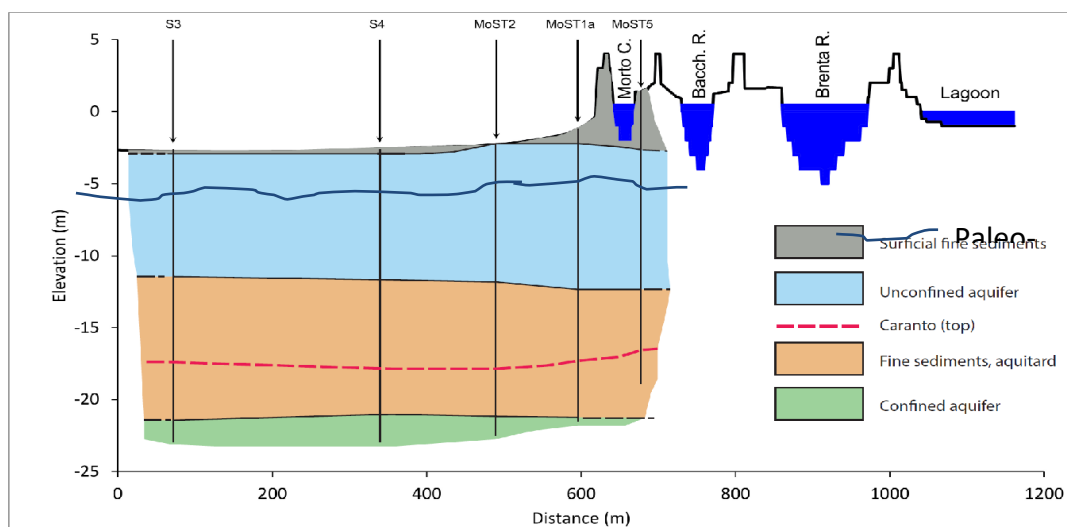
Fig. 9 - Hydrogeological model along a N-S the ground elevation profile of the pilot test site. The positions of the sediment cores are shown in Fig. 10.

Focusing on the shallower units, which is the target of the MoST project, a more detailed hydro-stratigraphic model, obtained by the analysis of sediment cores taken next to the pilot site is shown in Fig. 9.

The hydrogeological model is sketched along the same direction of the selected paleo-channel. Along this section, the subsoil shows two main quite uniform units consisting in an upper sandy body about 10 m thick, at the top of which is located the paleo-channel, and the lower unit, mostly formed by silty sand and silty clay layers.

The over-consolidated clay known as caranto lies at about 17 m below msl. This is the uppermost Pleistocene alluvial sedimentation and above it, the Holocene units are formed by marine-lagoon and back barrier deposits.

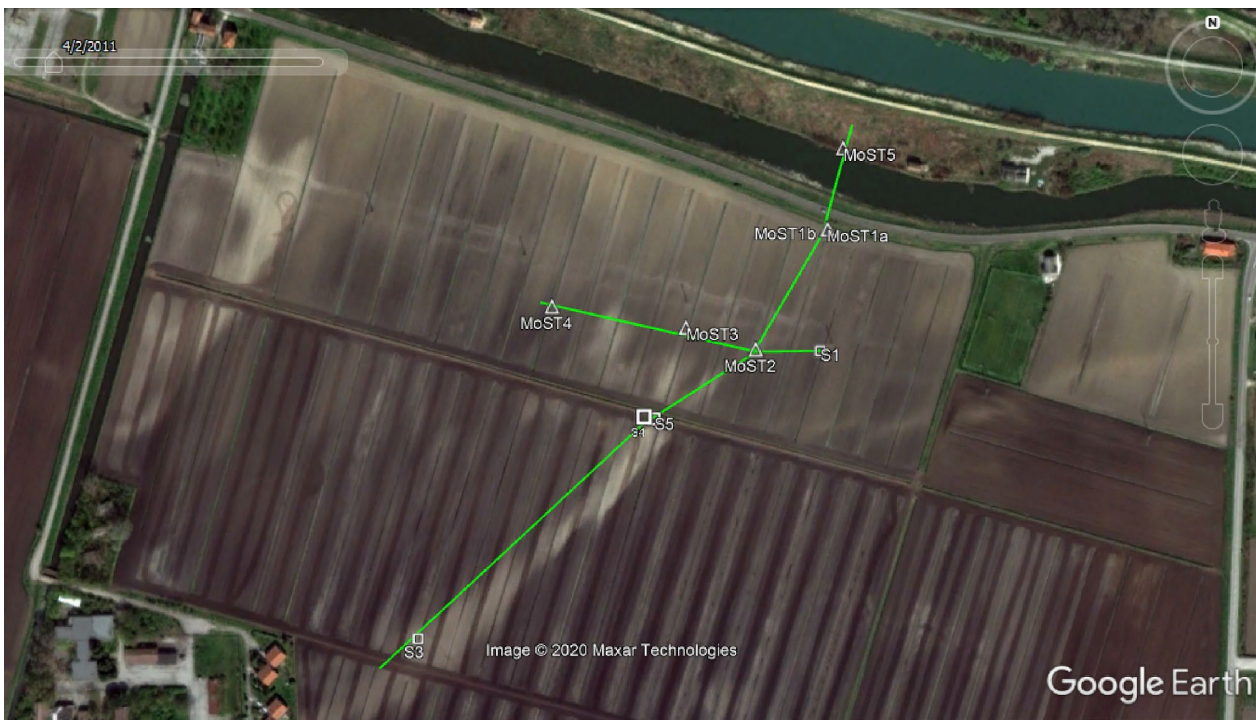
Fig. 10 - Pilot site with the position of the sediment cores and wells.

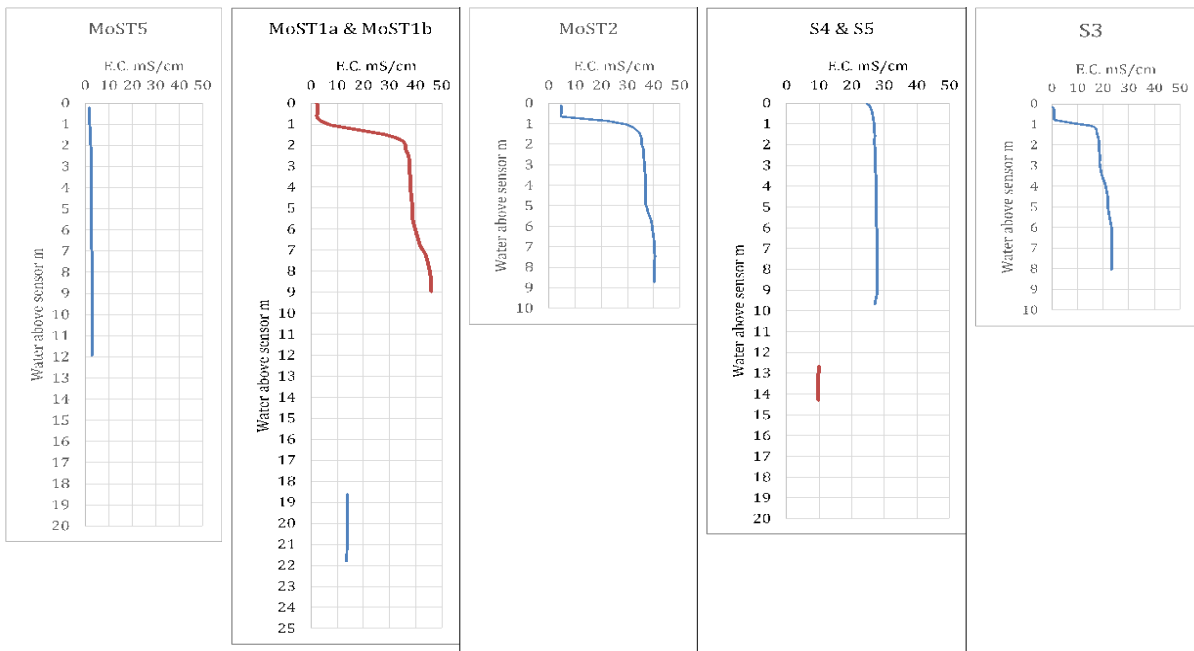
Fig. 11 - EC logs reflecting the salinity degree in aquifers A1 (0-8 m) and A2 (15-20 m) in the pilot site along the profile shown in Fig. 10.

The EC logs, reflecting the salinity degree in aquifers A1 (0-8 m) and A2 (15-20 m) in the pilot site, are shown in *Fig. 11* and *Fig. 12*.

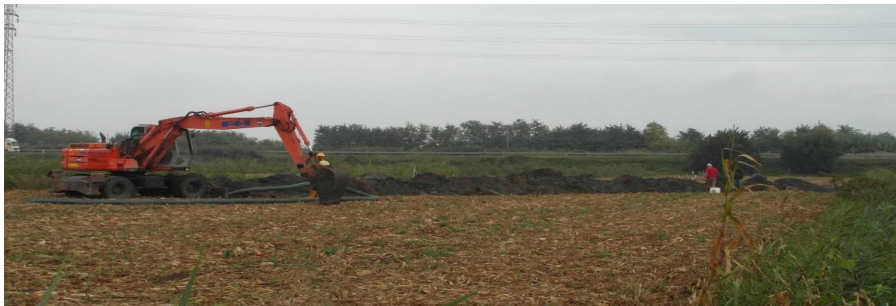
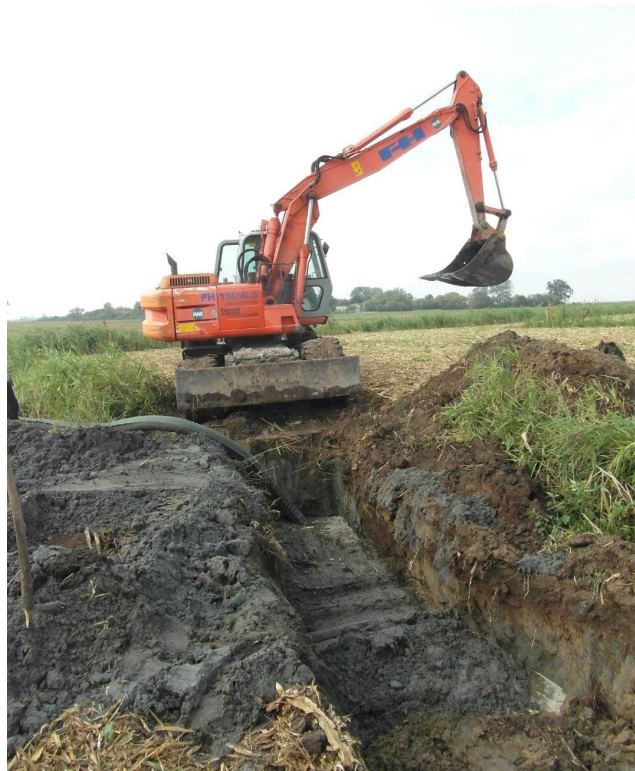
Fig. 14 - Excavator working for the excavation of the trench and positioning of the pipe.

The works for the installation of the drainage pipe started in October 2020 and finished at the beginning of November 2020 (*Fig. 14, Fig. 15*).

A trench around 2 m deep has been excavated along the selected path, around 220 m long. The pipe has been located at a depth of 1.7 m from the ground level.

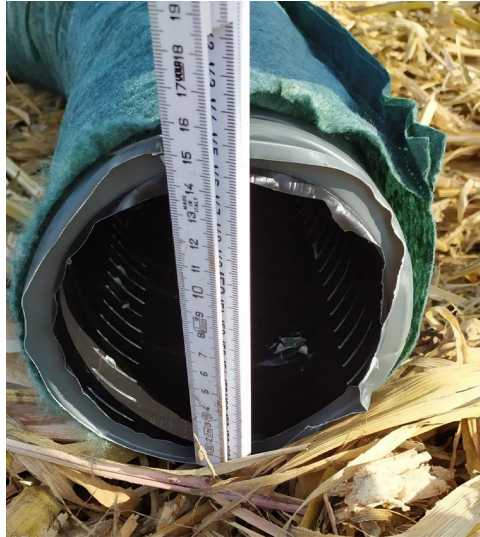
Fig. 15 - Detail of the drainage pipe.

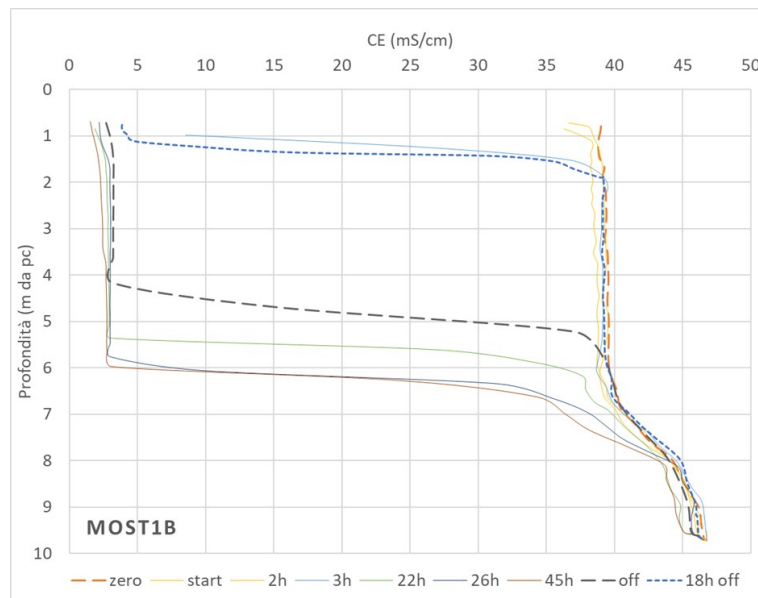
Fig. 19 - Electrical Conductivity (EC) recorded in MoST1b piezometer before, during and after the

functioning of the pipe.

The sub-irrigation system started on November 3rd and stopped on November 5th (Fig. 18). Temperature, pressure and electrical conductivity in the aquifer have been monitored before, during, and after the functioning of the drainage pipe, using logging sensors equipped in the piezometers installed in the test area (see DOC n. MoST-CNR 3.1-007). In Fig. 19 and Fig. 20 we show the EC data, collected in MoST1b and MoST2 wells, located both along the path of the pipe (Fig. 21), respectively, MoST1b next to the initial part and MoST2 next to the central part of the sub-irrigation pipe. The data collected highlight the progressive development of a fresh-water lens during the functioning of the system, (up to six meters deep, around 24h after the system started), in the

MoST1b piezometer, while they do not show significant variations in the EC of the MoST2 piezometer.

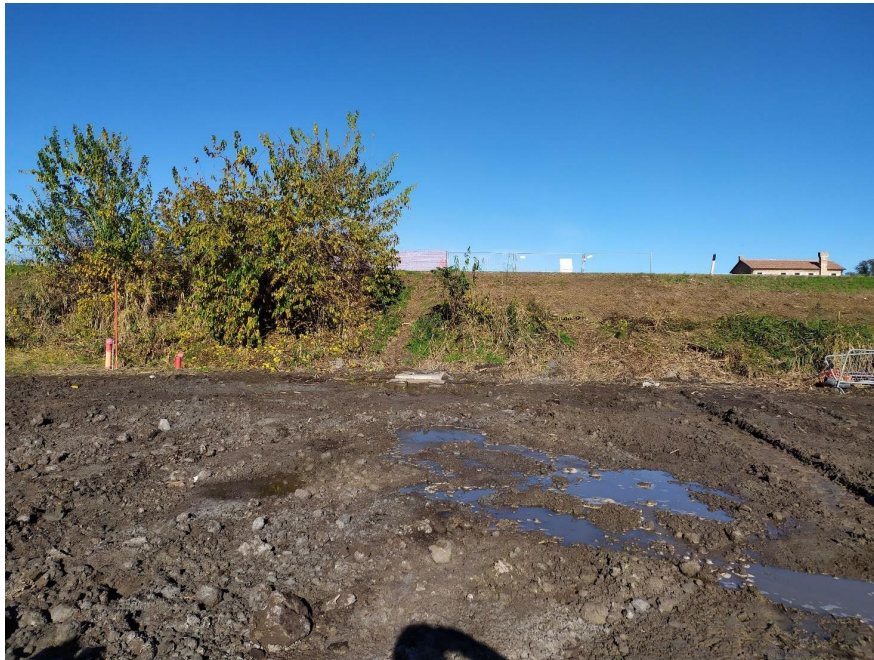
Fig. 24 - The northernmost part of the test area flooded during the operation of the pipe, due to a breakage of the sub-irrigation-pipe.

In fact, a hole was found in the initial part of the pipe, which prevented the fresh water from flowing southward and caused flooding in the northernmost part of the site (Fig. 24).

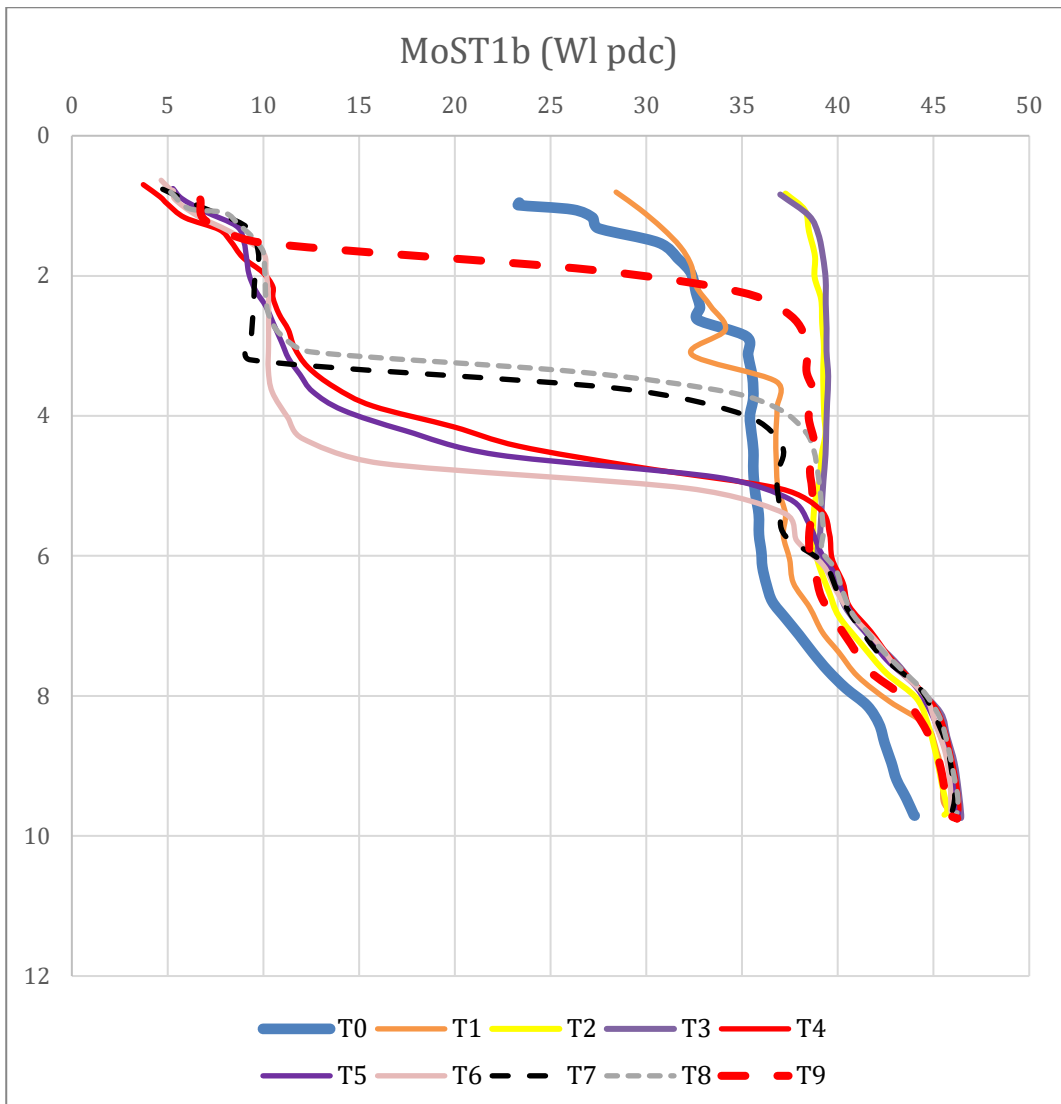
Fig. 26 - Vertical EC profiles in MoST1b during the functioning of the sub-irrigation system. T0: system off. T1: system starting. T2: 4h. T3: 5h. T4: 23h. T5: 25h. T6: 28h. T7: 46h. T8: 48h. T9: system shut down.

ET2 and MoST1b (*Fig. 25; Fig. 26*) show a weak mitigation after 24h of functioning (B5-B6) and the presence of a brackish water lens up to 5 m depth, respectively. The resulted weaker mitigation in this area of the aquifer in respect of the stronger one of the first experiment is due to the reparation of the pipe: during the first experiment, the presence of holes in the first portion of the pipe, all the fresh water flowed around this area.

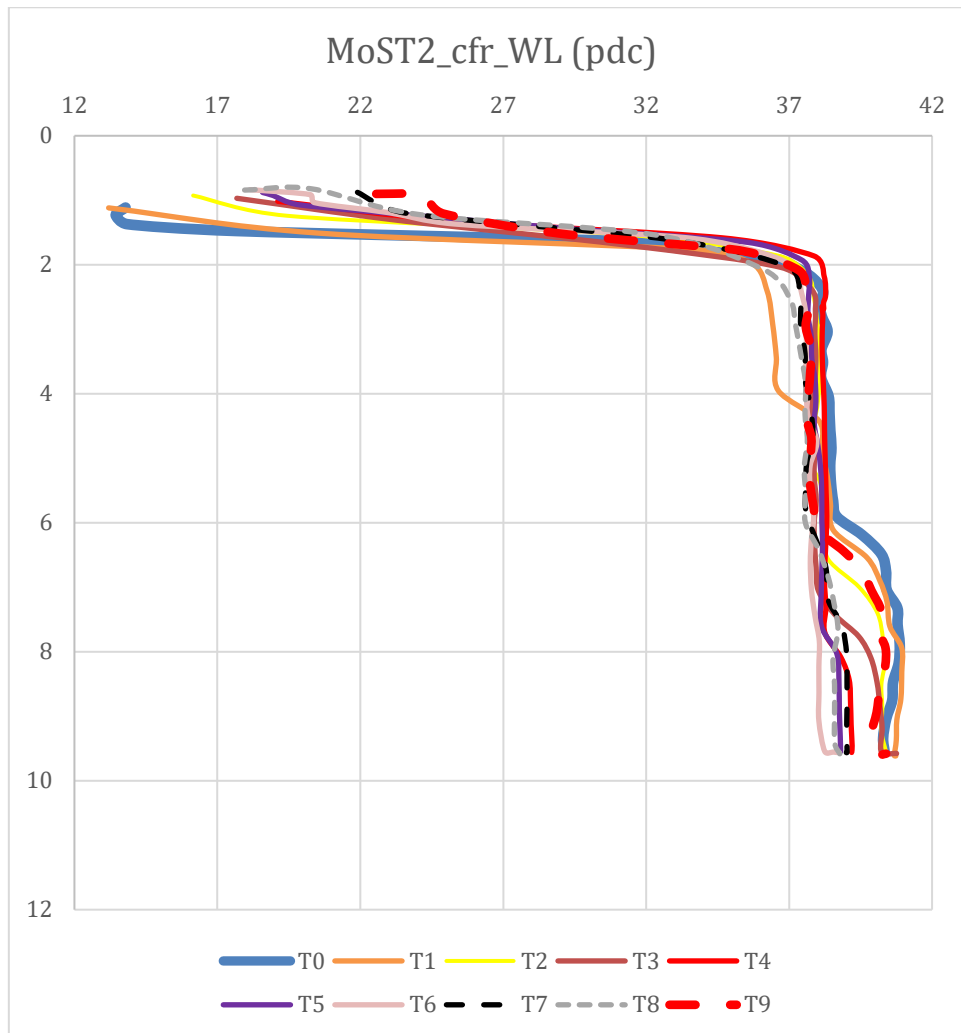
Fig. 28 - Vertical EC profiles in MoST2 during the functioning of the sub-irrigation system. T0: system off. T1: system starting. T2: 4h. T3: 5h. T4: 23h. T5: 25h. T6: 28h. T7: 46h. T8: 48h. T9: system shut down.

In ET2 and MoST2 the mitigation is still negligible (*Fig. 27, Fig. 28*).

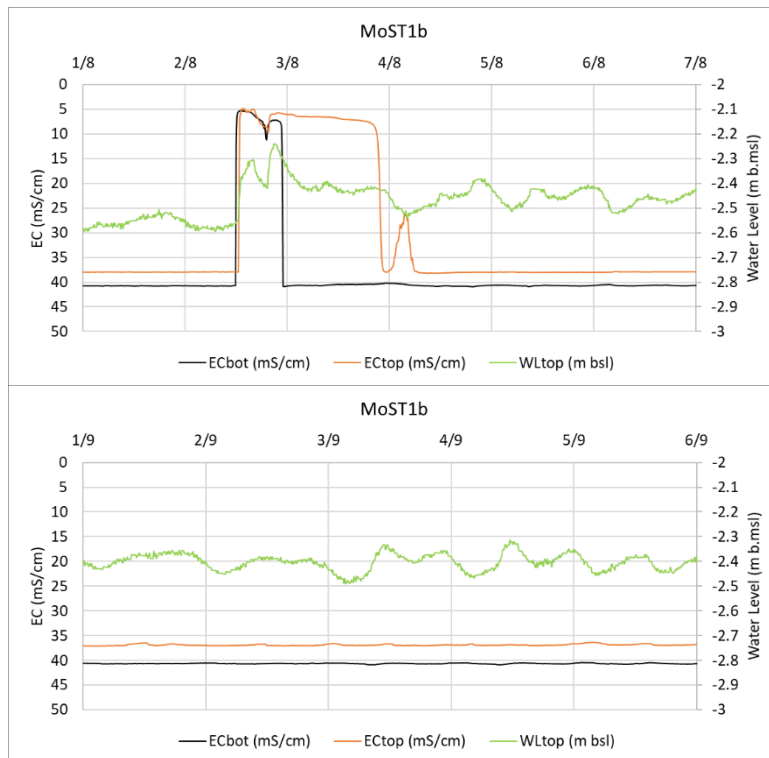
Fig. 30 - Water level and EC recorded in well MoST1b.

The results of the groundwater monitoring are shown in Fig. 30 - Fig. 33. They consist in the time series of water level (WL) and electrical conductivity (EC) recorded in MoST1b, MoST2, MoST3, MoST4, S1, and S5, i.e. the Pilot site monitoring wells located in the vicinity of the sub-irrigation pipe.

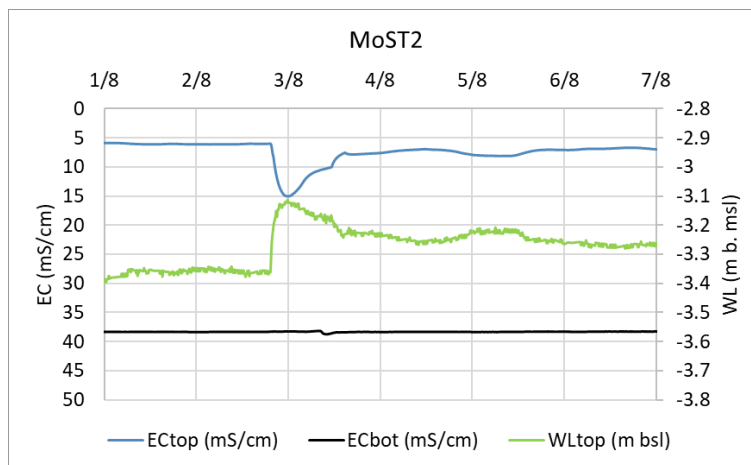
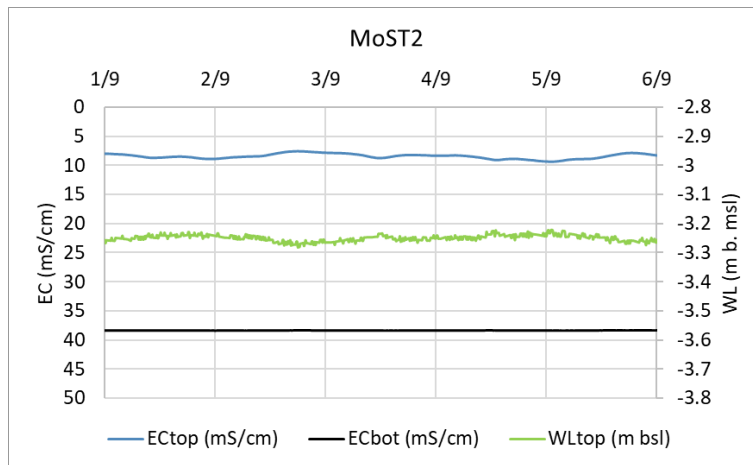
Fig. 31 - Water level and EC recorded in well MoST2.

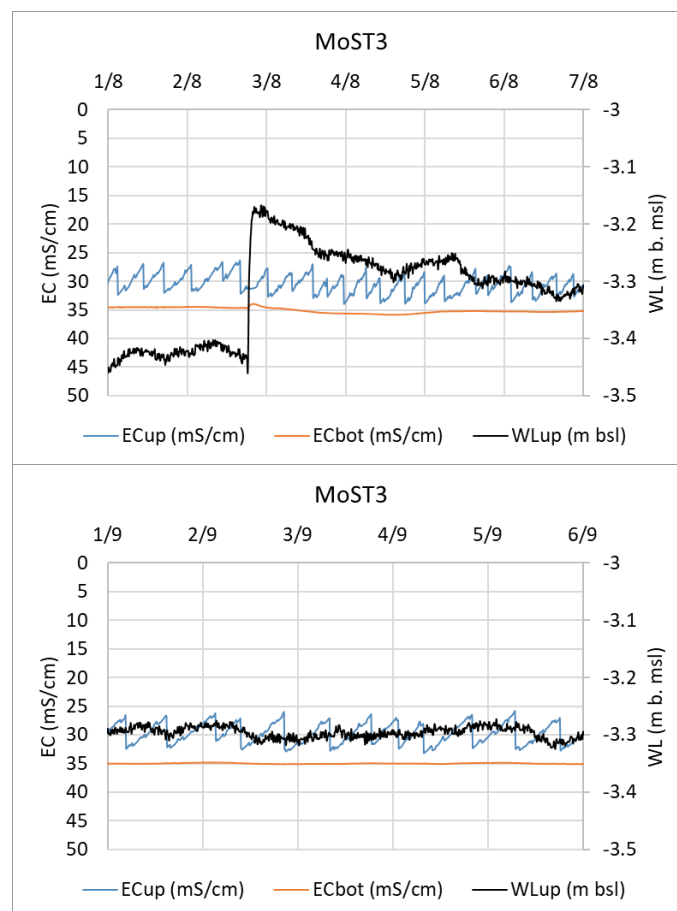
Fig. 32 - Water level and EC recorded in well MoST3.

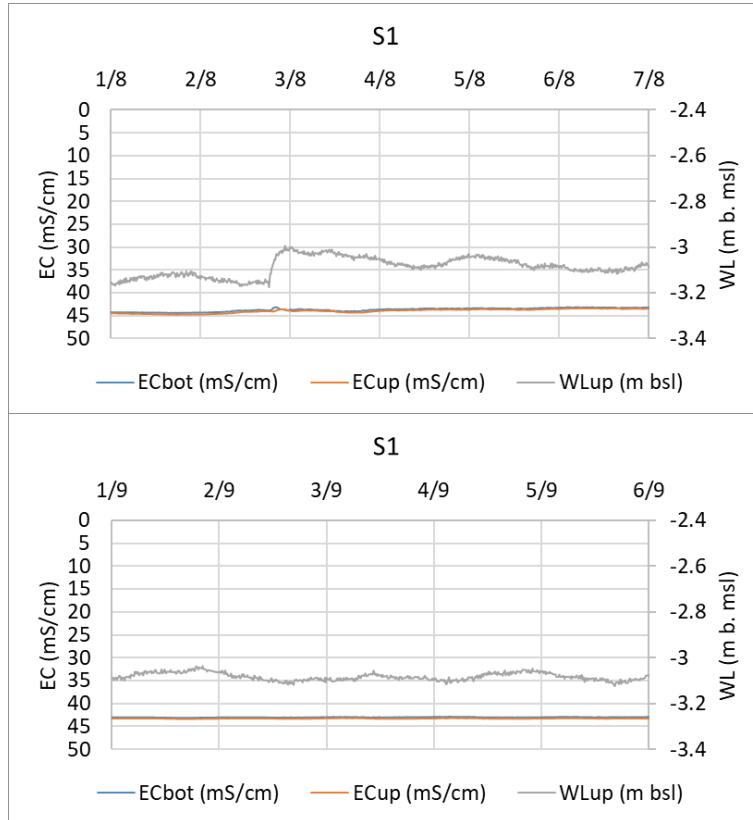
Fig. 33 - Water level and EC recorded in well S1.

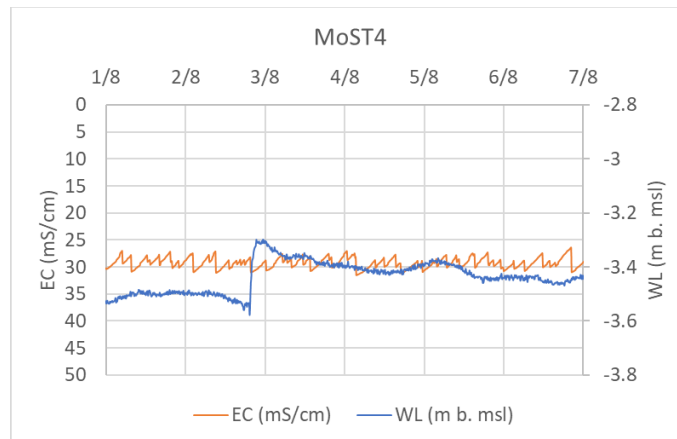
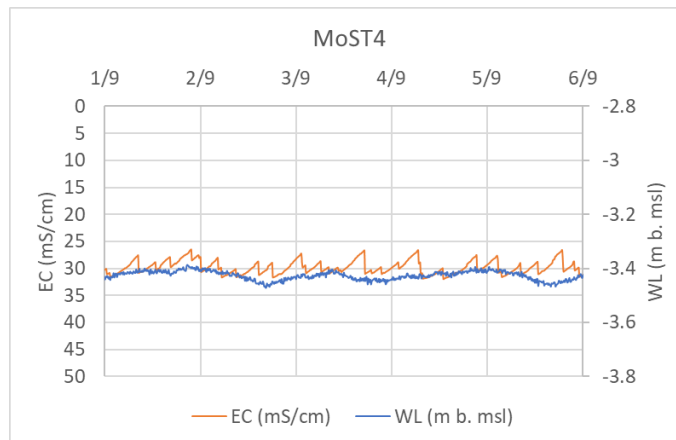
Fig. 34 - Water level and EC recorded in well MoST4.

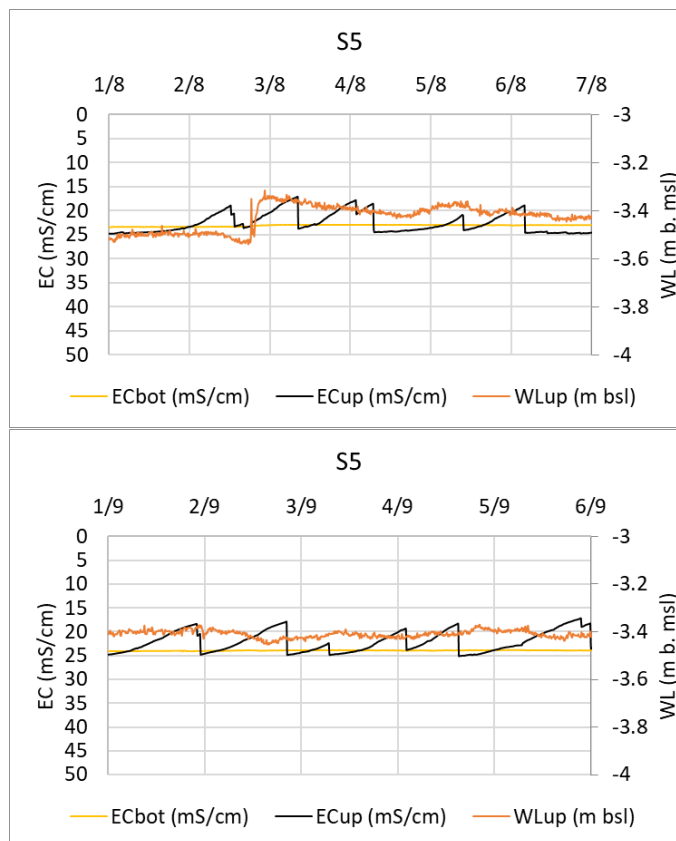
Fig. 35 - Water level and EC recorded in well S5.

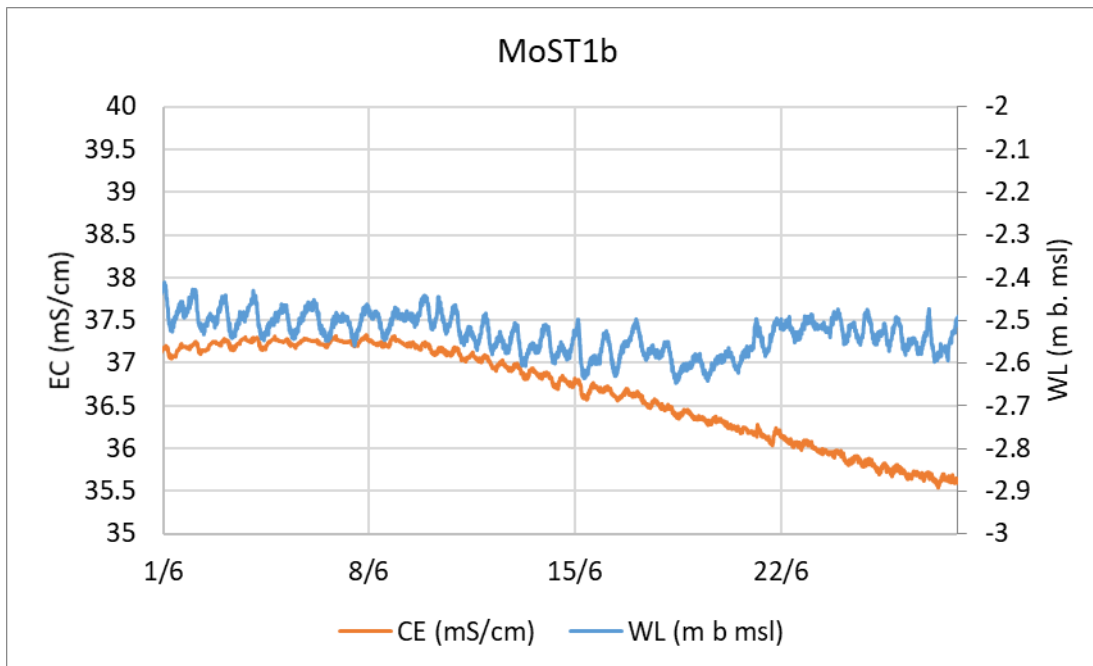
In June 2022 the sub-irrigation was activated. Fig. 36 shows the variation of EC and WL detected in MoST1b by the upper sensor. A slight decrease in EC was detected from 8 June. However, the values remained very high. The WL also shows a decrease attributable to the severe drought in this period that compromises the initial phase of salinity mitigation in the phreatic aquifer.

Fig. 36 - Water level and EC recorded in well MoST1b up.

- In Summer 2022 the sub-irrigation pipe was activated at the beginning of June. Unfortunately the exceptional drought period caused the lowering of the water level in the Canal Morto and its salinization up to 3-4 mS/cm.
