Archaeological site Ostrog with hill Balvan

Final Version of 31/12/2021

Deliverable Number D.4.6.1.

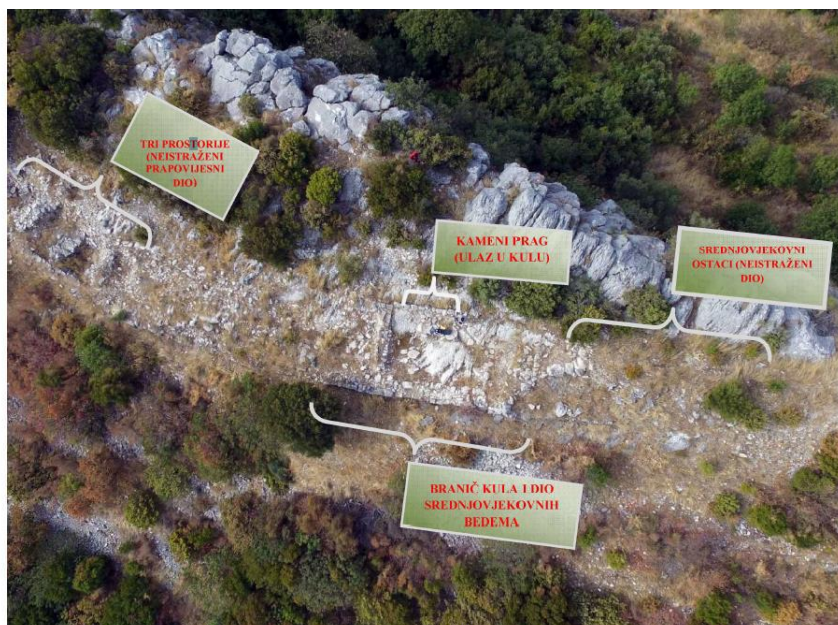
Slika 9. Pogled iz zraka s označenim dijelovima lokaliteta Ostrog - Balavan, izvor: T. Burić.

Picture 1. Panoramic picture of site with marked parts of pilot site Ostrog

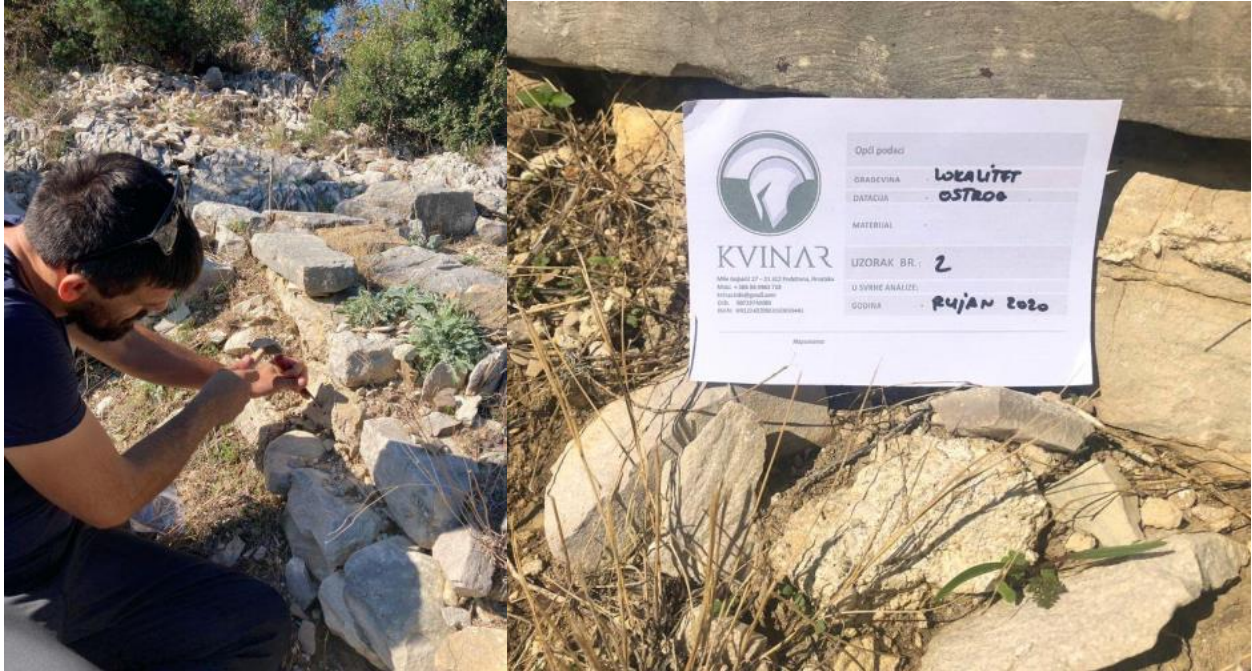
Picture 2. Research and labeling of the site in the progress

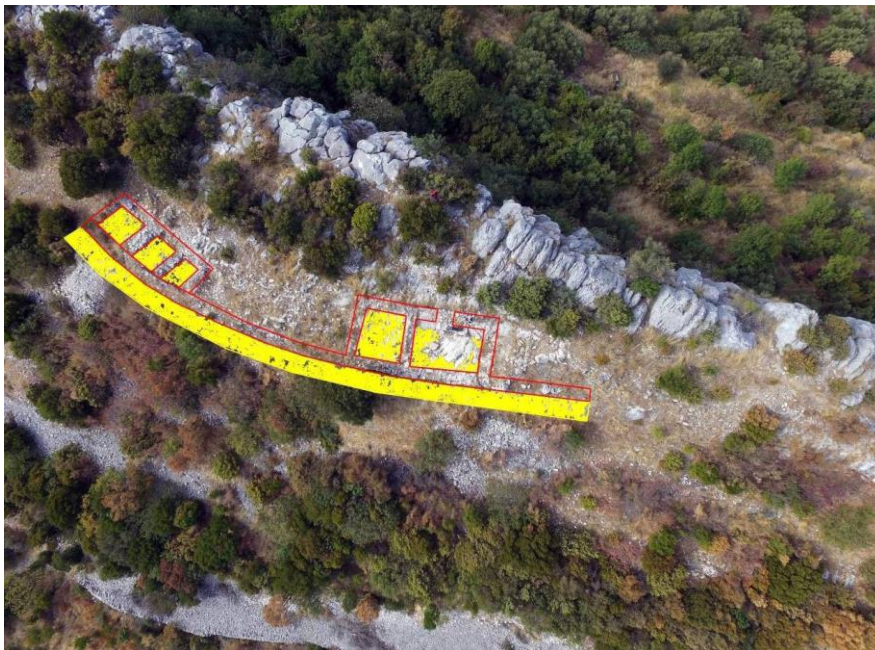
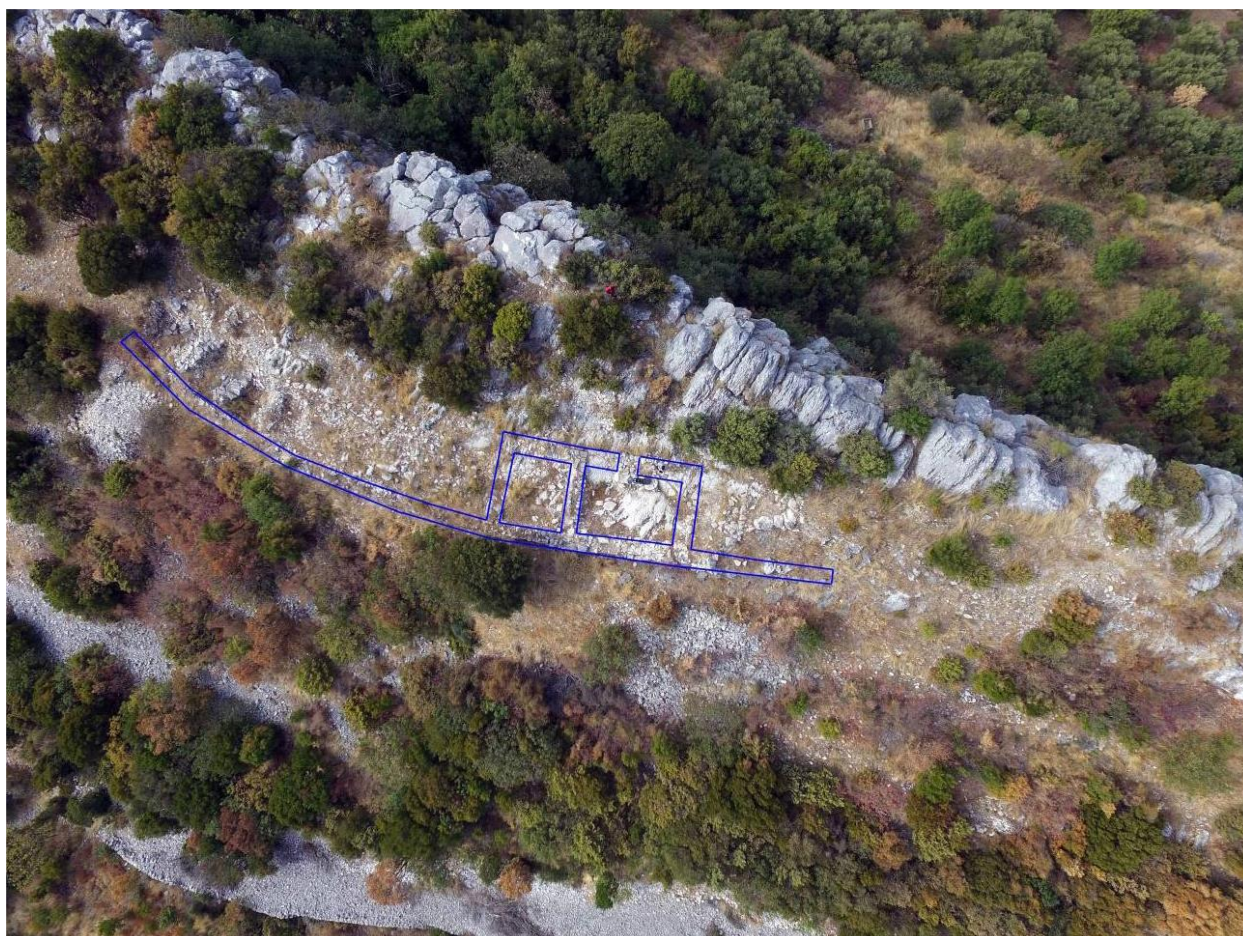
Picture 3. The walls of a prehistoric rampart and a medieval tower

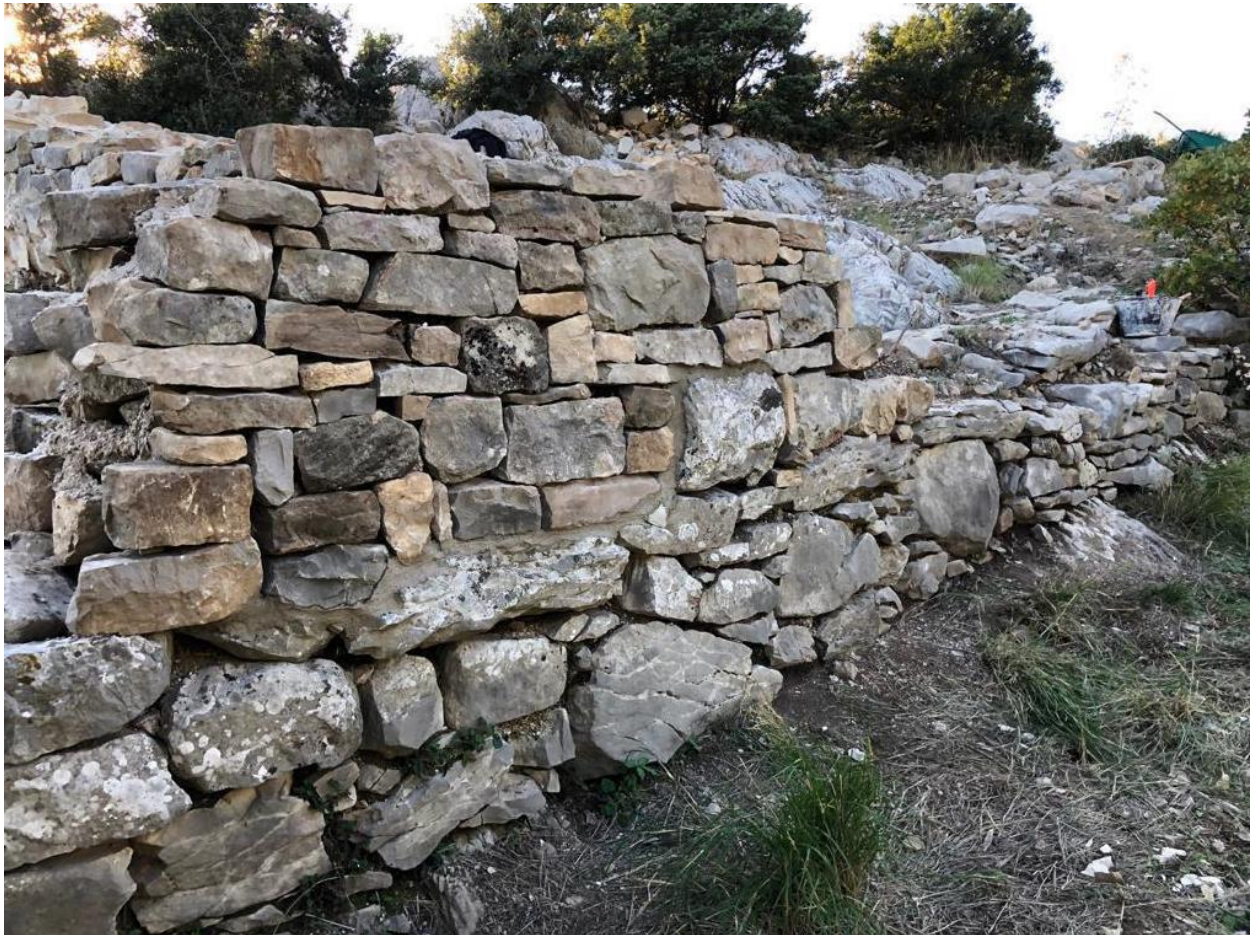
Picture 4. The upbringing of the original wall

The second phase of the project was the restoration and conservation of the fortification system. The activities took place during the summer of 2021. In this period, parts of the fortification system were reconstructed and preserved in order to restore the overall picture of the site. Methodology and tools used in that activity are presented in “REPORT ON CONDUCTED CONSERVATION AND RESTORATION WORKS ON THE PART OF THE SITE OSTROG - BALAVAN - II. WORK PHASE” October 2021. On the site wall construction was carried out through the anchoring of loose stones and basic landscaping to make the site more accessible.

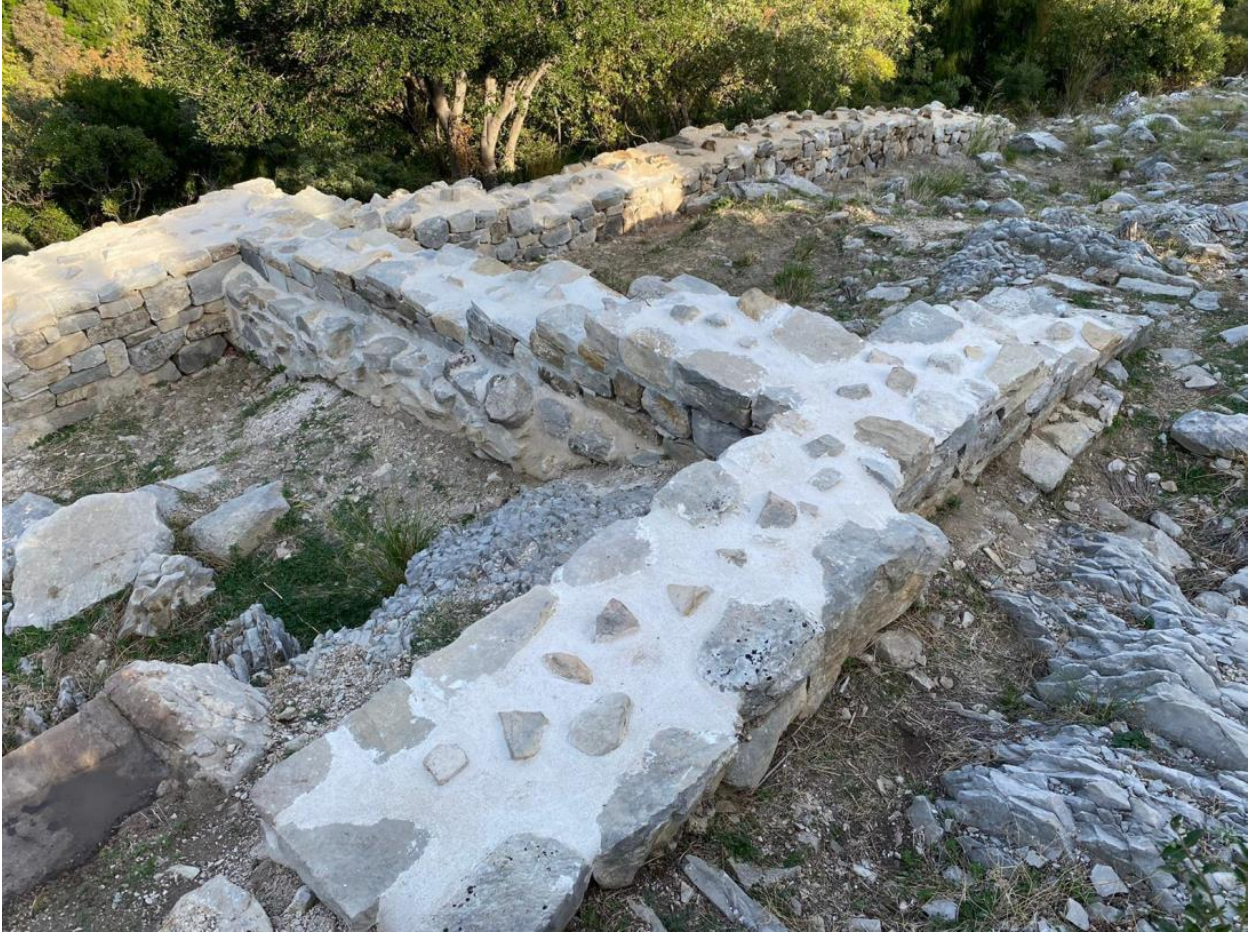
Picture 5. Wall after reconstruction

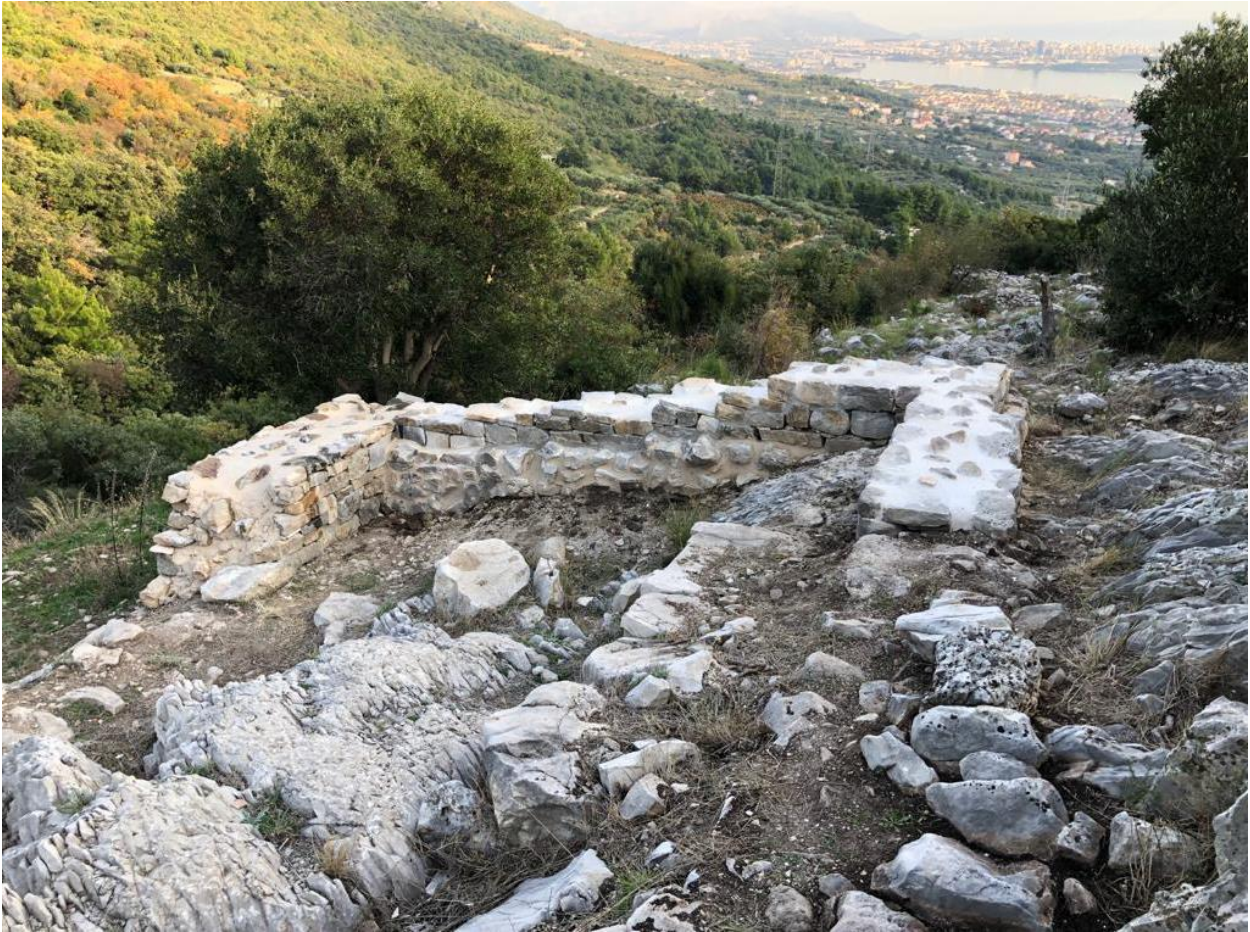
Picture 6. Location of the fortification and reconstruction process

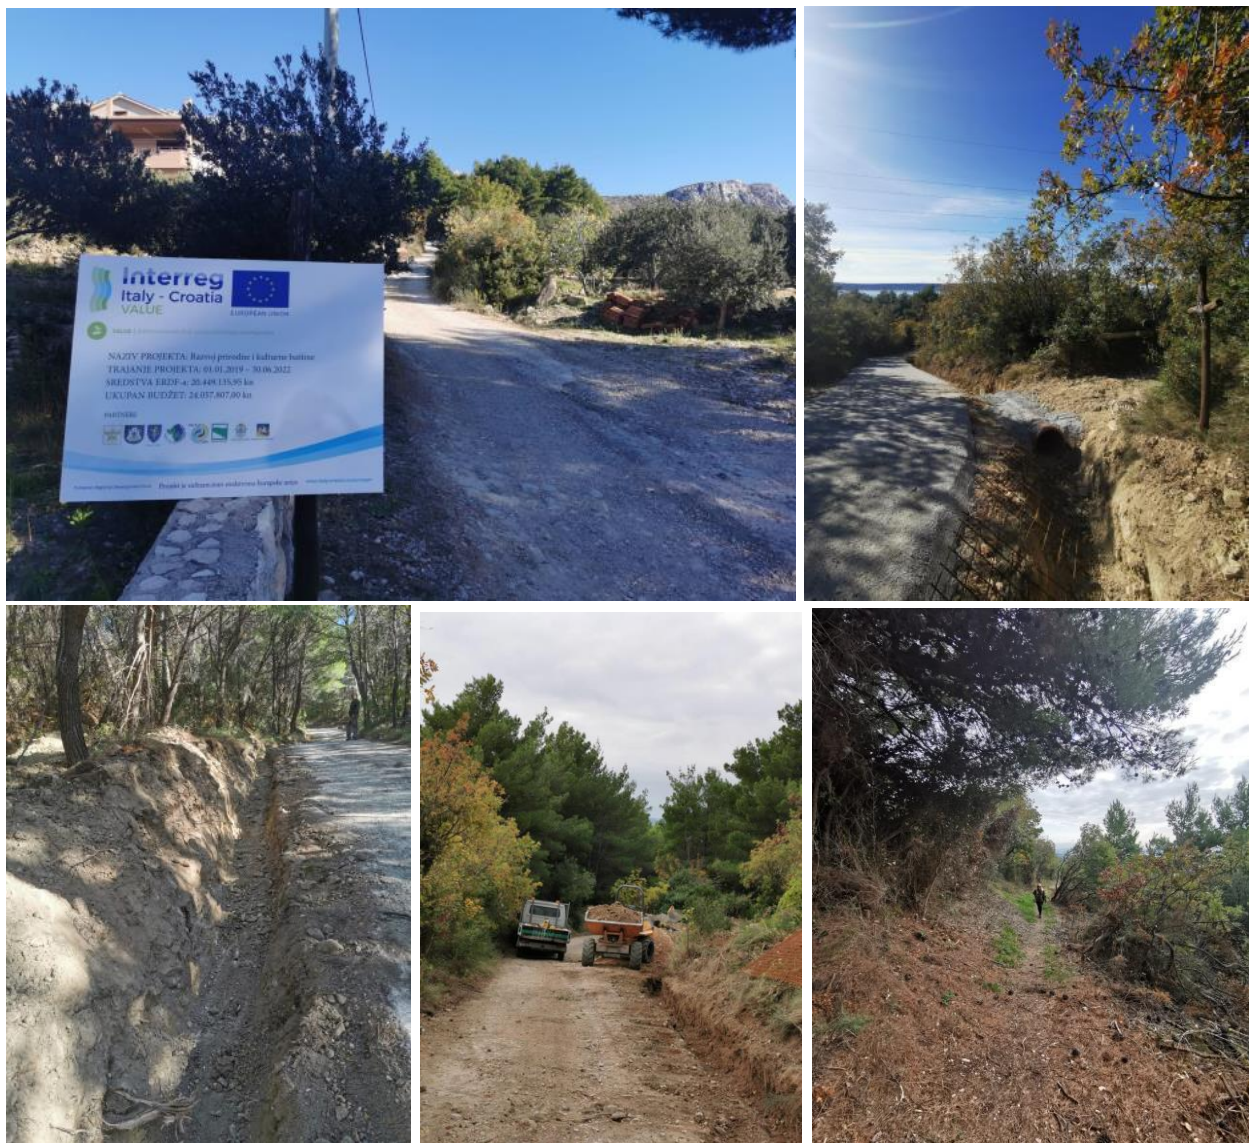
Since the site of Ostrog is situated on the top of the hill Balavan the dirt road and foot path that lead to that place were in bad shape and needed basic reconstruction in order to make the site accessible to a wider population. Dirt road is partly paved on the most exposed parts and drainage channels are made in order to prevent erosion. Some of the vegetation near the road was removed but minimal interventions were needed to make it more accessible. The path that leads to the site was cleaned from vegetation and collapsed stone walls were repaired.
